**2021 USEPA CCR RULE OPERATING
RECORD PERIODIC CERTIFICATION
REPORT
§257.73(a)(2)-(3), (c), (d¹), (e) and §257.82
COAL PILE RUNOFF POND
Zimmer Power Plant
Moscow, Ohio**

Zimmer Power Company LLC

October 11, 2021

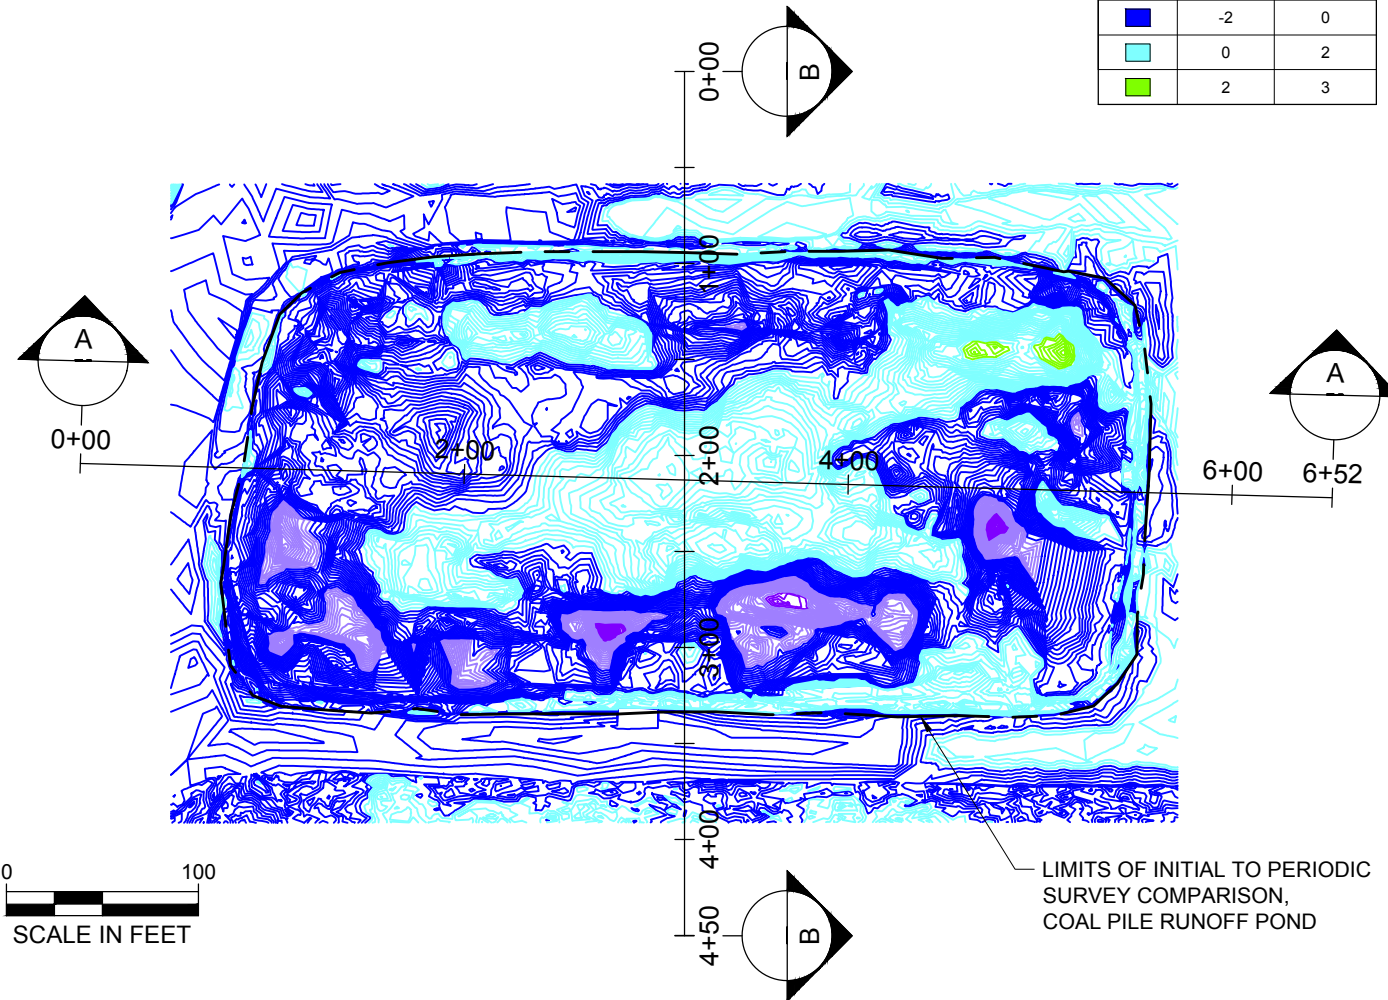
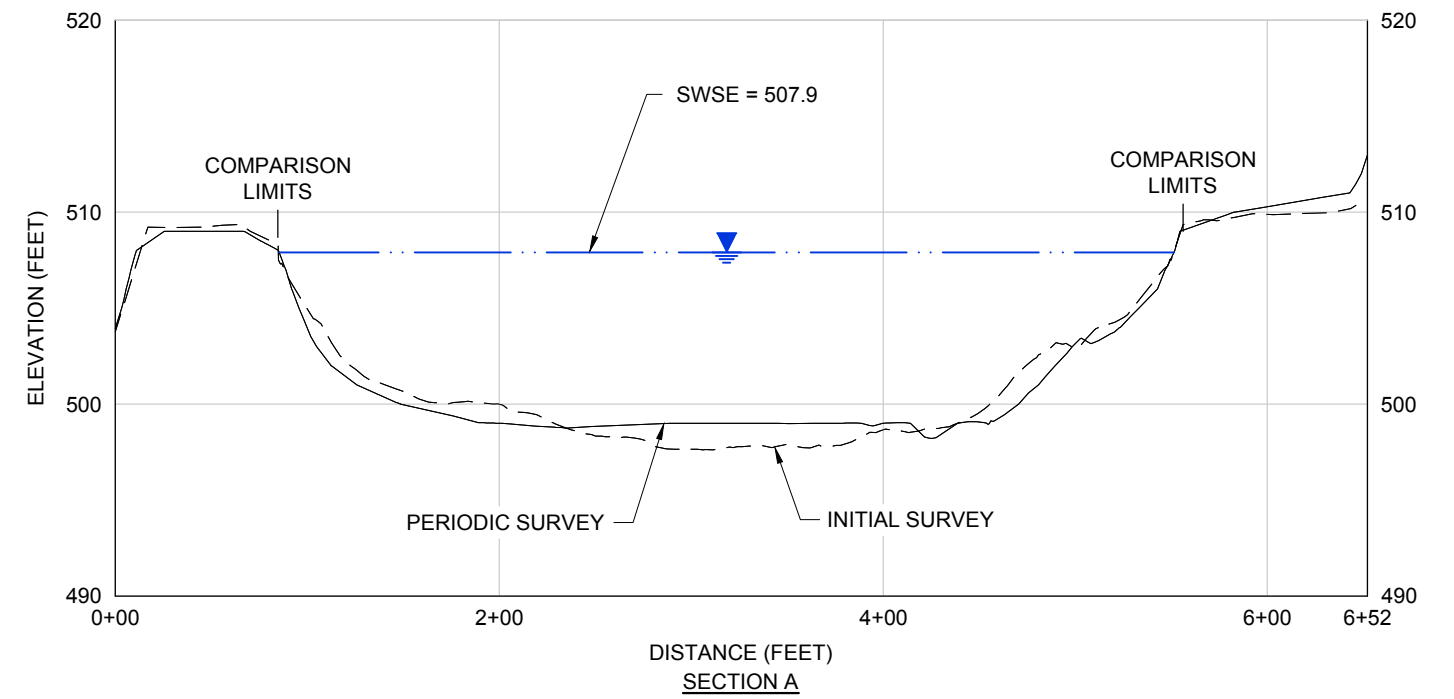
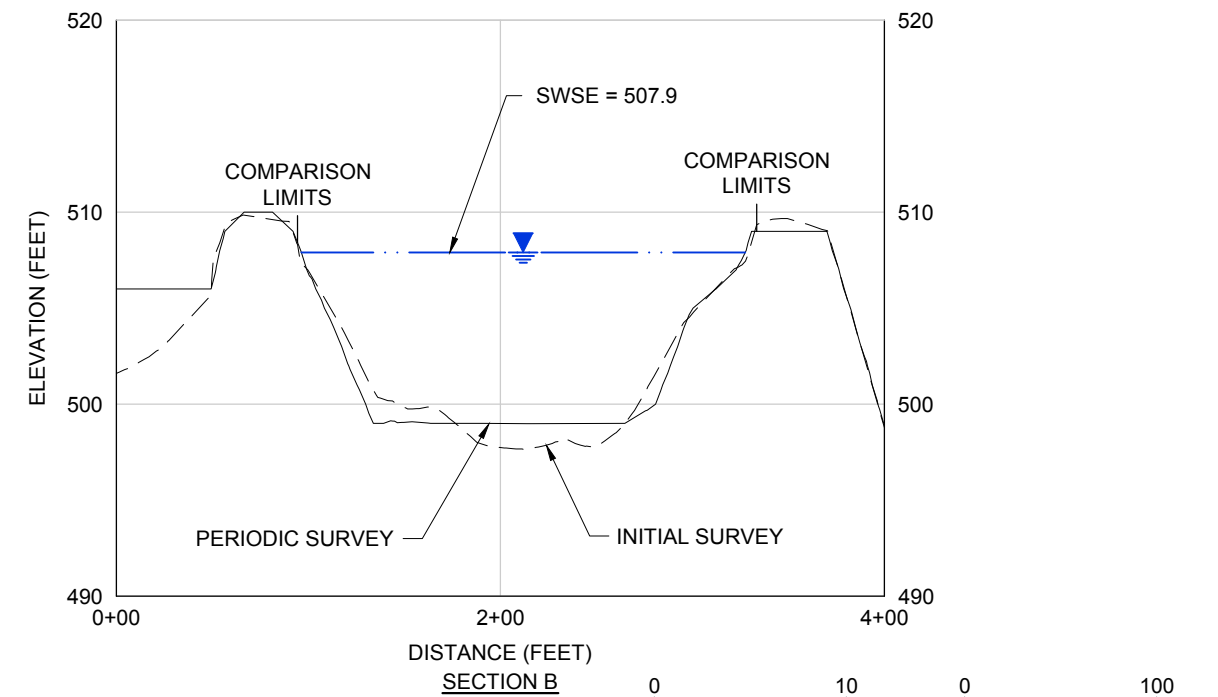
SURVEY COMPARISON ISOPACH COAL PILE RUNOFF POND ZIMMER POWER PLANT MOSCOW, OHIO	
GLP8027.10	JULY 2021
DRAWING 2

- No notable changes in geometry of the pond’s embankment was observed; and
- Some dredging appears to have been performed in the southeast corner.

INITIAL TO PERIODIC SURVEY COMPARISON SUMMARY			
	CUT	FILL	NET (CU. YD.)
COAL PILE YARD RUNOFF POND	2,220	930	1,290 (CUT)
ABOVE SWSE	215	84	131 (CUT)
BELOW SWSE	2,007	842	1,165 (CUT)

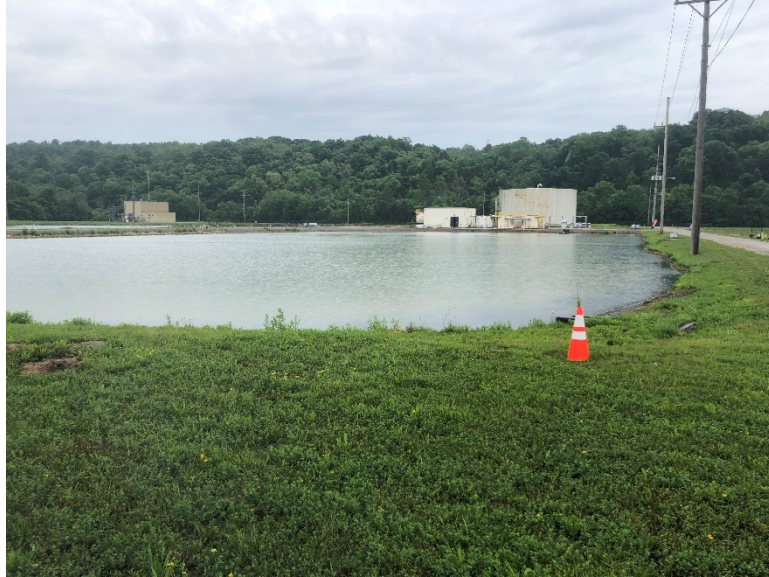
Direction Facing:
NE

Comments:
Photo taken from the west embankment. Example of vegetative coverage along the upstream sides of the pond's embankments.

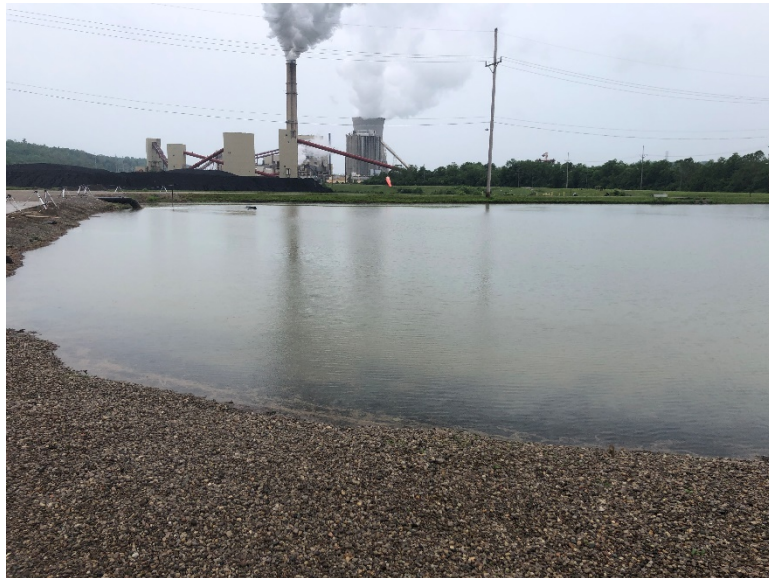
Photo: 02

Comments:
Photo taken from the northeast corner of the pond. Upstream slopes protected with stone. No signs of erosion.
