**2021 USEPA CCR RULE PERIODIC
CERTIFICATION REPORT
§257.73(a)(2)-(3), (c), (d), (e) and §257.82
D BASIN
Zimmer Power Plant
Moscow, Ohio**

Zimmer Power Company LLC

October 11, 2021

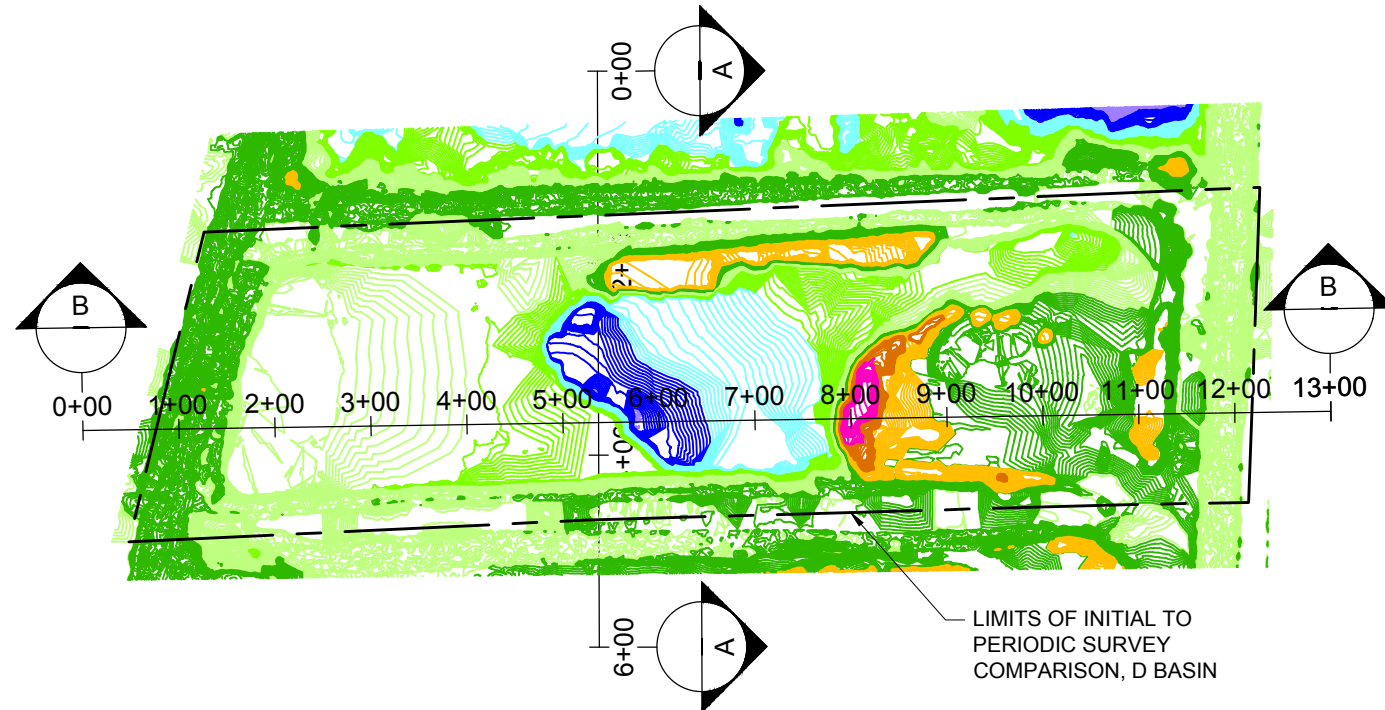
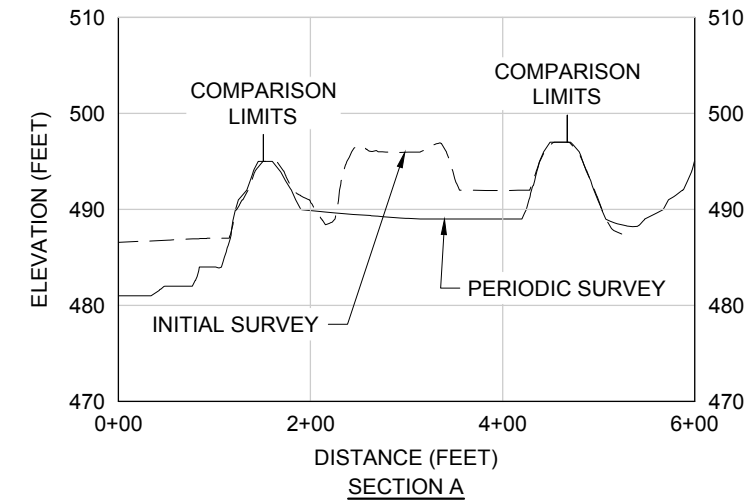
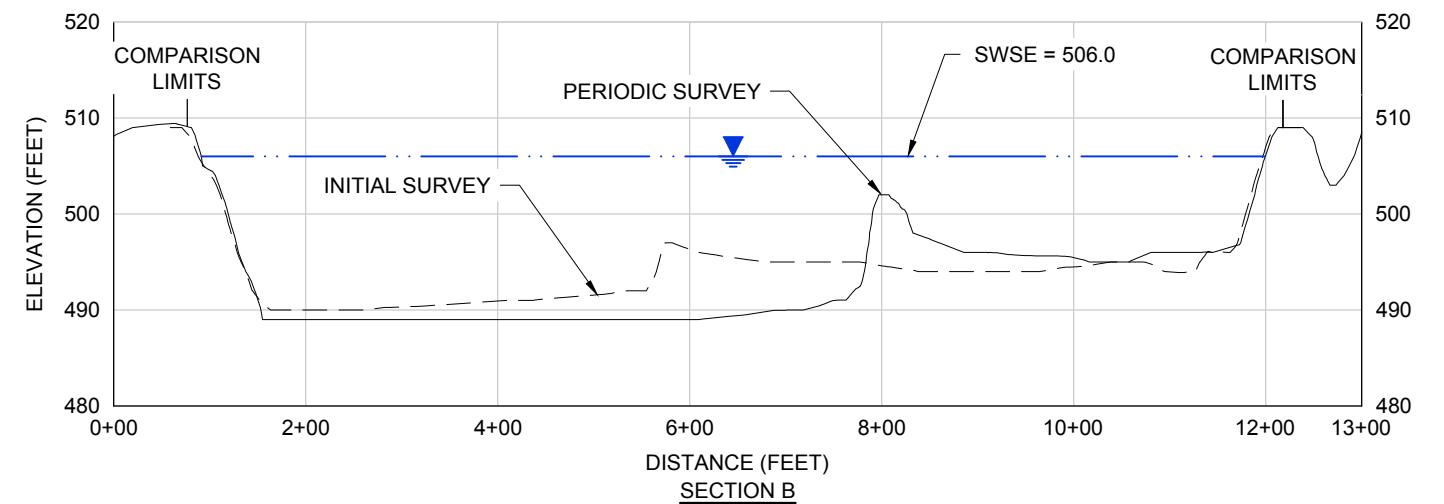
SURVEY COMPARISON ISOPACH ZIMMER POWER PLANT MOSCOW, OHIO	
GLP8027.10	JUNE 2021
DRAWING 2

INITIAL TO PERIODIC SURVEY COMPARISON SUMMARY			
SURFACE IMPOUNDMENT	CUT	FILL	NET (CU. YD.)
D BASIN	18,183	6,336	11,846 (CUT)
ABOVE SWSE	18,079	6,195	11,884 (CUT)
BELOW SWSE	106	143	37 (FILL)

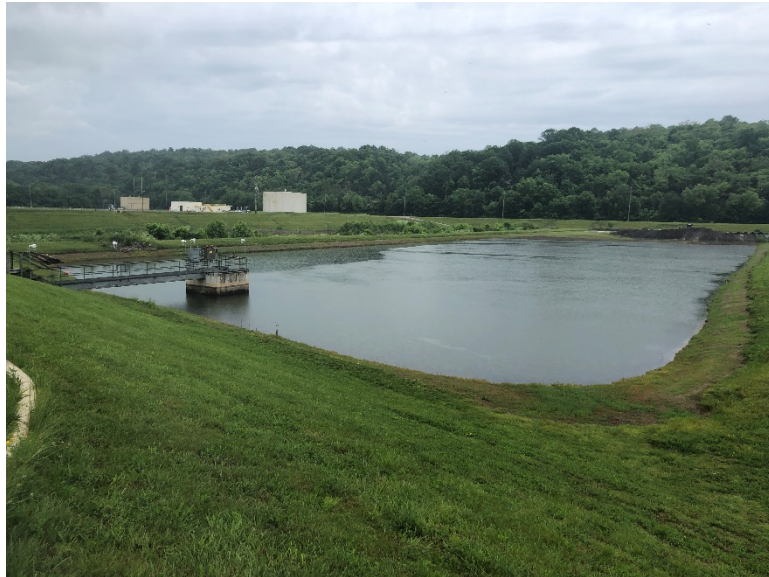
Comments:
Photo of the D Basin from the west embankment. Example of vegetative coverage along the upstream sides of the basin's embankments.

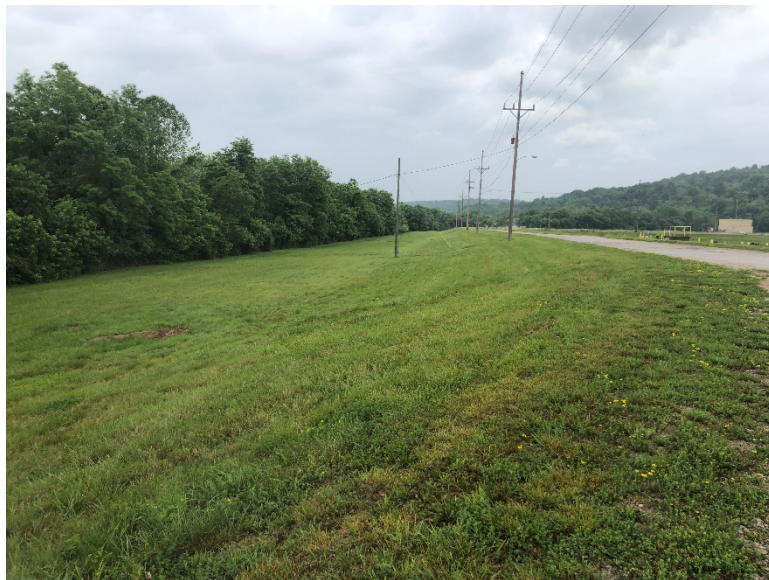
Photo: 02

Comments:
Example of vegetative coverage for the downstream slope along the west embankment.

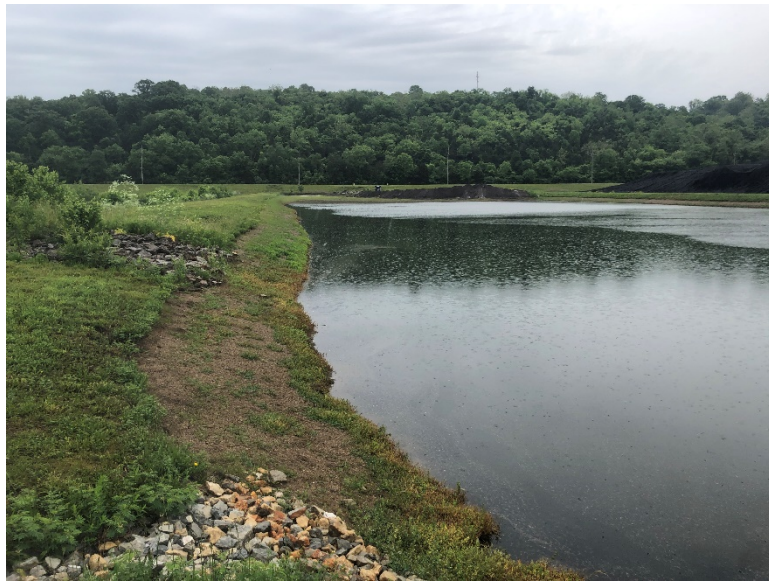
Comments:
North upstream embankment. Some sparse vegetated cover between the current and what appears to be historic high-water level.

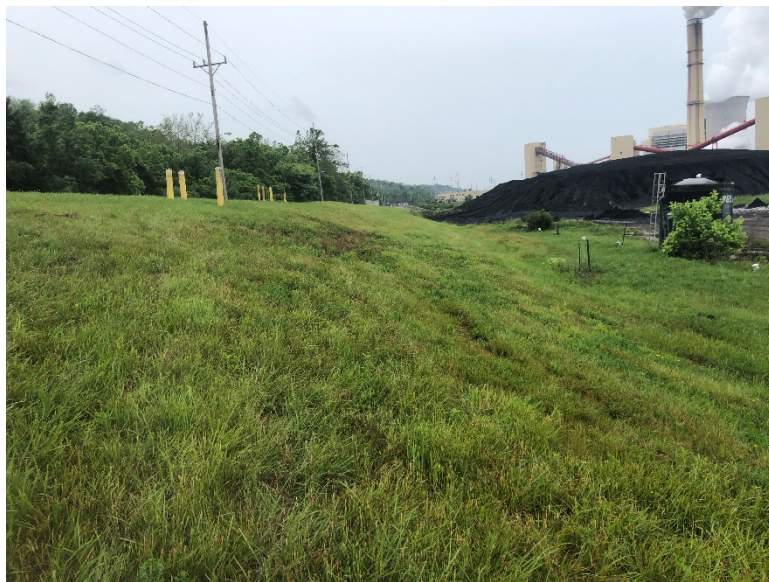
Photo: 04

Comments:
Photo of the upstream side of the east embankment. Example of vegetative cover along the slope of the embankment.

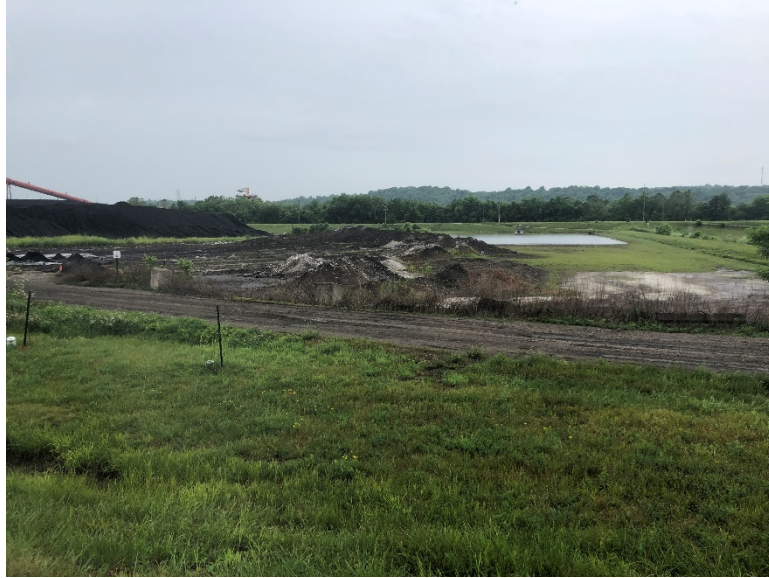
Comments:
Photo of D Basin
taken from the east
embankment.
Photo is of the
portion of the basin
that is filled with
ash.

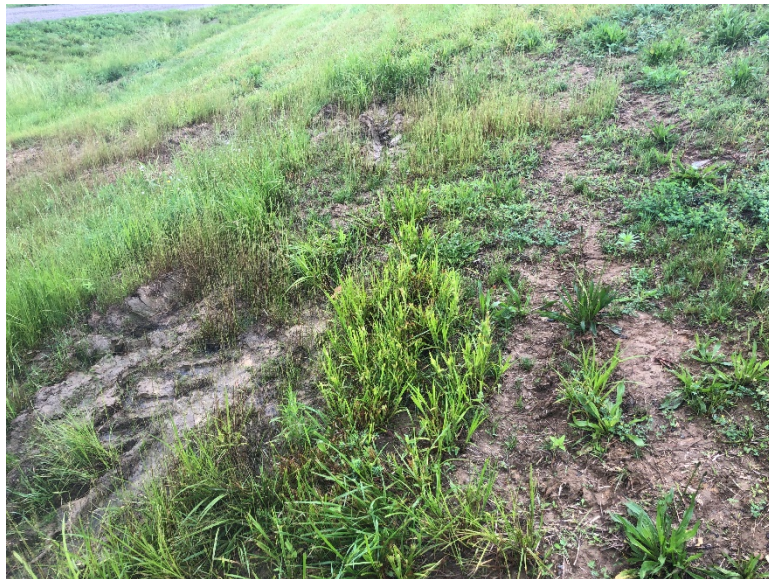
Photo: 06

Comments:
Observed some
spots of poor
vegetation along
the upstream side
of the east
embankment.
Geosyntec
recommend these
areas be seeded
during regular
maintenance.

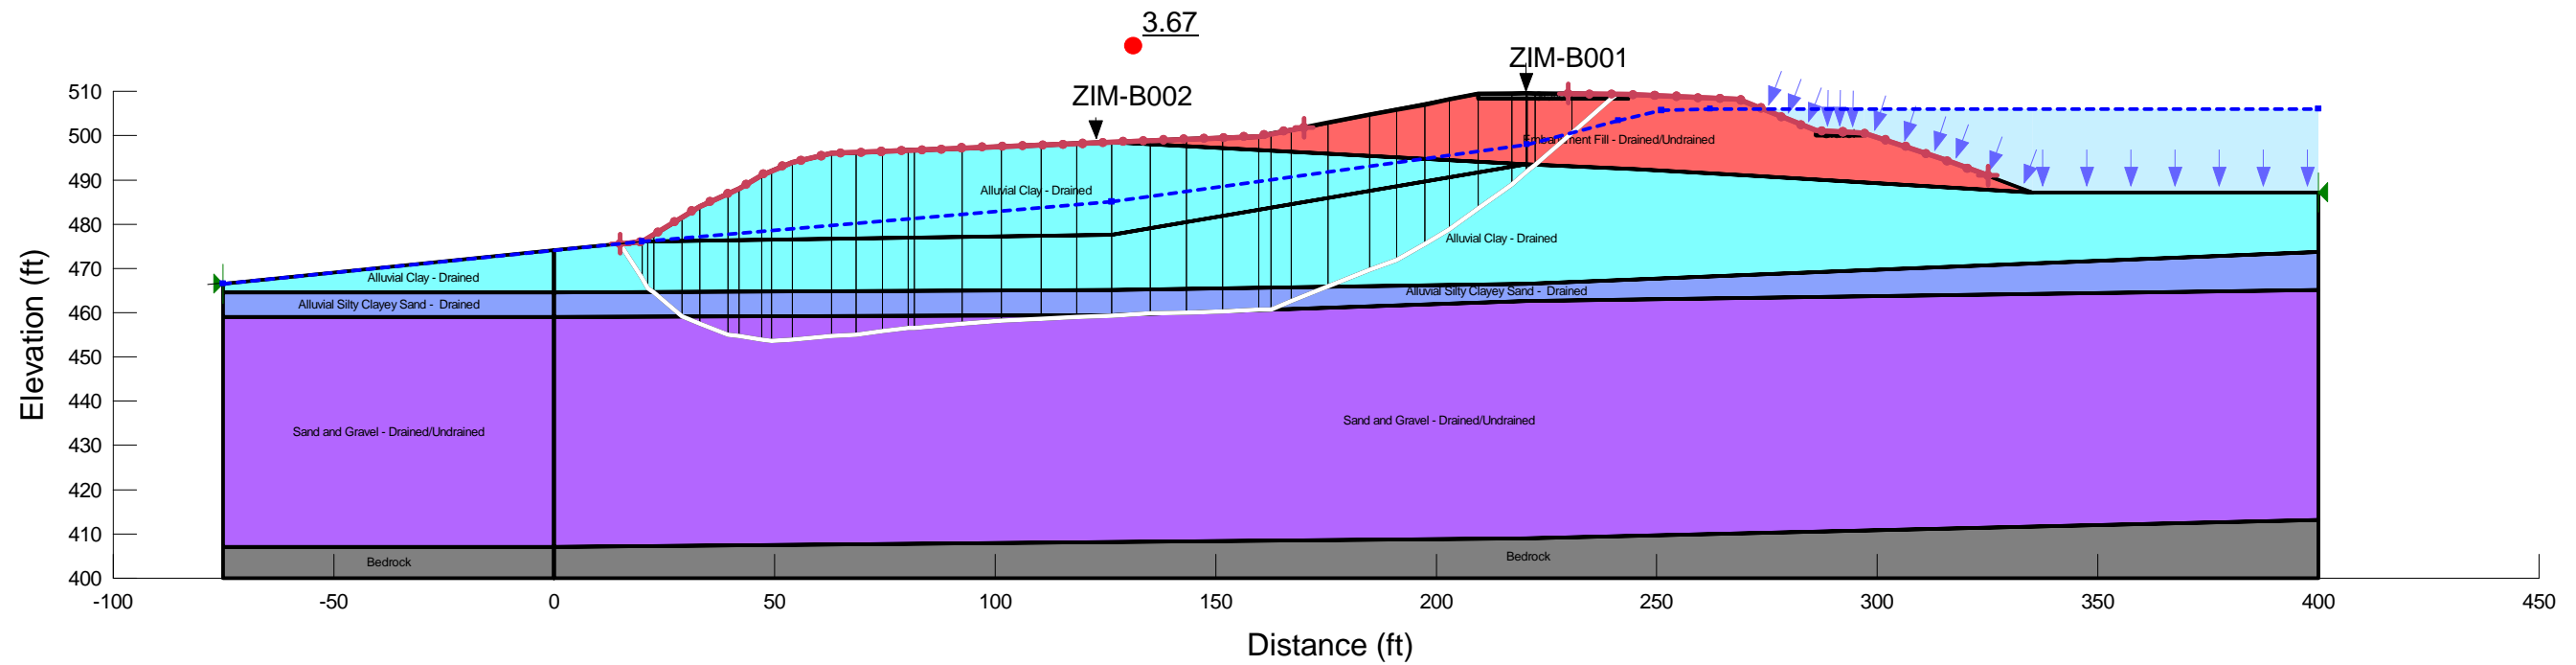
**Static Global (Drained Strengths) Downstream
Cross-Section 1
D Basin, West Embankment**

Factors of safety from the Periodic SFA and Initial SFA, including factors for safety for loading conditions required by the Initial and Periodic SSA, are summarized in **Table 3**. The factors of safety confirm that the DBSN meets the requirements of §257.73(e)(1). Slope stability analyses associated with the Initial SFA are provided in **Attachment D**.
