**ANNUAL CCR UNIT INSPECTION REPORT  
LUMINANT – BIG BROWN STEAM ELECTRIC STATION  
NORTH AND SOUTH ASH PONDS & ASH DISPOSAL AREA II  
FREESTONE COUNTY, TEXAS**

January 14, 2016

PBW Project No. 5170A

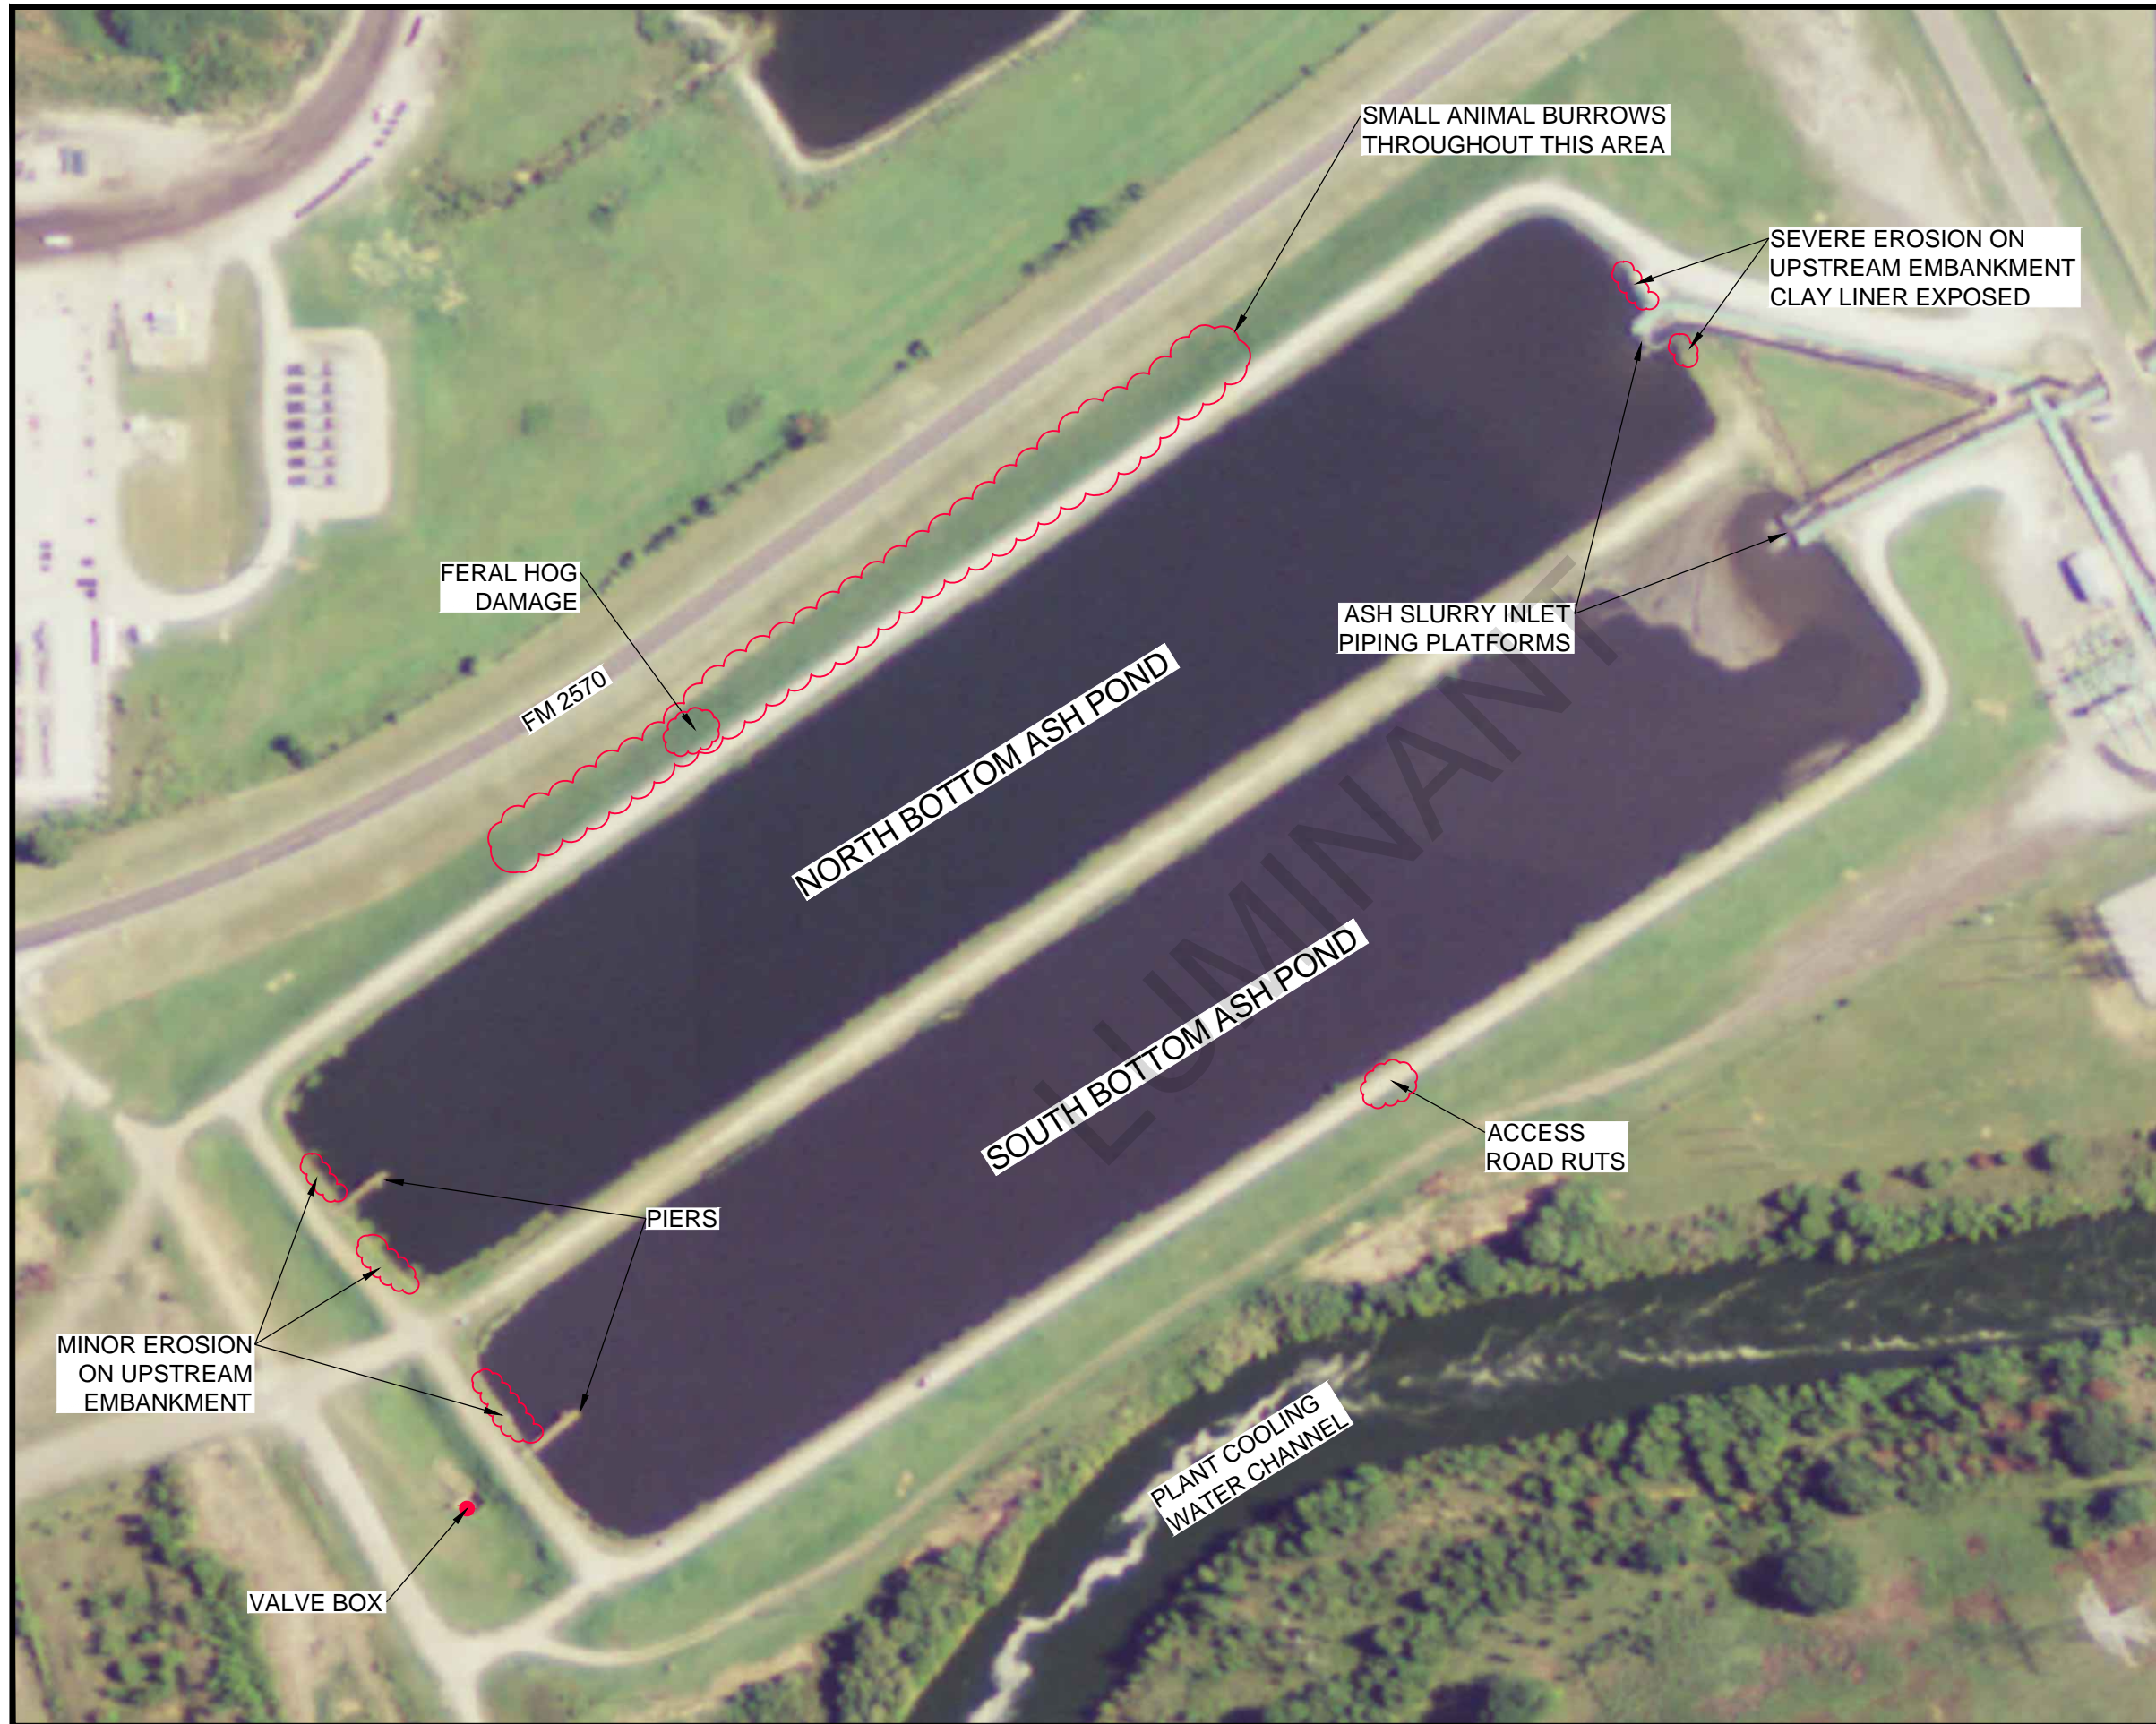
- Monitor the small area of feral hog damage on the north embankment of the NBAP;

- Monitor the area of small animal burrows observed on the north embankment of the NBAP and repair with compacted clay fill or similar material if necessary; and
- Monitor the wet areas observed near the toe of the embankment slopes to allow for identification of potential seepage during weekly inspections performed during seasonally dry periods.

- Severe erosion was observed on the upstream embankment on the east side of the NBAP, near the ash slurry piping platform. A section of concrete near the platform had been undermined and the clay liner of the impoundment was visible in these areas. These areas should be repaired and provided with rock rip rap or other erosion control material.
- Minor areas of erosion were observed on the upstream embankment on the west side of both BAPs, near the piers. These areas should be monitored and rock rip rap or other erosion control material should be placed in these areas if the erosion becomes worse.

SMALL ANIMAL BURROWS  
THROUGHOUT THIS AREA

SEVERE EROSION ON  
UPSTREAM EMBANKMENT  
CLAY LINER EXPOSED

FERAL HOG  
DAMAGE

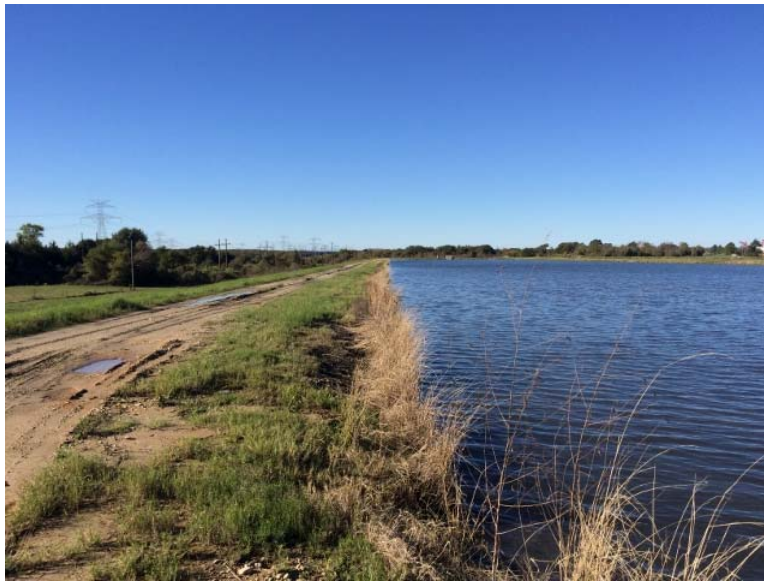
The majority of the embankment crest is improved with a crushed aggregate access road. The access roads are generally in good condition with limited areas of rutting observed on the crest of the south embankment of the SBAP. No visual evidence of slope failures or misalignments were noted on the crests of the embankments.

Pastor, Behling & Wheeler	DESCRIPTION	<b>Photograph 3</b> – (View W) View along crest of south embankment of SBAP. Note rutting on left.	
PROJECT NO. 5170A	SITE NAME	Big Brown Steam Electric Station – Bottom Ash Pond Annual Inspection	DATE 11/18/2015

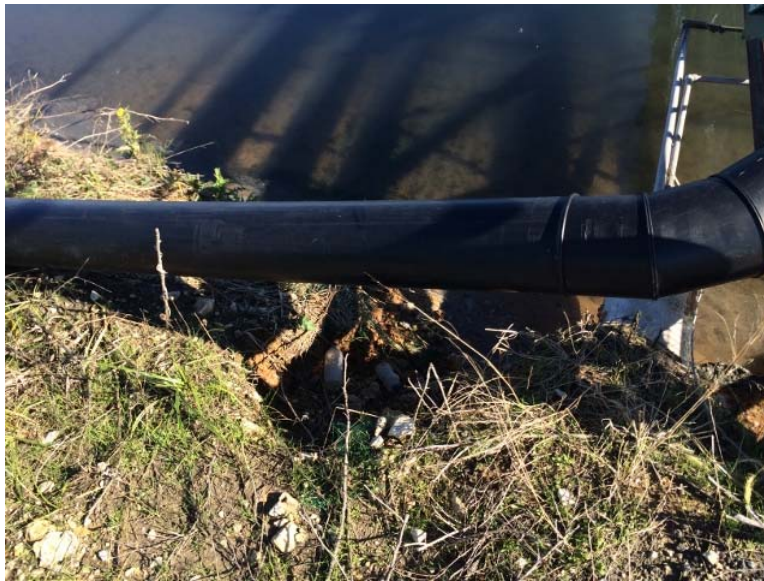
Pastor, Behling & Wheeler  PROJECT NO. 5170A	DESCRIPTION	<b>Photograph 5</b> – Minor erosion of upstream embankment at west end of SBAP.	
	SITE NAME	Big Brown Steam Electric Station – Bottom Ash Pond Annual Inspection	DATE 11/18/2015

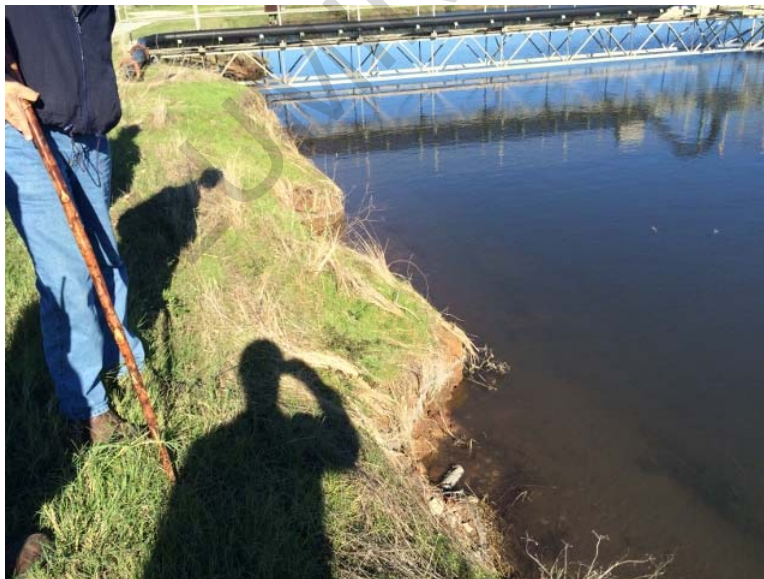
Pastor, Behling & Wheeler  PROJECT NO. 5170A	DESCRIPTION	<b>Photograph 6</b> – Minor erosion along upstream embankment at west end of NBAP. Pier in background.	
	SITE NAME	Big Brown Steam Electric Station – Bottom Ash Pond Annual Inspection	DATE 11/18/2015

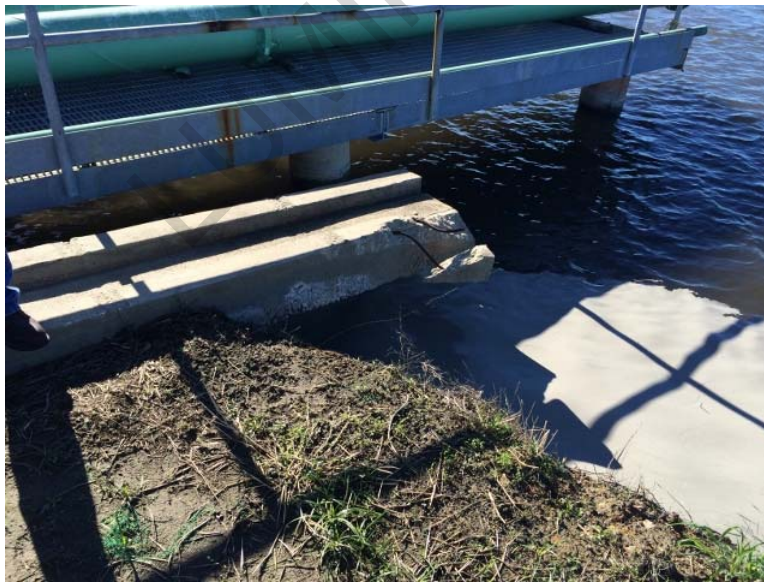
Pastor, Behling & Wheeler	DESCRIPTION	<b>Photograph 10</b> – Severe erosion of upstream embankment at east end of NBAP.	
PROJECT NO. 5170A	SITE NAME	Big Brown Steam Electric Station – Bottom Ash Pond Annual Inspection	DATE 11/18/2015

- Severe erosion was observed on the upstream embankment on the east side of the NBAP, near the ash slurry piping platform. A section of concrete near the platform had been undermined and the clay liner of the impoundment was visible in these areas. These areas should be repaired and provided with rock rip rap or other erosion control material.

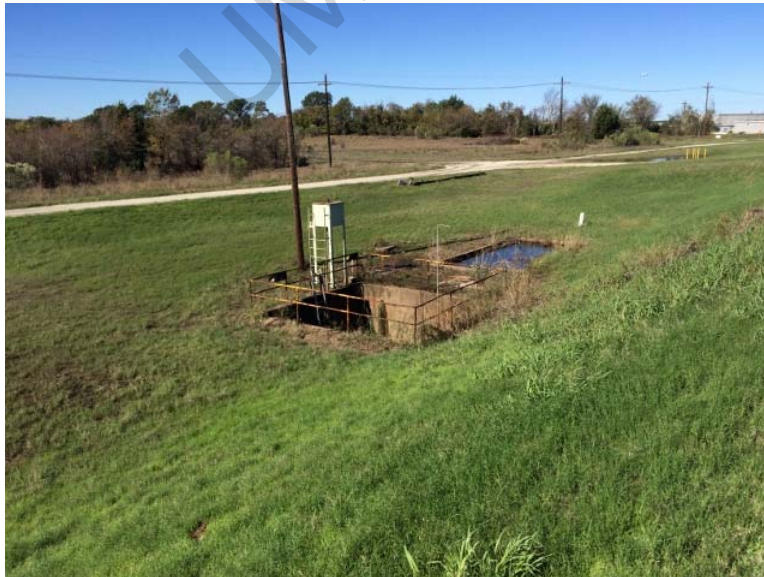
The below grade valve box located immediately west of the SBAP was also inspected during the annual inspection. No evidence of seepage or leakage around/through the subsurface piping running from the impoundments to the valve box was observed.

Pastor, Behling & Wheeler	DESCRIPTION	<b>Photograph 12</b> – Below grade valve box at west end of SBAP.	
PROJECT NO. 5170A	SITE NAME	Big Brown Steam Electric Station – Bottom Ash Pond Annual Inspection	DATE 11/18/2015

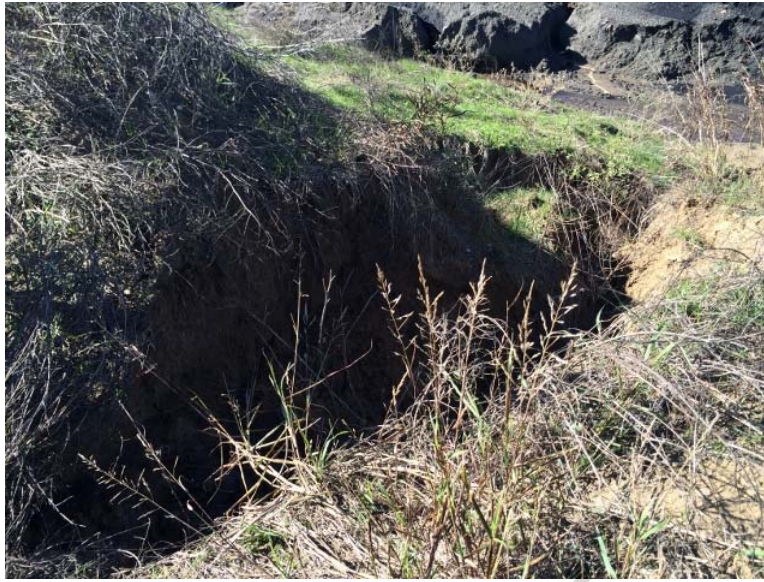
- Severe erosion was observed in several areas on the interior slope face of the Cell 10 embankment, along the south side. These areas should be repaired and provided with rock rip rap or other erosion control material.

Pastor, Behling & Wheeler	DESCRIPTION	<b>Photograph 3</b> – Severe erosion of interior slope face of south embankment of Cell 10.	
PROJECT NO. 5170A	SITE NAME	Big Brown Steam Electric Station – Ash Disposal Area II Annual Inspection	DATE 11/18/2015

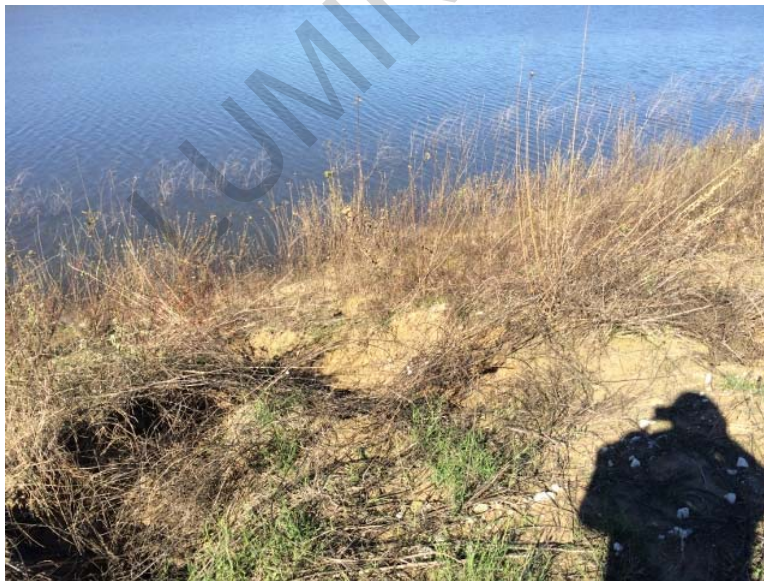
Pastor, Behling & Wheeler	DESCRIPTION	<b>Photograph 4</b> – Severe erosion of interior slope face of south embankment of Cell 10.	
PROJECT NO. 5170A	SITE NAME	Big Brown Steam Electric Station – Ash Disposal Area II Annual Inspection	DATE 11/18/2015

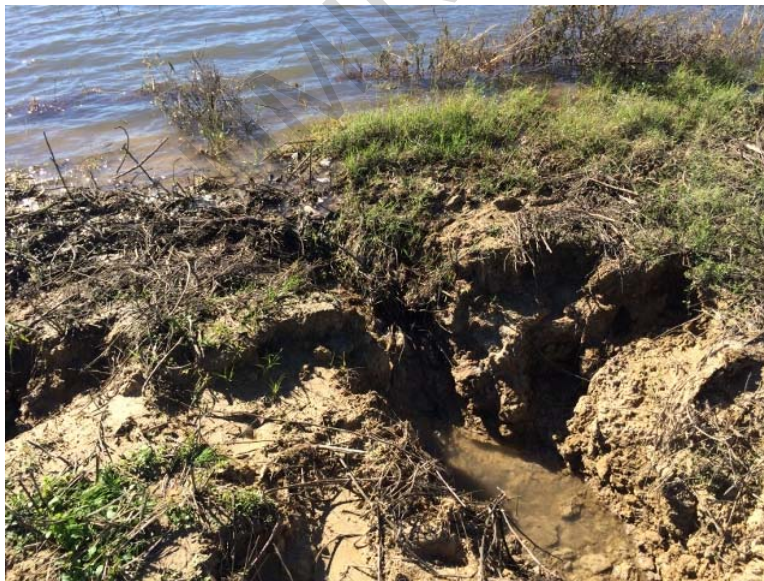
- Severe erosion was observed in the earthen embankment separating Cell 10 from Cell 11 and ash contact water from Cell 10 was observed to be flowing into Cell 11. Cell 11 is enclosed with an earthen embankment and constructed with a clay liner and all observations indicated that the contact water was being contained in Cell 11. A minimum freeboard of approximately 2 feet was being maintained in Cell 11 at the time of the inspection.

The flow of contact water over the top of the interior embankment between the cells will accelerate the observed erosion, potentially to the degree that the stability of the interior embankment between the cells is compromised. It is recommended that the embankment be repaired and the contact water level in Cell 10 be lowered to prevent flow into Cell 11, with appropriate freeboard.

Pastor, Behling & Wheeler  PROJECT NO. 5170A	DESCRIPTION	<b>Photograph 6</b> – Severe erosion of crest of embankment separating Cell 10 and Cell 11. Contact water flowing from Cell 10 to Cell 11.	
	SITE NAME	Big Brown Steam Electric Station – Ash Disposal Area II Annual Inspection	DATE 11/18/2015

- Severe erosion was observed in the earthen embankment separating Cell 10 from Cell 11 and ash contact water from Cell 10 was observed to be flowing into Cell 11. It is recommended that the embankment be repaired and the contact water level in Cell 10 be lowered to prevent flow into Cell 11, with appropriate freeboard.

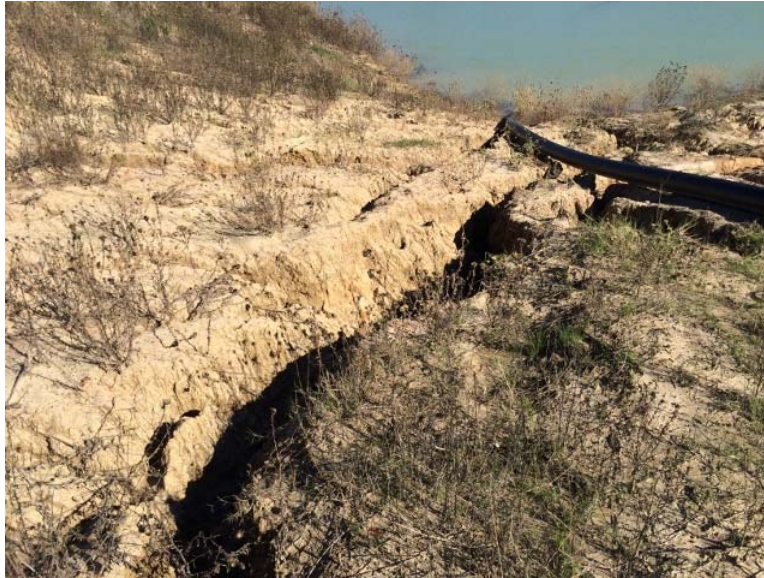
- Severe erosion was observed on the interior slope face of the Cell 11 embankment in the northwest corner. The clay liner of the landfill cell was visible in these areas. These areas should be repaired and provided with rock rip rap or other erosion control material.

Pastor, Behling & Wheeler	DESCRIPTION	<b>Photograph 9</b> – Severe erosion of interior slope face of embankment of Cell 11 in northwest corner.	
PROJECT NO. 5170A	SITE NAME	Big Brown Steam Electric Station – Ash Disposal Area II Annual Inspection	DATE 11/18/2015

- Severe erosion was observed on the interior slope face of the Cell 11 embankment in the northwest corner. The clay liner of the landfill cell was visible in these areas. These areas should be repaired and provided with rock rip rap or other erosion control material.

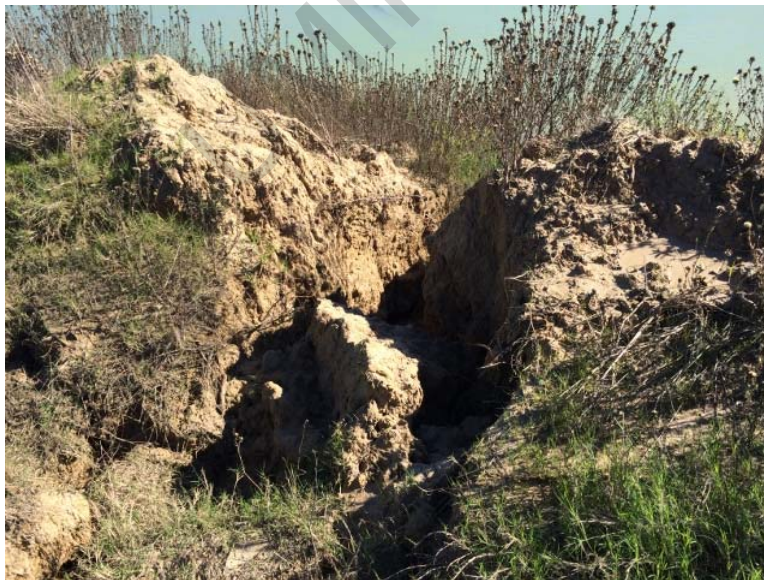
Pastor, Behling & Wheeler	DESCRIPTION	<b>Photograph 10</b> – Severe erosion of interior slope face of embankment of Cell 11 in northwest corner.	
PROJECT NO. 5170A	SITE NAME	Big Brown Steam Electric Station – Ash Disposal Area II Annual Inspection	DATE 11/18/2015

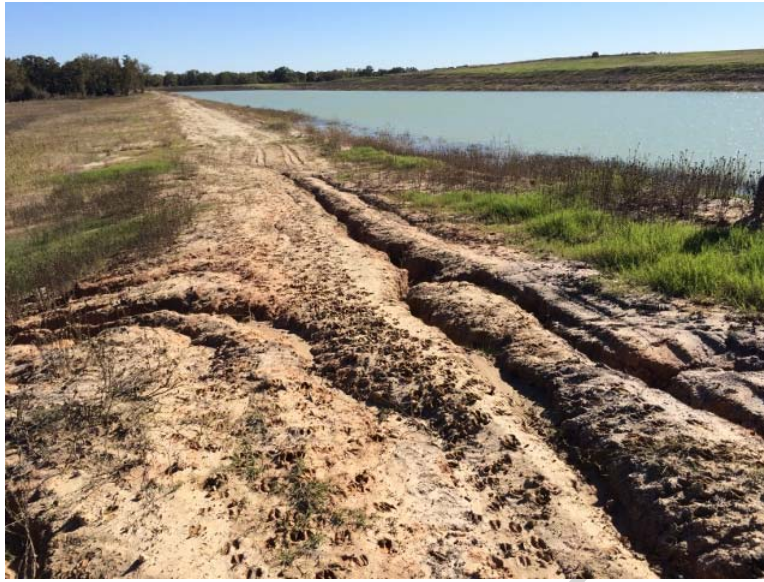
Pastor, Behling & Wheeler	DESCRIPTION	<b>Photograph 11</b> – (View SE) View along crest of north embankment of Cell 11. Note minor erosion and rutting. Cell 11 on right.	
PROJECT NO. 5170A	SITE NAME	Big Brown Steam Electric Station – Ash Disposal Area II Annual Inspection	DATE 11/18/2015
