**2016 ANNUAL CCR UNIT INSPECTION REPORT  
LUMINANT BIG BROWN STEAM ELECTRIC STATION  
ASH DISPOSAL AREA II  
FREESTONE COUNTY, TEXAS**

January 13, 2017

**PASTOR, BEHLING & WHEELER, LLC**  
2201 Double Creek Drive, Suite 4004  
Round Rock, Texas 78664  
Texas Engineering Firm No. 4760

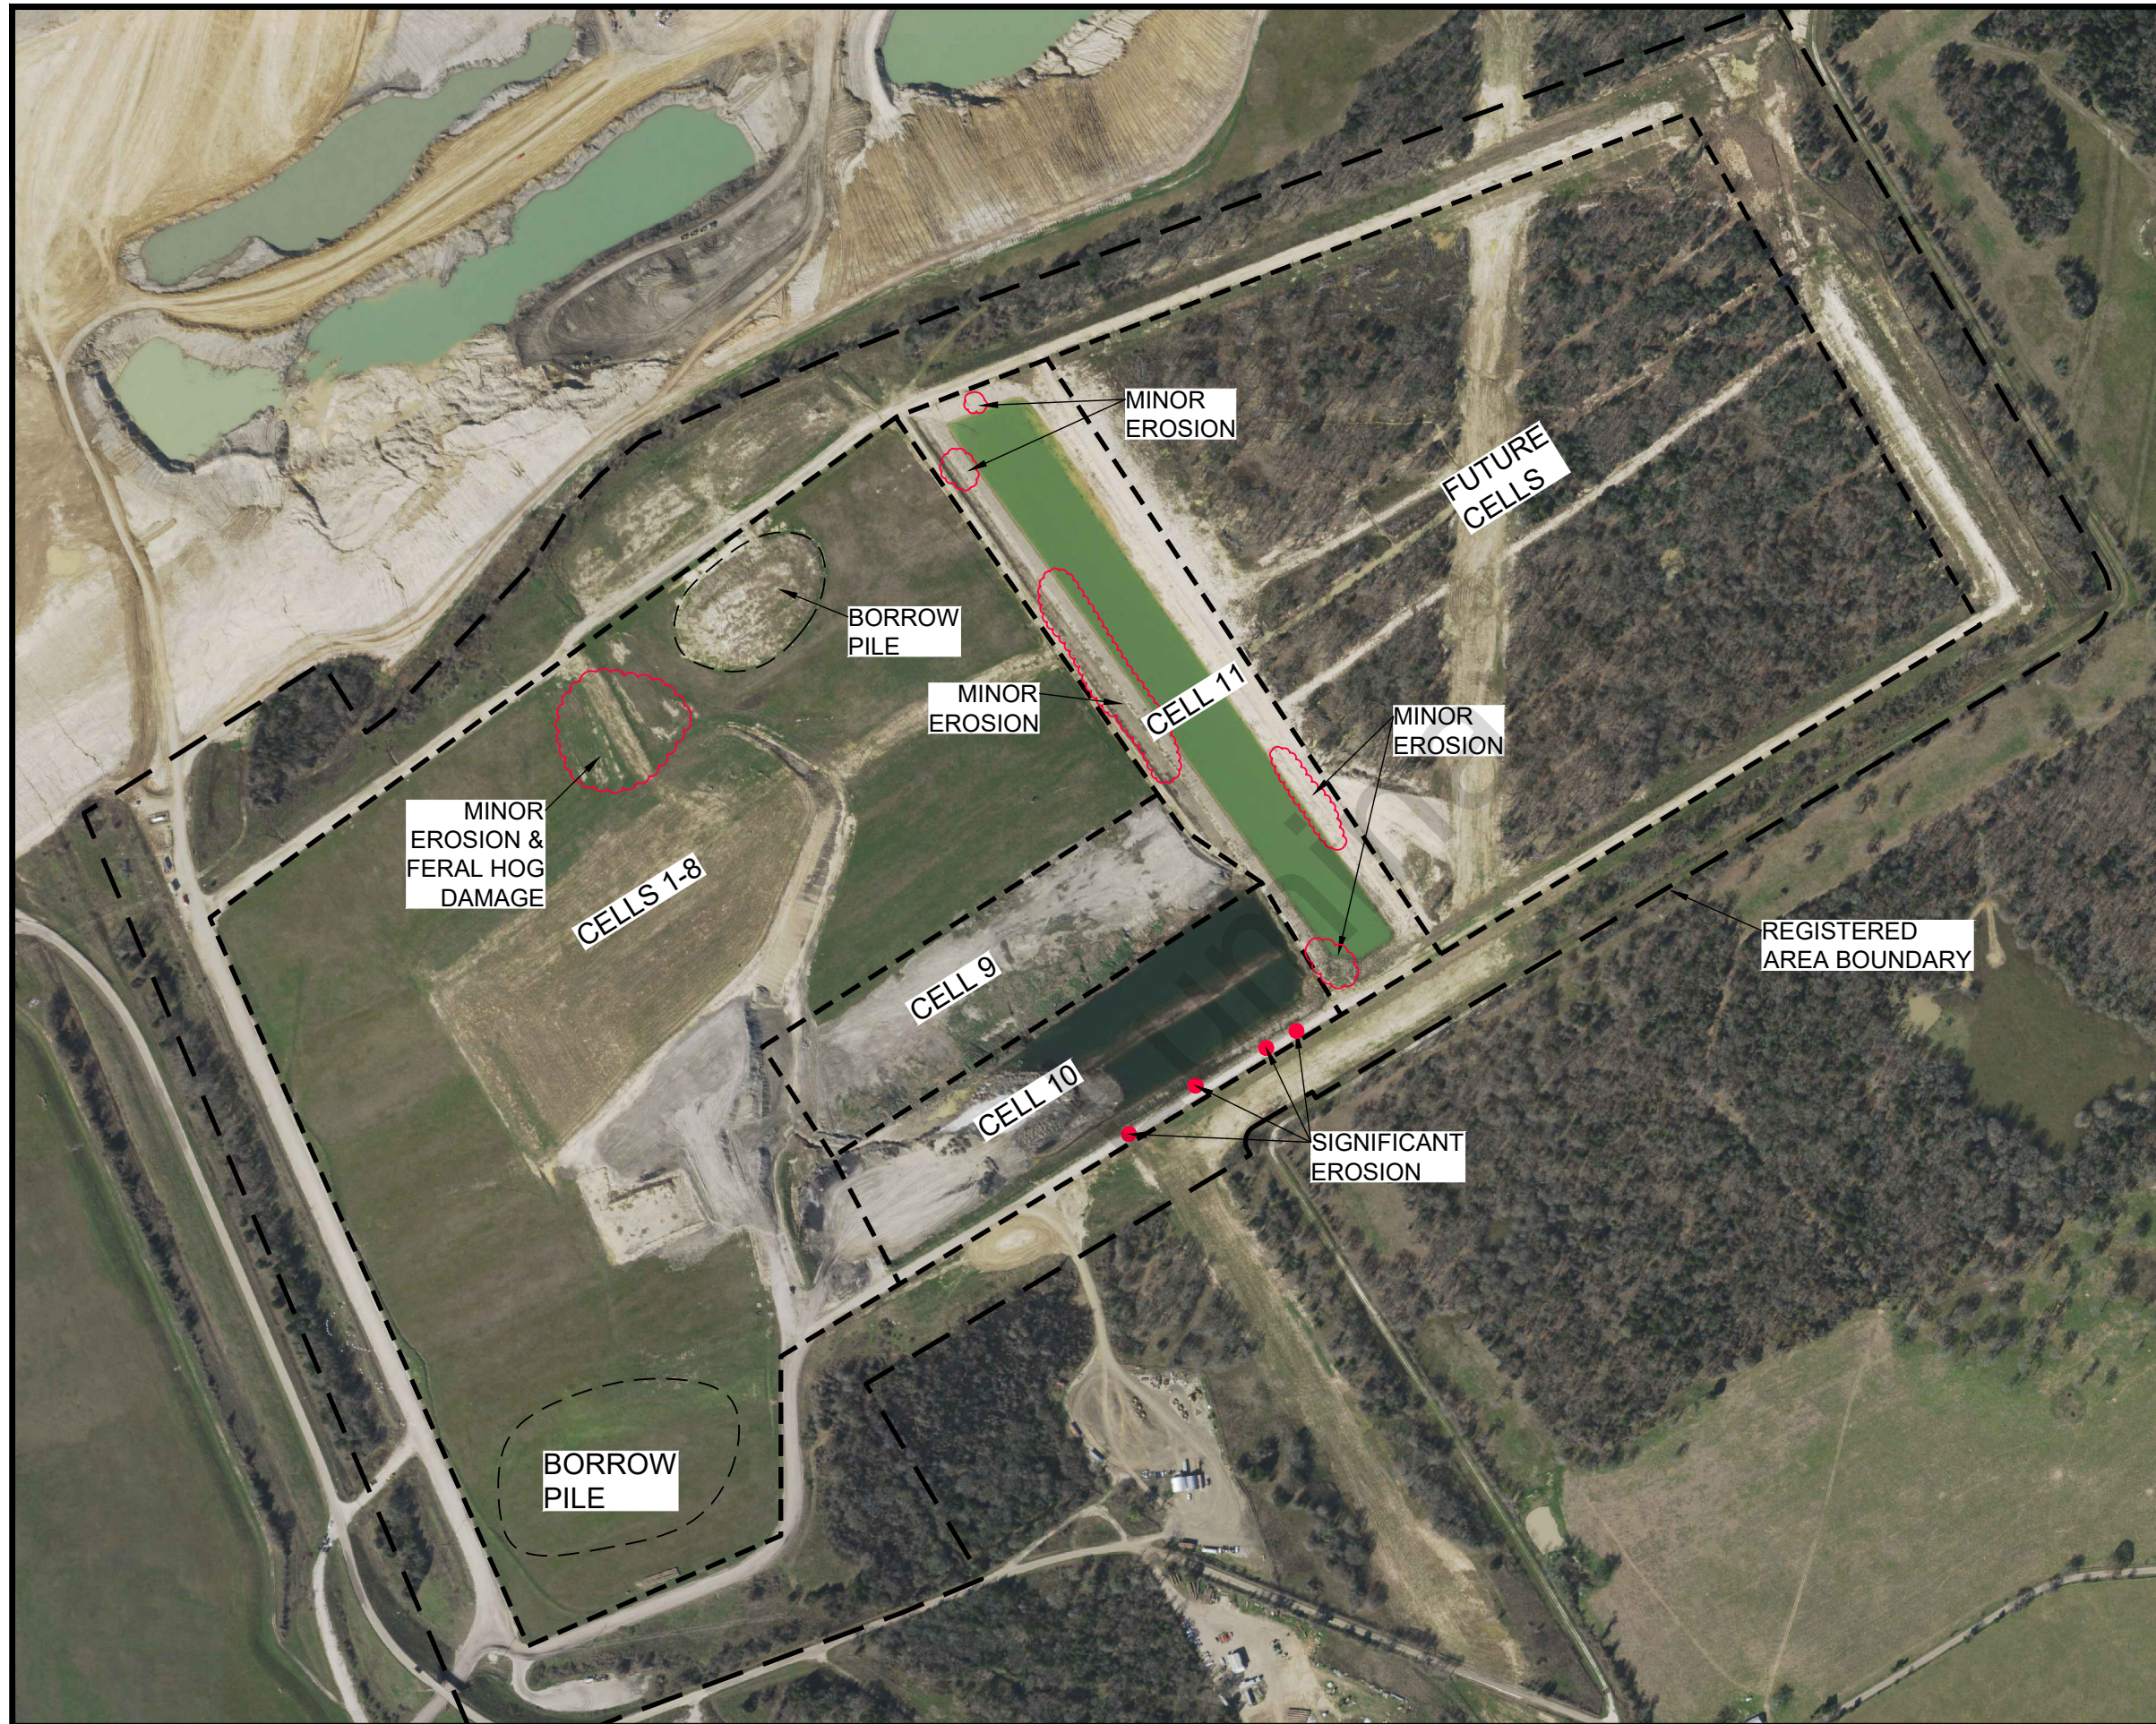
Figure 3  
**ANNUAL INSPECTION FINDINGS  
SUMMARY MAP  
ASH DISPOSAL AREA II**

As indicated on Figure 3, the following areas were noted for future monitoring or repair on the embankments around Cells 10 and 11:

- Significant erosion was observed in several areas on the interior slope face of the Cell 10 embankment, along the south side. These areas should be repaired and provided with rock rip rap or other erosion control material.
- Minor erosion was observed along the interior slope face of the north, east and west embankments of Cell 11. These areas should continue to be monitored and repaired as necessary.

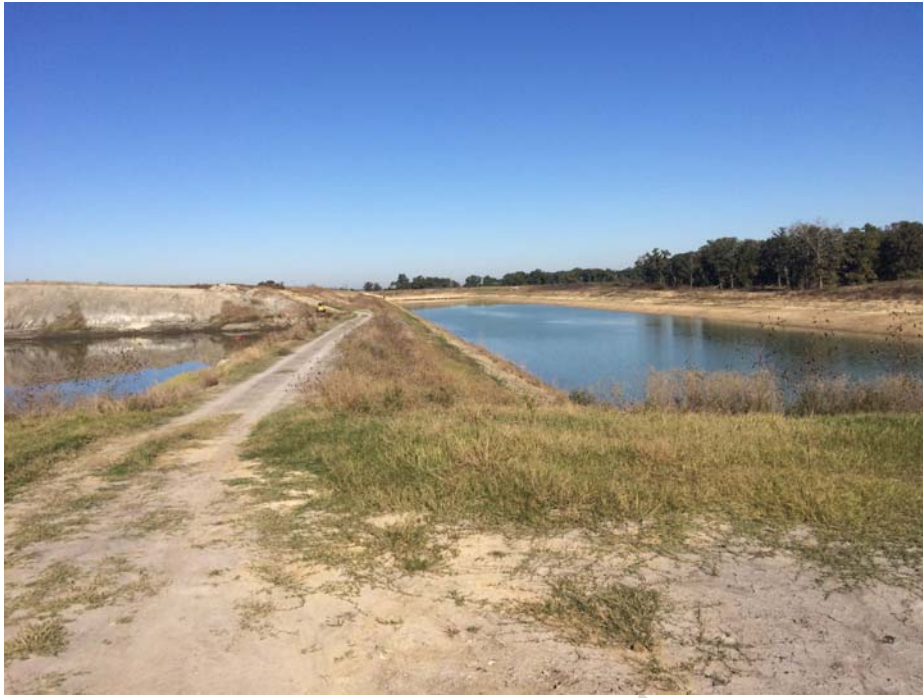
Pastor, Behling & Wheeler	DESCRIPTION	<b>Photograph 1</b> – (View NW) Southwest corner Cell 11, along repaired dike between Cells 10 and 11. Cell 10 on left, Cell 11 on right.	
PROJECT NO. 5255	SITE NAME	Big Brown Steam Electric Station – Ash Disposal Area II Annual Inspection	DATE 11/15/2016

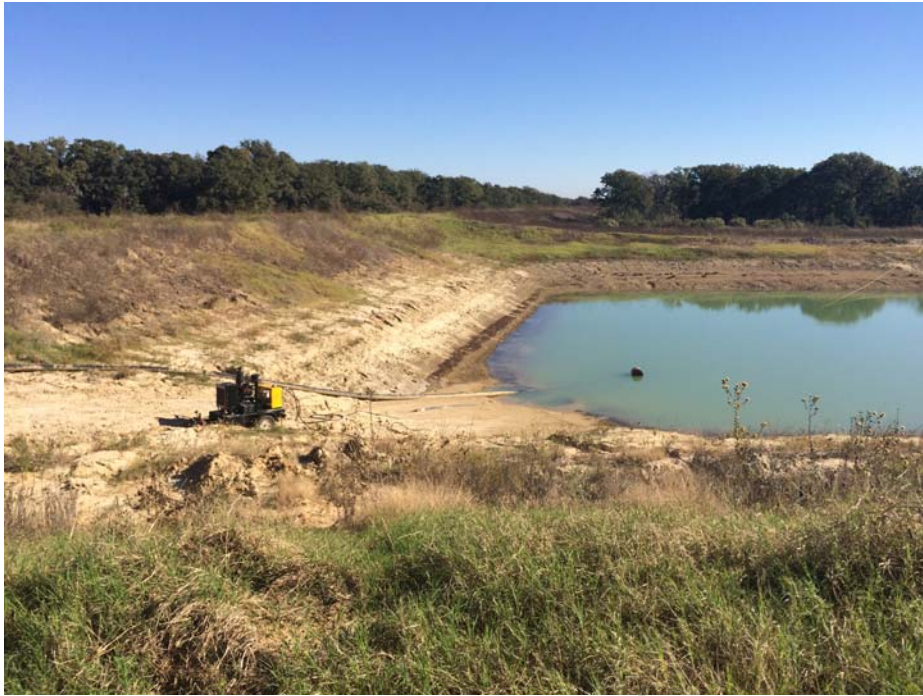
- Minor erosion was observed along the interior slope face of the north, east and west embankments of Cell 11. These areas should continue to be monitored and repaired as necessary.

Pastor, Behling & Wheeler	DESCRIPTION	<b>Photograph 3</b> – (View E) View along north dike of Cell 11. Area of minor erosion on left.	
PROJECT NO. 5255	SITE NAME	Big Brown Steam Electric Station – Ash Disposal Area II Annual Inspection	DATE 11/15/2016

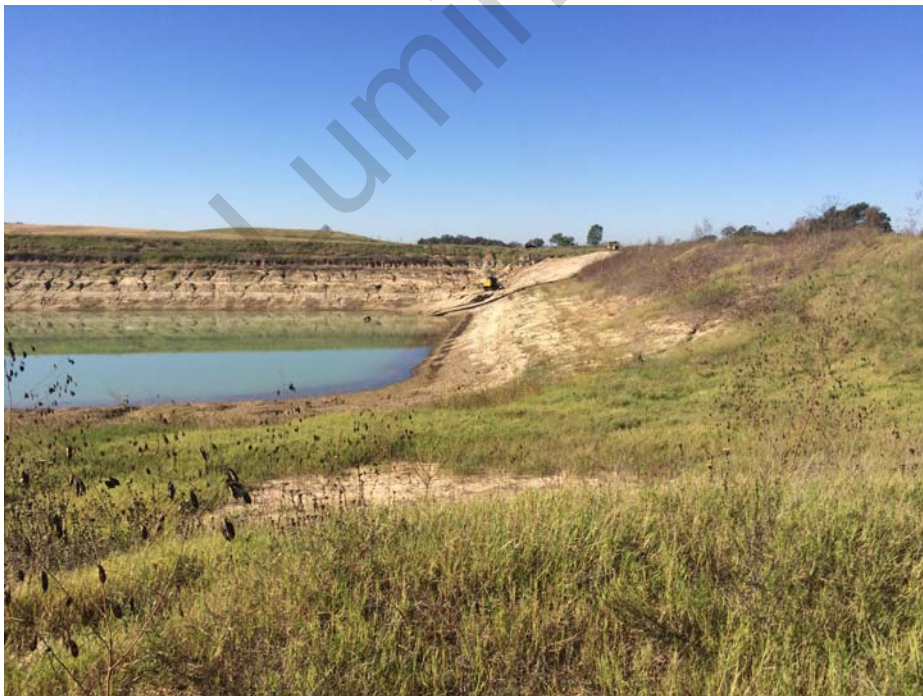
Pastor, Behling & Wheeler	DESCRIPTION	<b>Photograph 4</b> – (View W) View along north dike of Cell 11. Minor erosion along west dike of Cell 11 in background.	
PROJECT NO. 5255	SITE NAME	Big Brown Steam Electric Station – Ash Disposal Area II Annual Inspection	DATE 11/15/2016

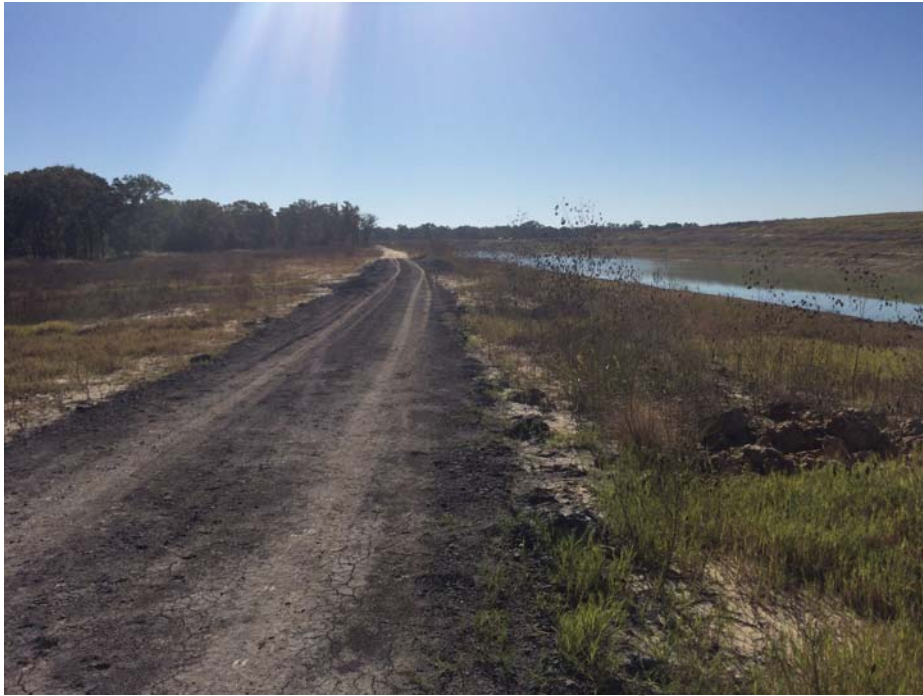
Pastor, Behling & Wheeler	DESCRIPTION	<b>Photograph 5</b> – (View SE) View along top of east dike of Cell 11. Repaired/raised access road in foreground.	
PROJECT NO. 5255	SITE NAME	Big Brown Steam Electric Station – Ash Disposal Area II Annual Inspection	DATE 11/15/2016

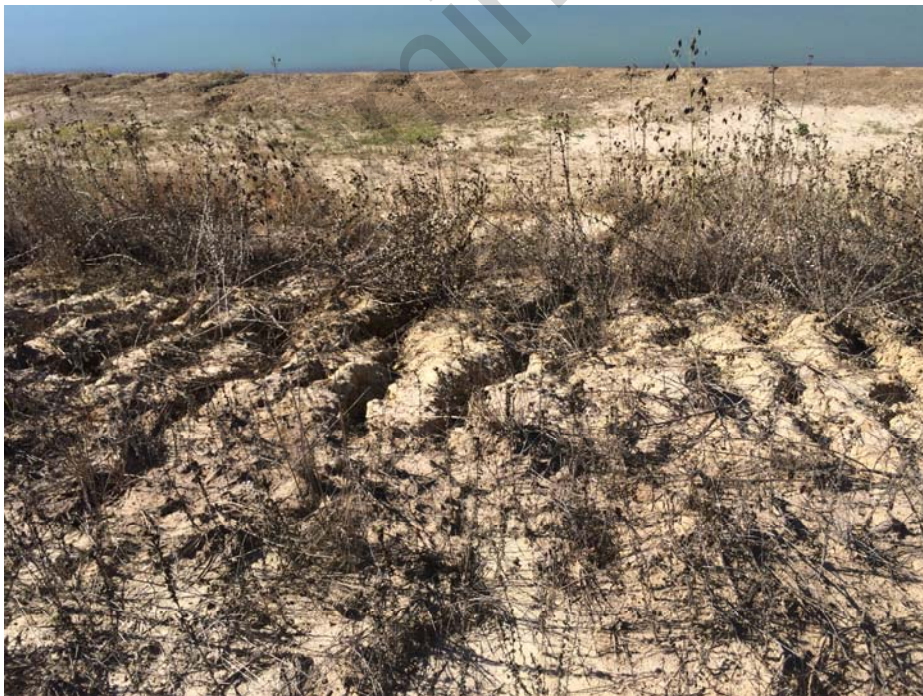
Pastor, Behling & Wheeler	DESCRIPTION	<b>Photograph 6</b> – Minor erosion along east bank of Cell 11.	
PROJECT NO. 5255	SITE NAME	Big Brown Steam Electric Station – Ash Disposal Area II Annual Inspection	DATE 11/15/2016

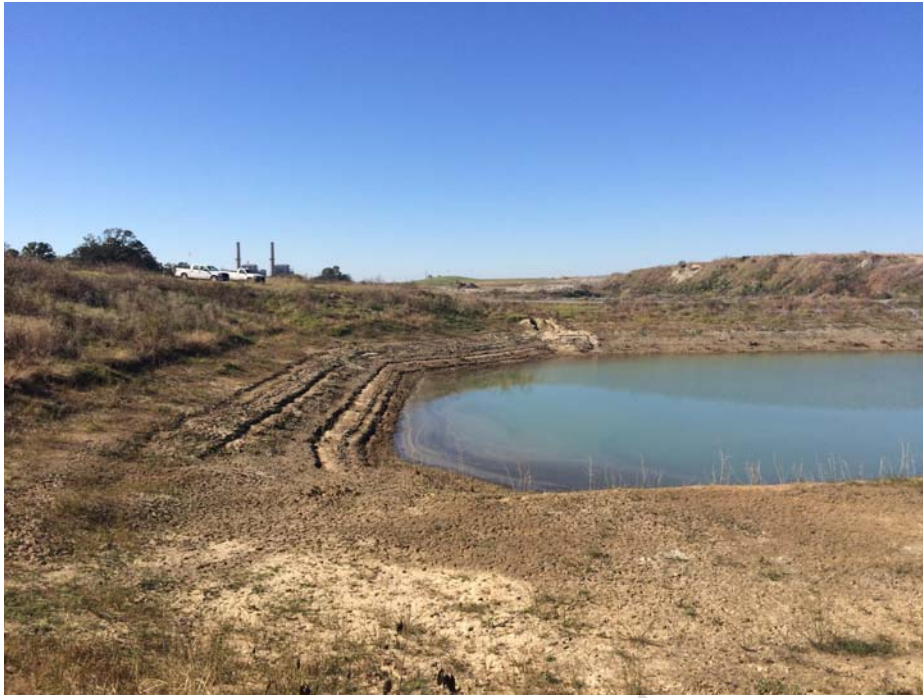
Pastor, Behling & Wheeler	DESCRIPTION	<b>Photograph 7</b> – (View W) View along south dike of Cell 11. Minor erosion on west dike of Cell 11 in background.	
PROJECT NO. 5255	SITE NAME	Big Brown Steam Electric Station – Ash Disposal Area II Annual Inspection	DATE 11/15/2016

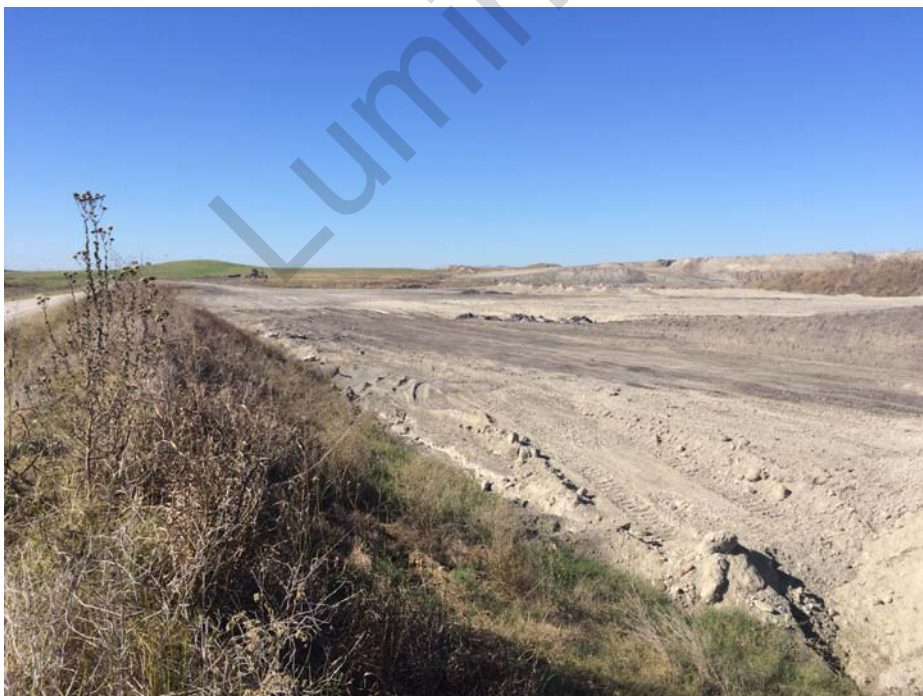
- Significant erosion was observed in several areas on the interior slope face of the Cell 10 embankment, along the south side. These areas should be repaired and provided with rock rip rap or other erosion control material as necessary.

Pastor, Behling & Wheeler	DESCRIPTION	<b>Photograph 10</b> – (View W) View along south dike of Cell 10. Active ash placement area. Typical area of significant erosion in foreground (partially obscured by vegetation)	
PROJECT NO. 5255	SITE NAME	Big Brown Steam Electric Station – Ash Disposal Area II Annual Inspection	DATE 11/15/2016

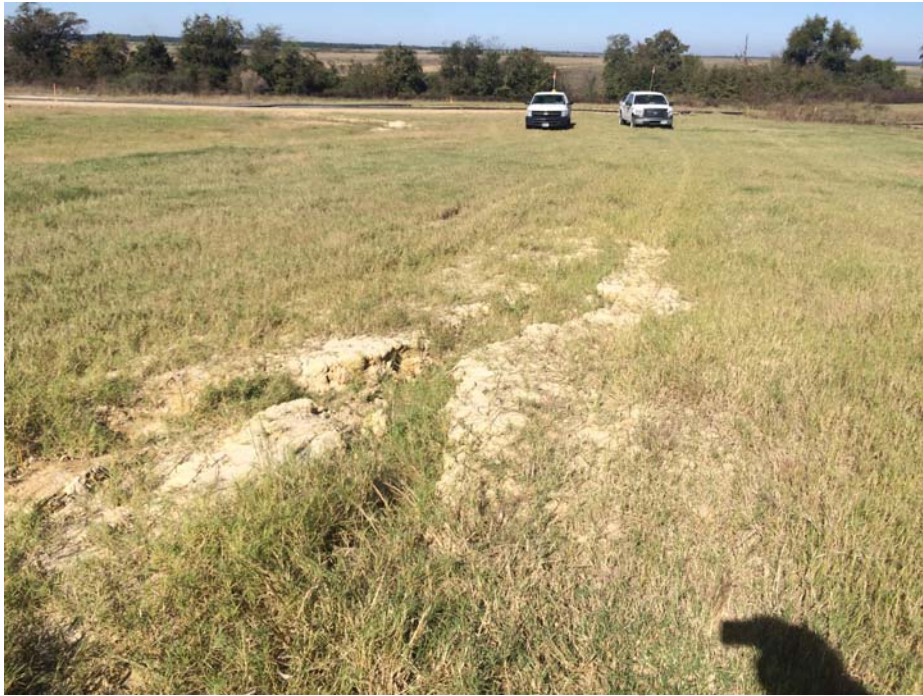
- The capped portions of Cells 1-8 appear to be adequately vegetated with limited areas of erosion. Small areas of feral hog damage and minor surficial erosion were observed along the north side of capped Cells 1-8. These areas should be monitored and repaired as necessary.

Pastor, Behling & Wheeler	DESCRIPTION	<b>Photograph 11</b> – (View N) Minor erosion of capped area.	
PROJECT NO. 5255	SITE NAME	Big Brown Steam Electric Station – Ash Disposal Area II Annual Inspection	DATE 11/15/2016
