ANNUAL INSPECTION OF CCR UNITS

**Oak Grove Steam Electric Station
Robertson County, Texas**

January 2018

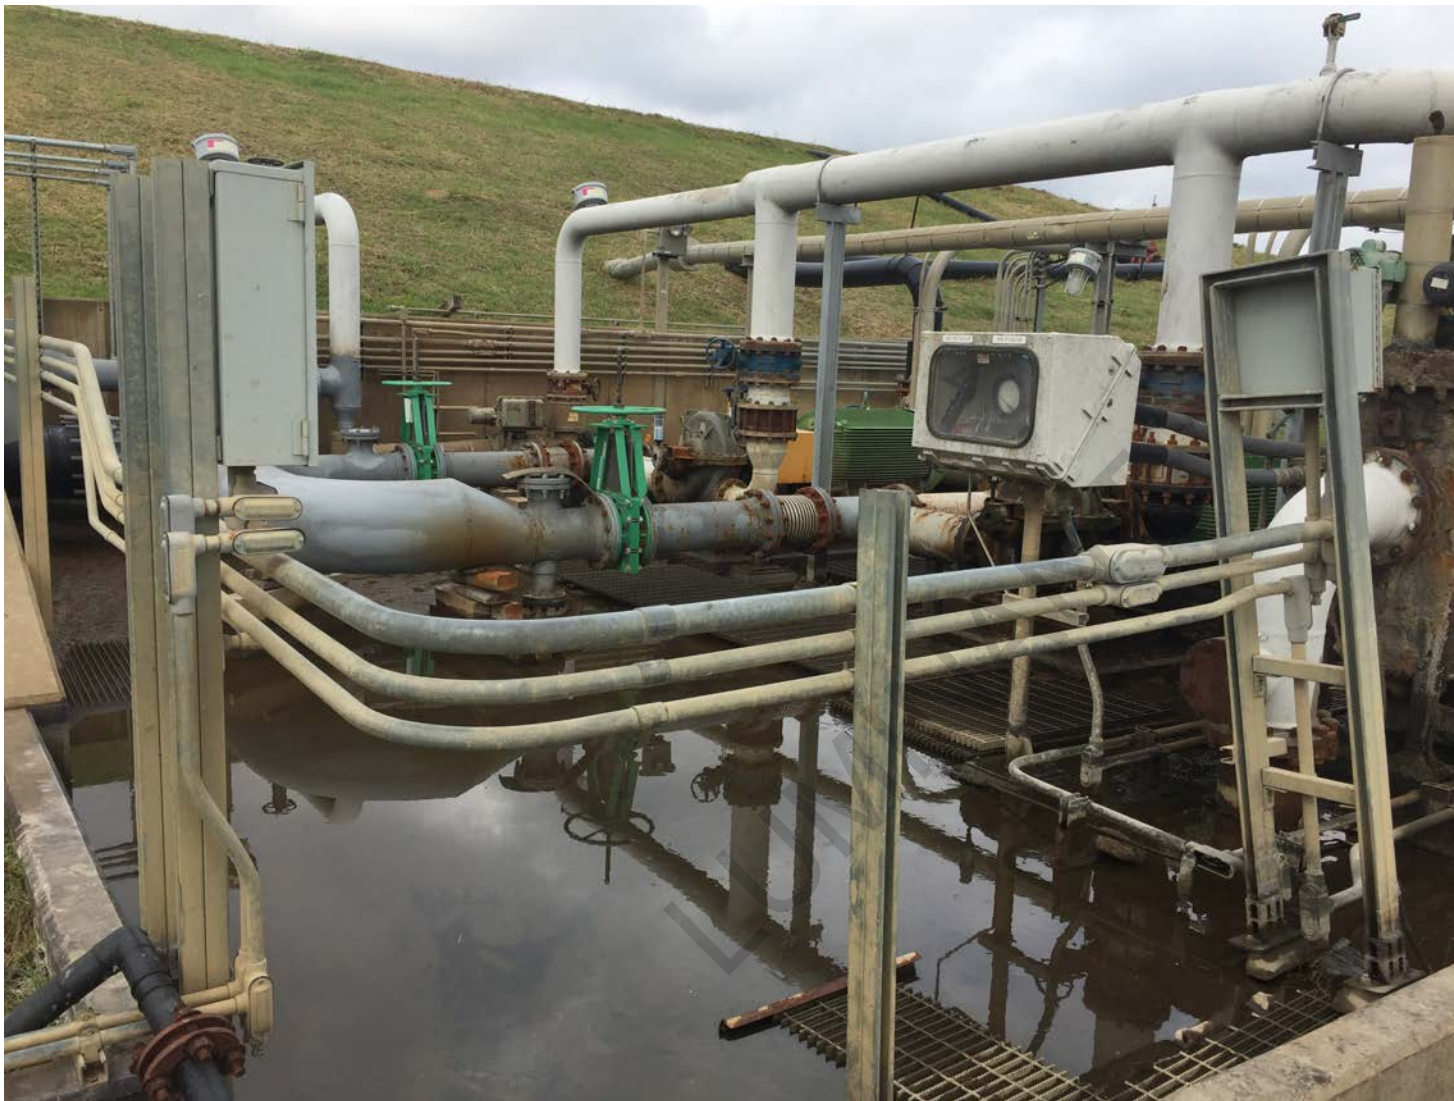
PHOTO DESCRIPTION:
 Reclaim/recycling pump station. Leakage collecting in containment area.

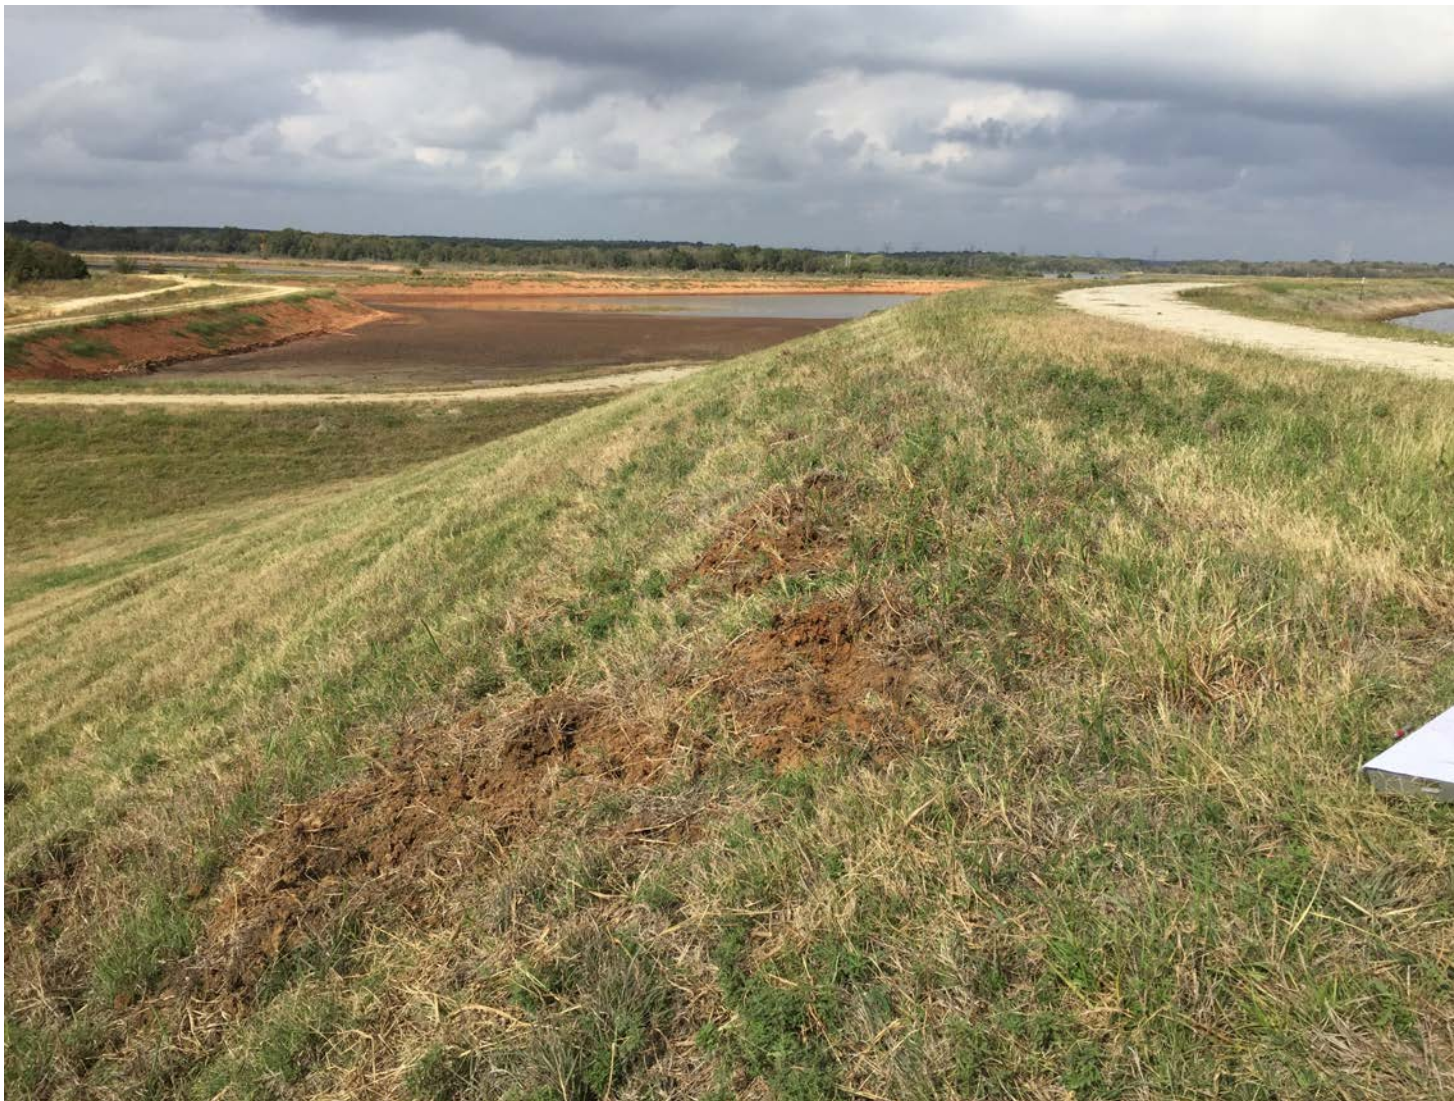
PHOTO DESCRIPTION:
 Southwestern downstream
 slope. Hog damage. FGD-B in
 background.

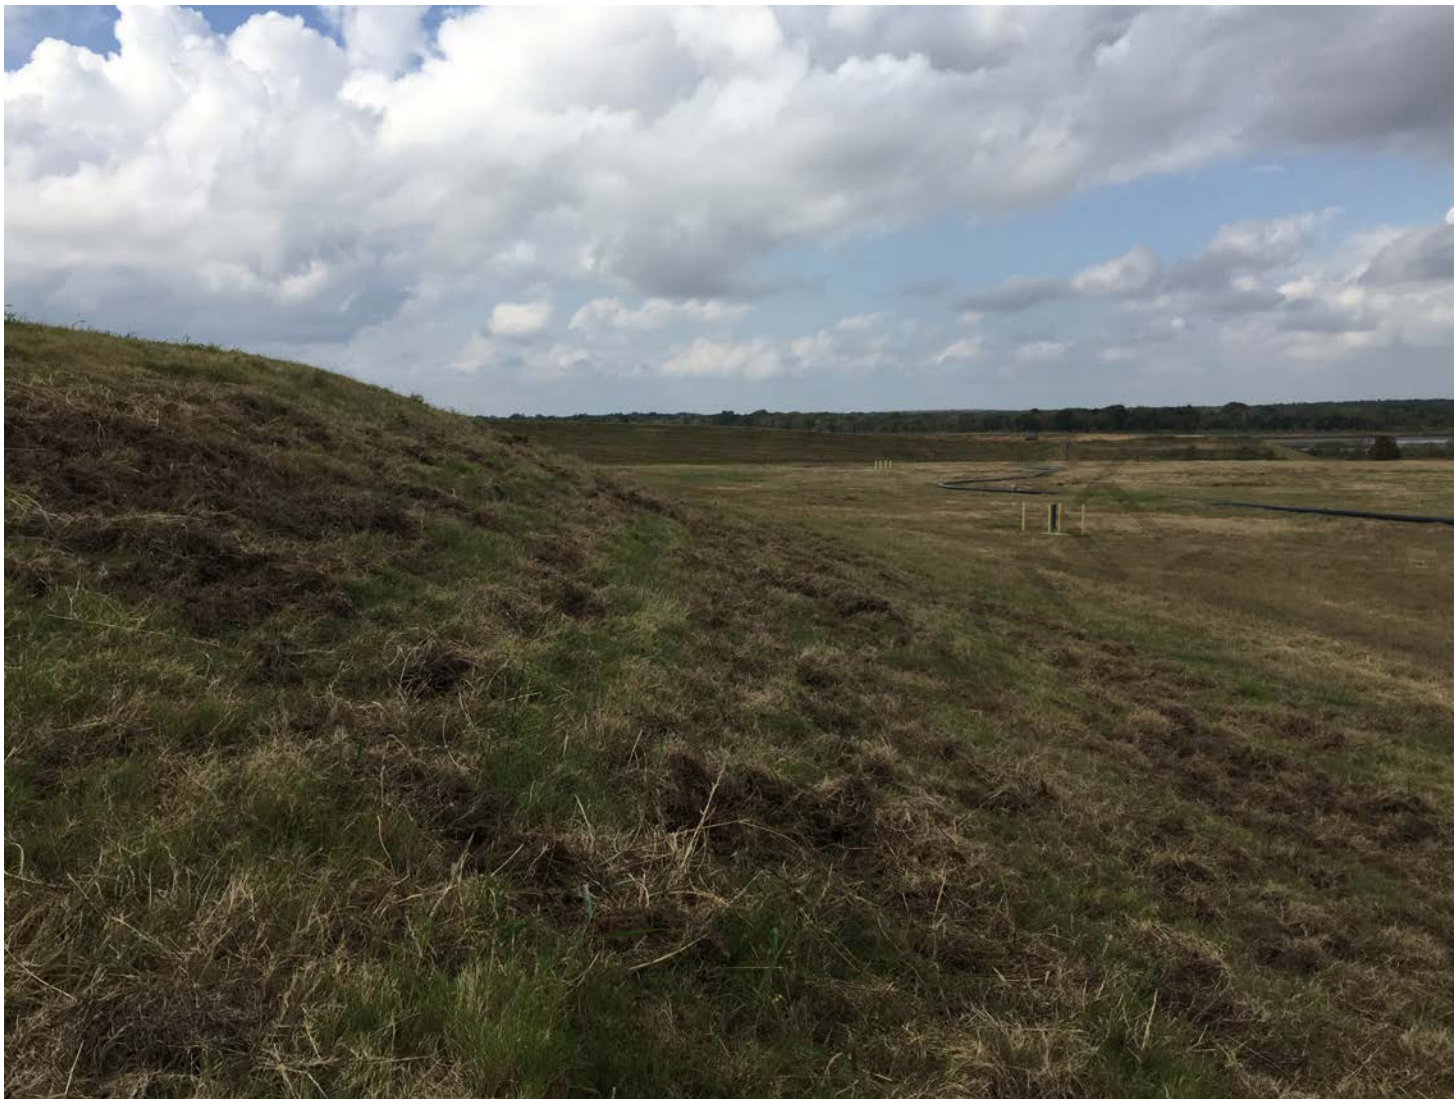
PHOTO DESCRIPTION:
 Northeastern downstream slope
 – looking NW. Hog damage.

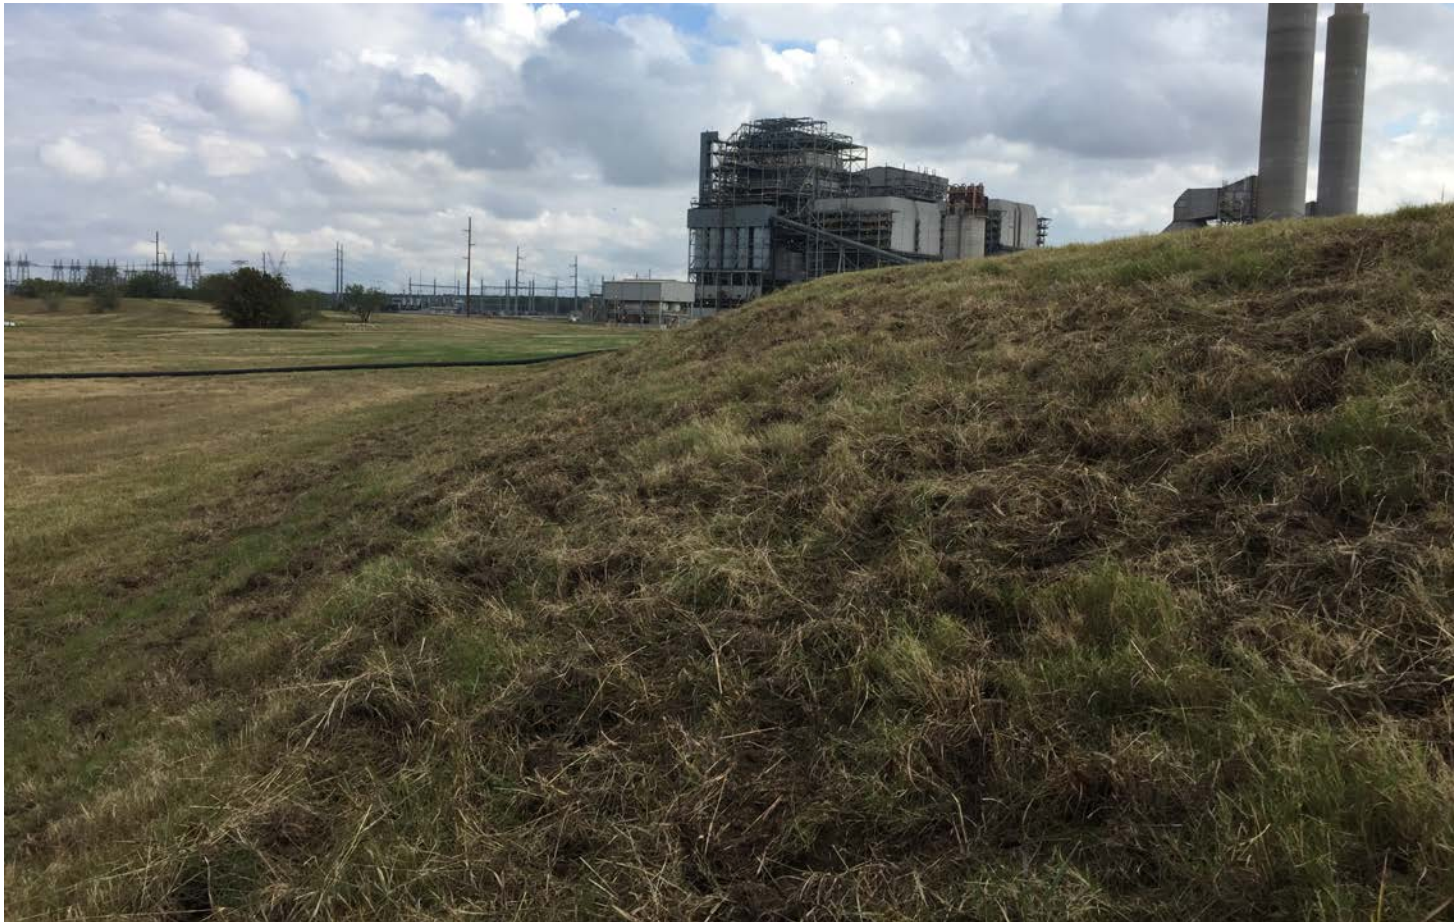
PHOTO DESCRIPTION:
 Northeastern downstream slope
 – looking SE. Hog damage.

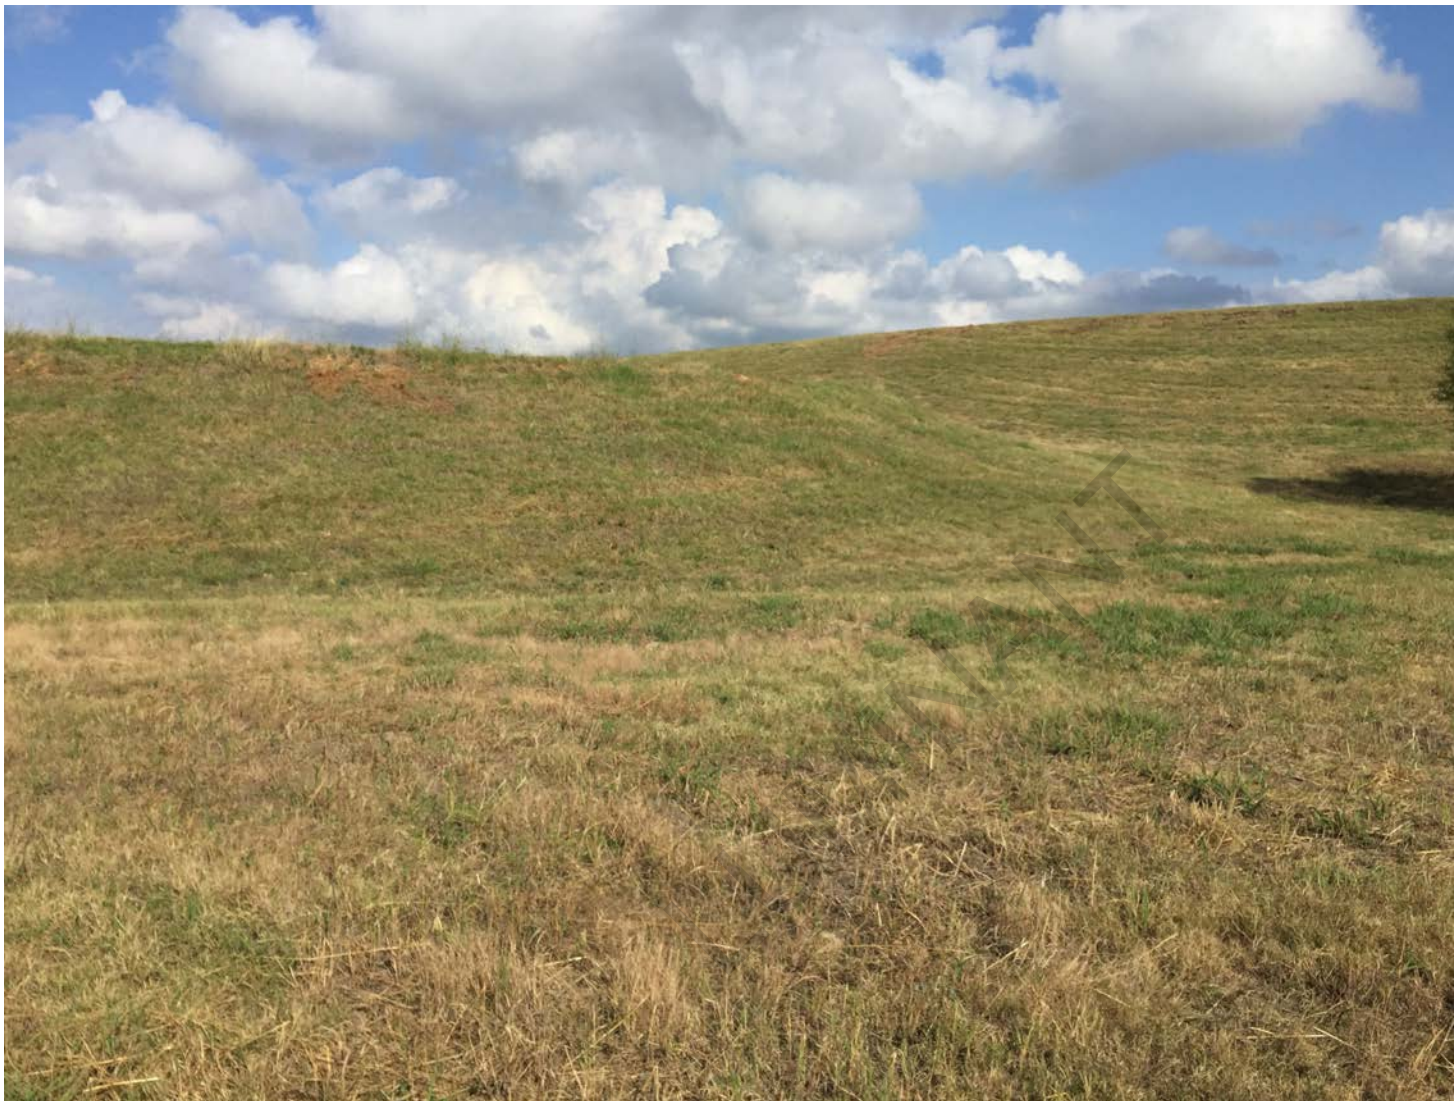
PHOTO DESCRIPTION:
 Southern downstream slope –
 looking NE. Hog damage near
 crest.

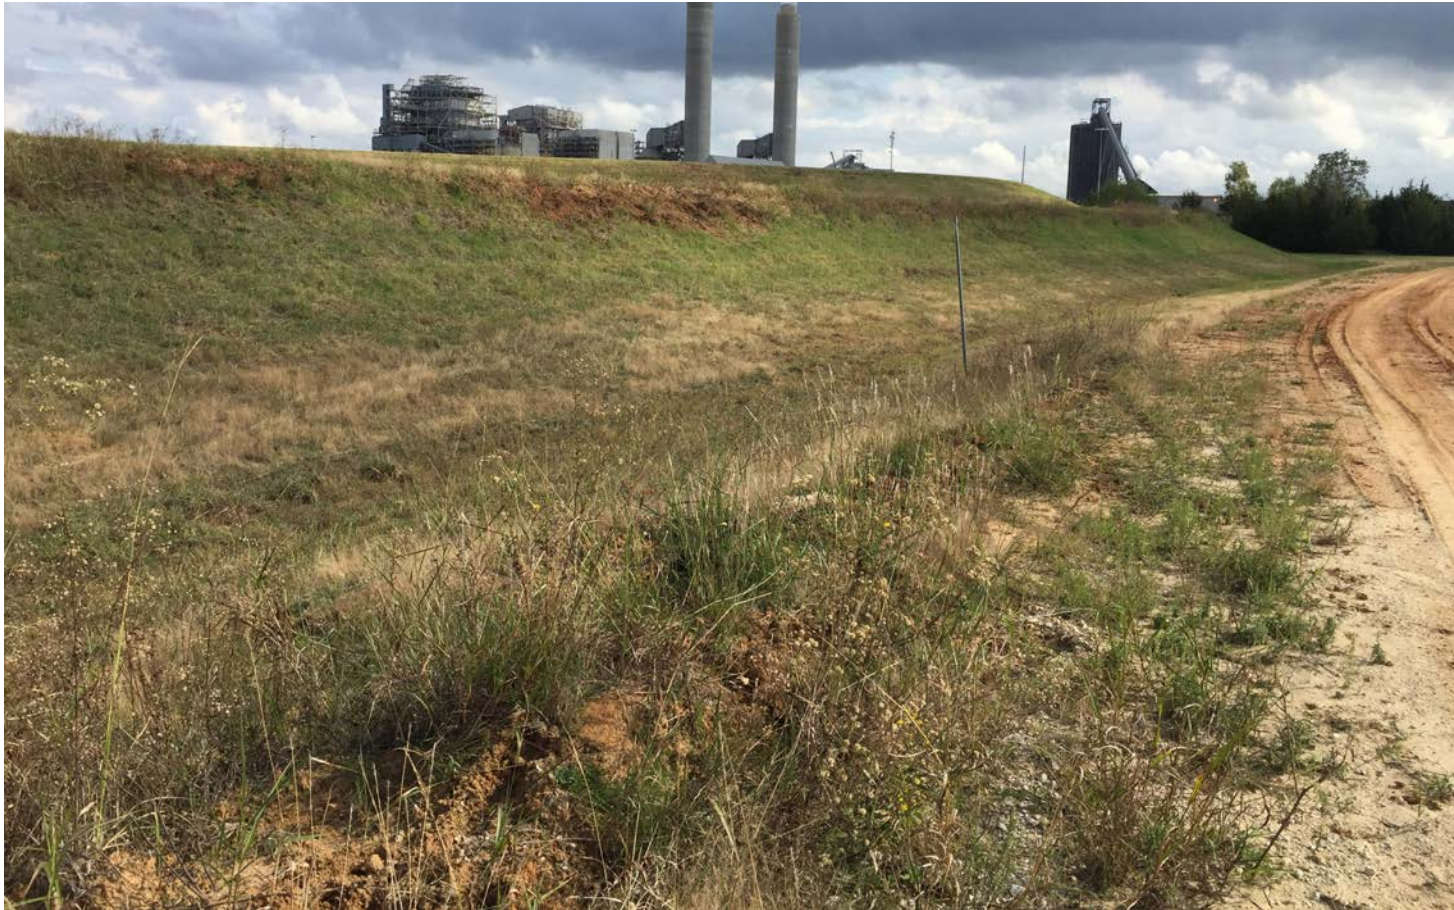
PHOTO DESCRIPTION:
 Southwestern downstream slope
 – looking SE. Hog damage
 near crest.

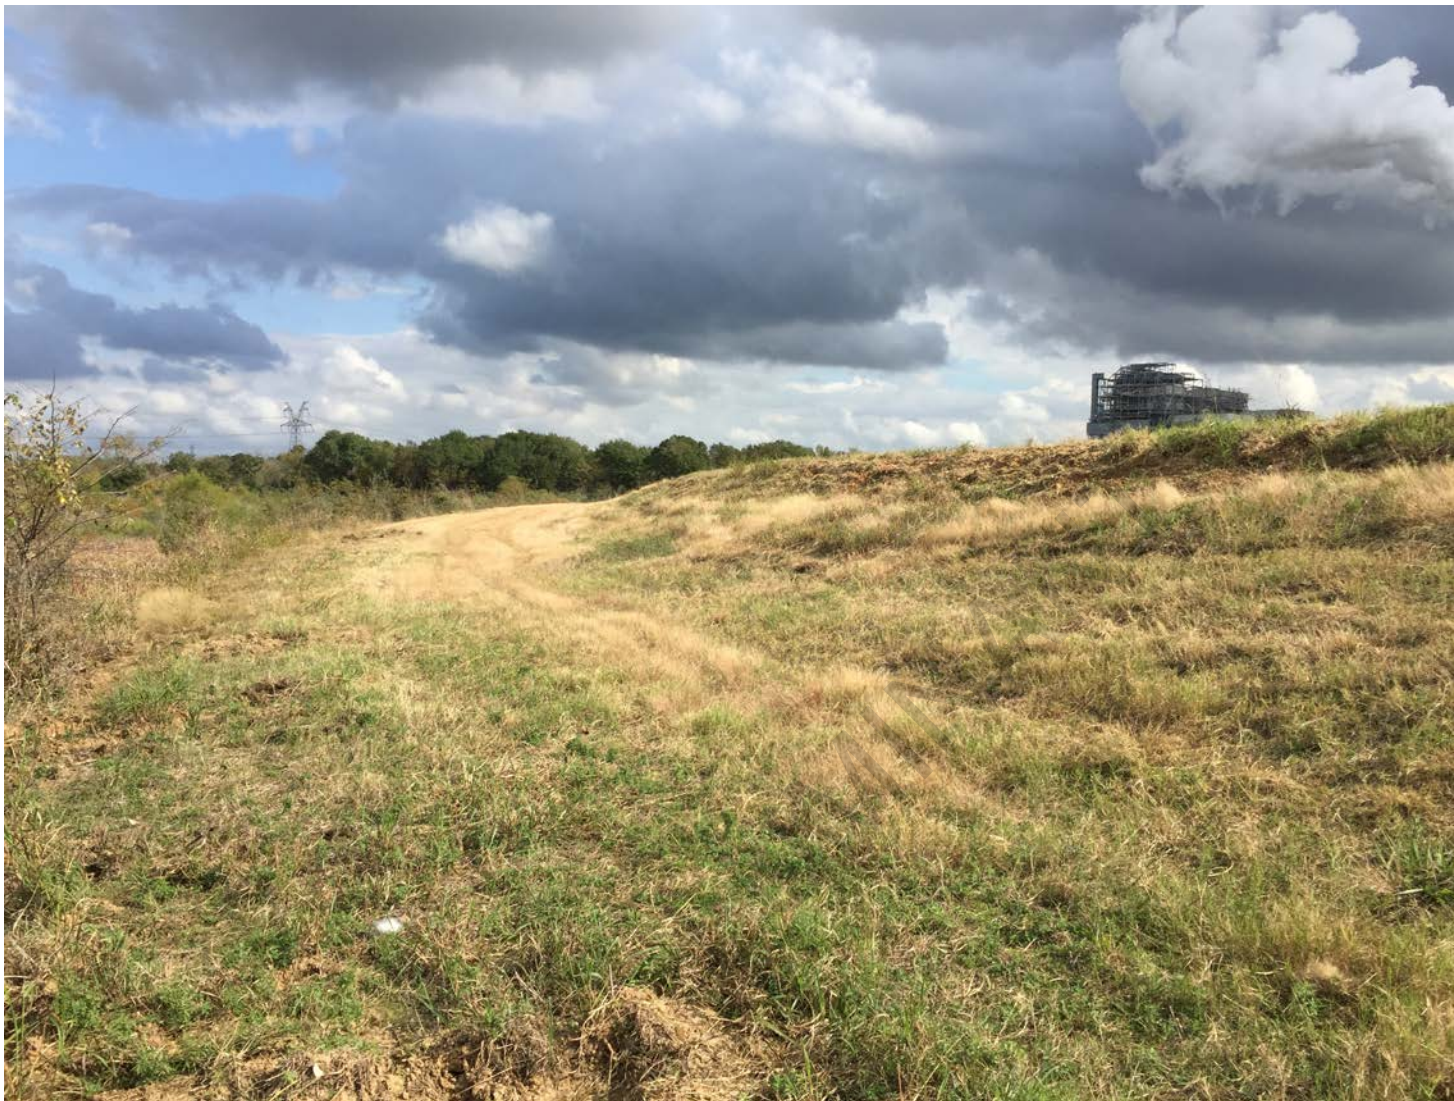
PHOTO DESCRIPTION:
 Northwestern downstream
 slope. Hog damage near
 crest.

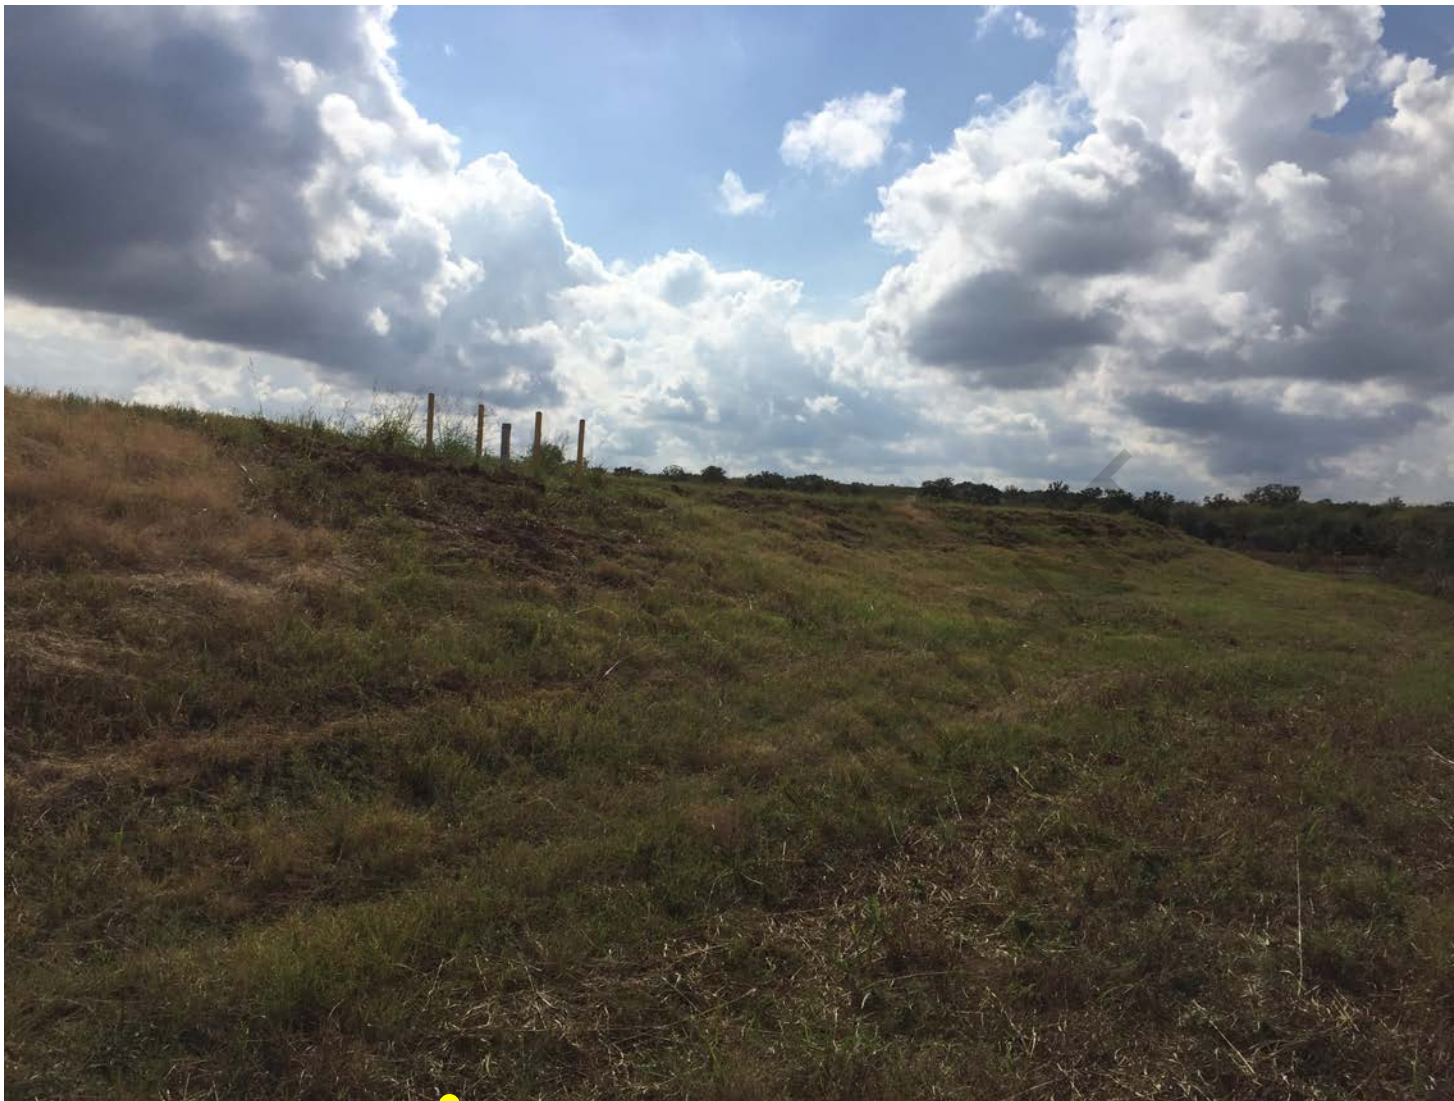
PHOTO DESCRIPTION:
 Northern downstream slope.
 Hog damage.

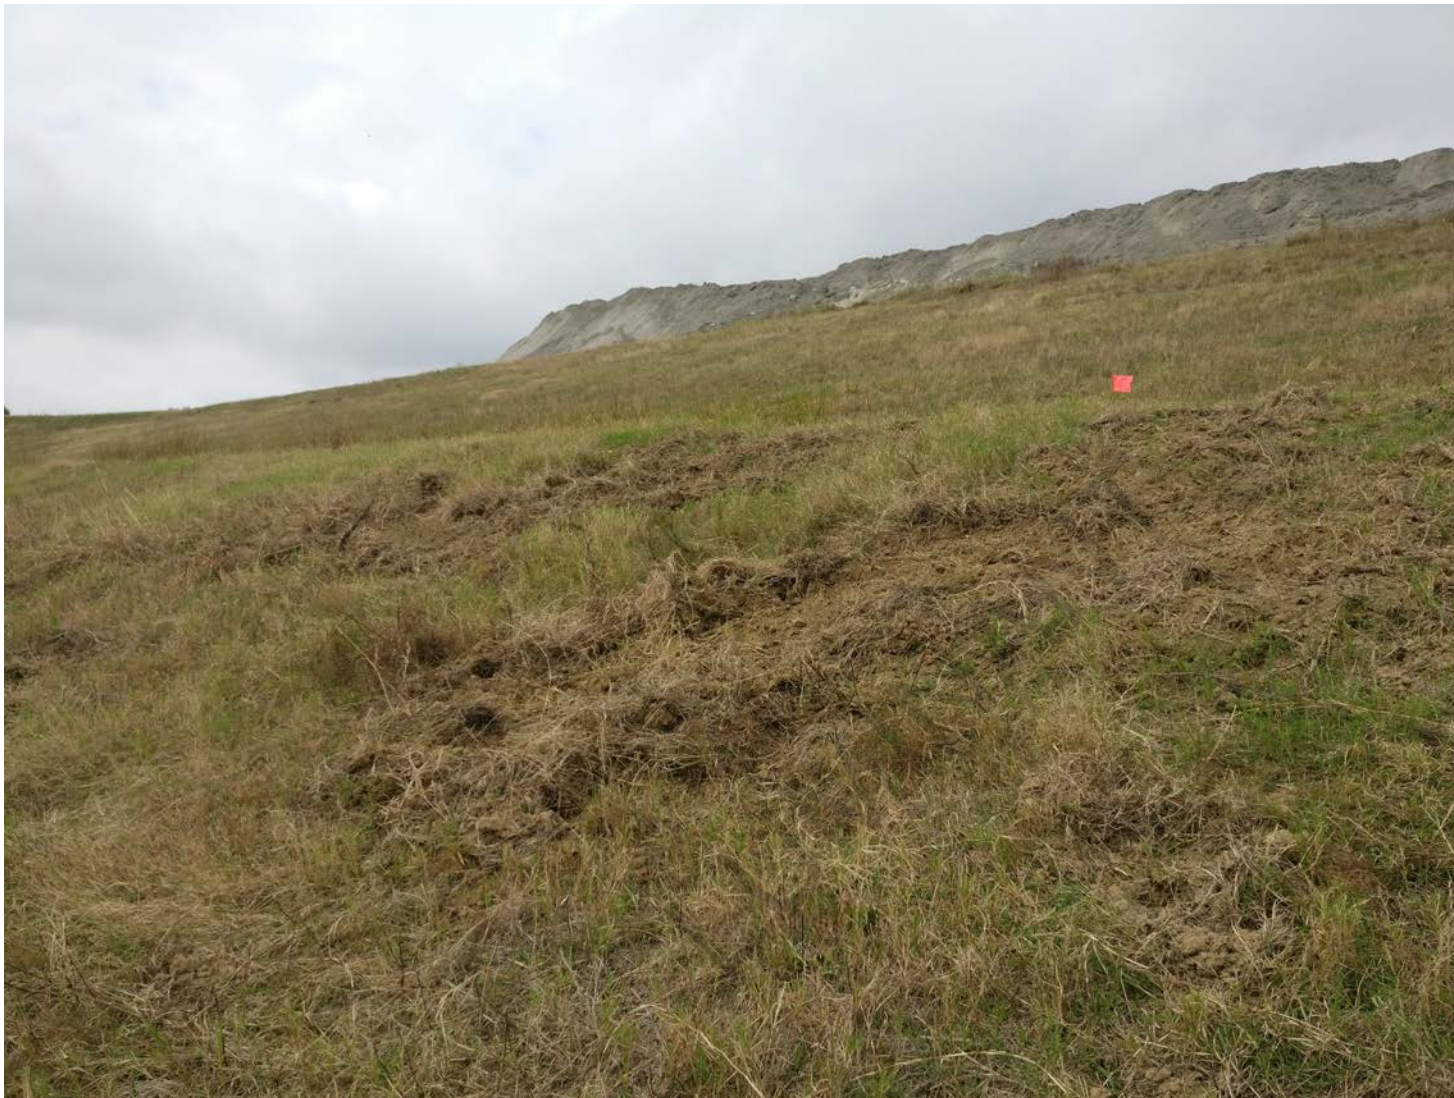
PHOTO DESCRIPTION:
 Hog damage on southern slope
 of Cell 2.

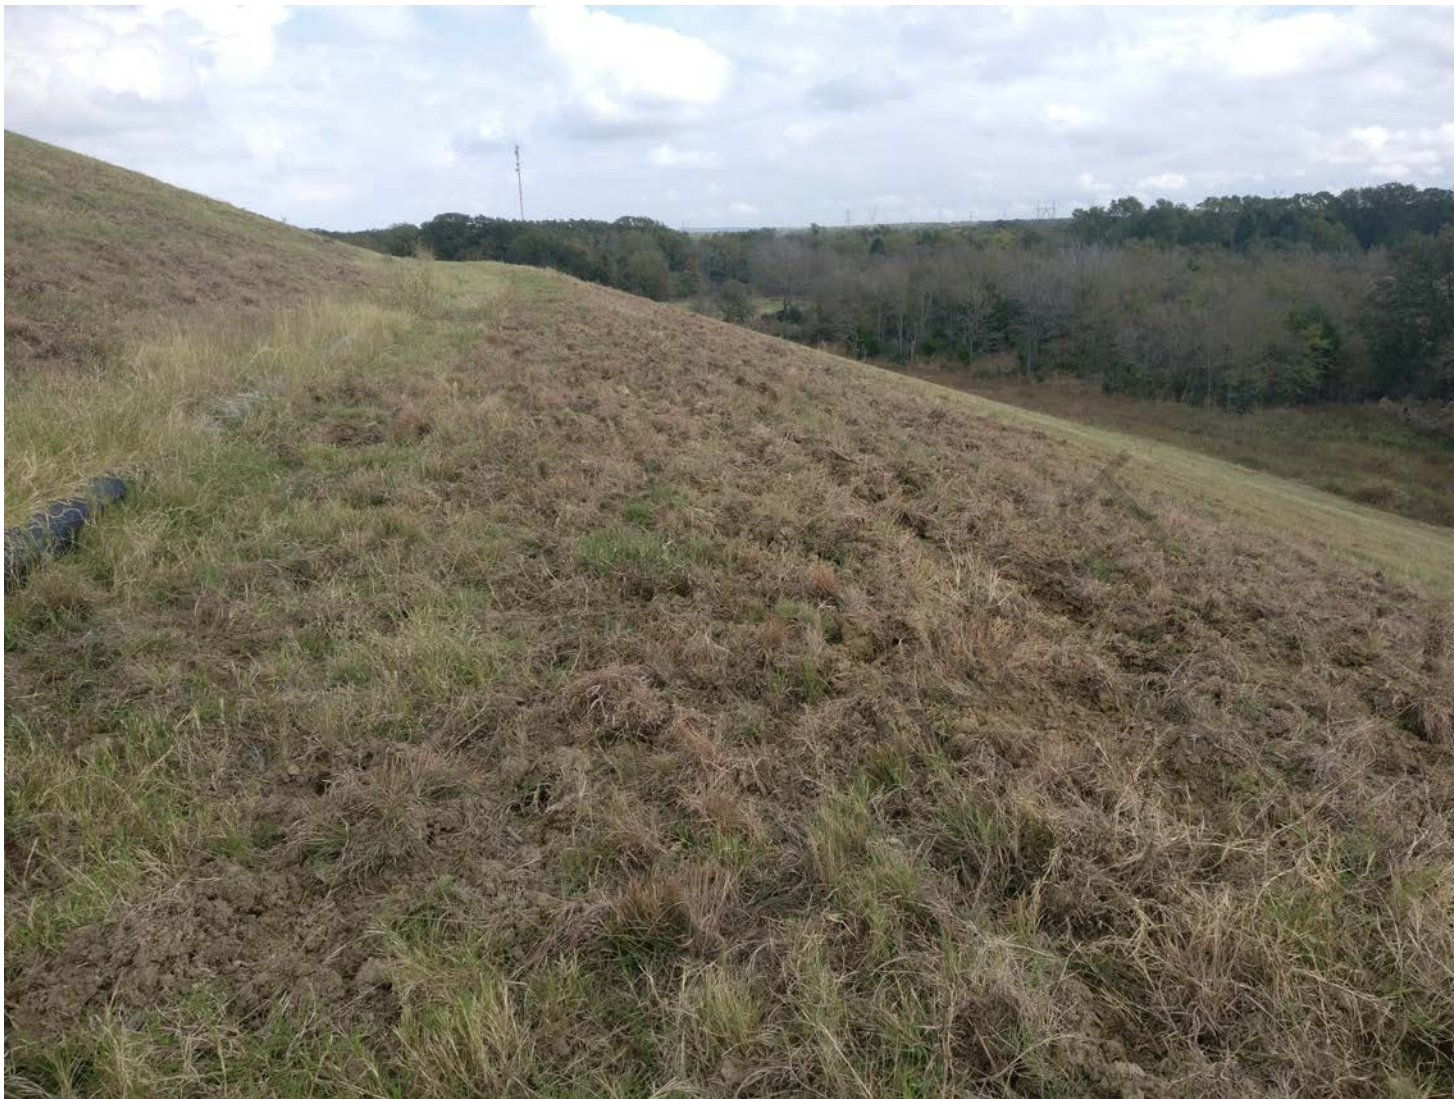
PHOTO DESCRIPTION:
 Hog damage on southern slope
 of Cell 1.

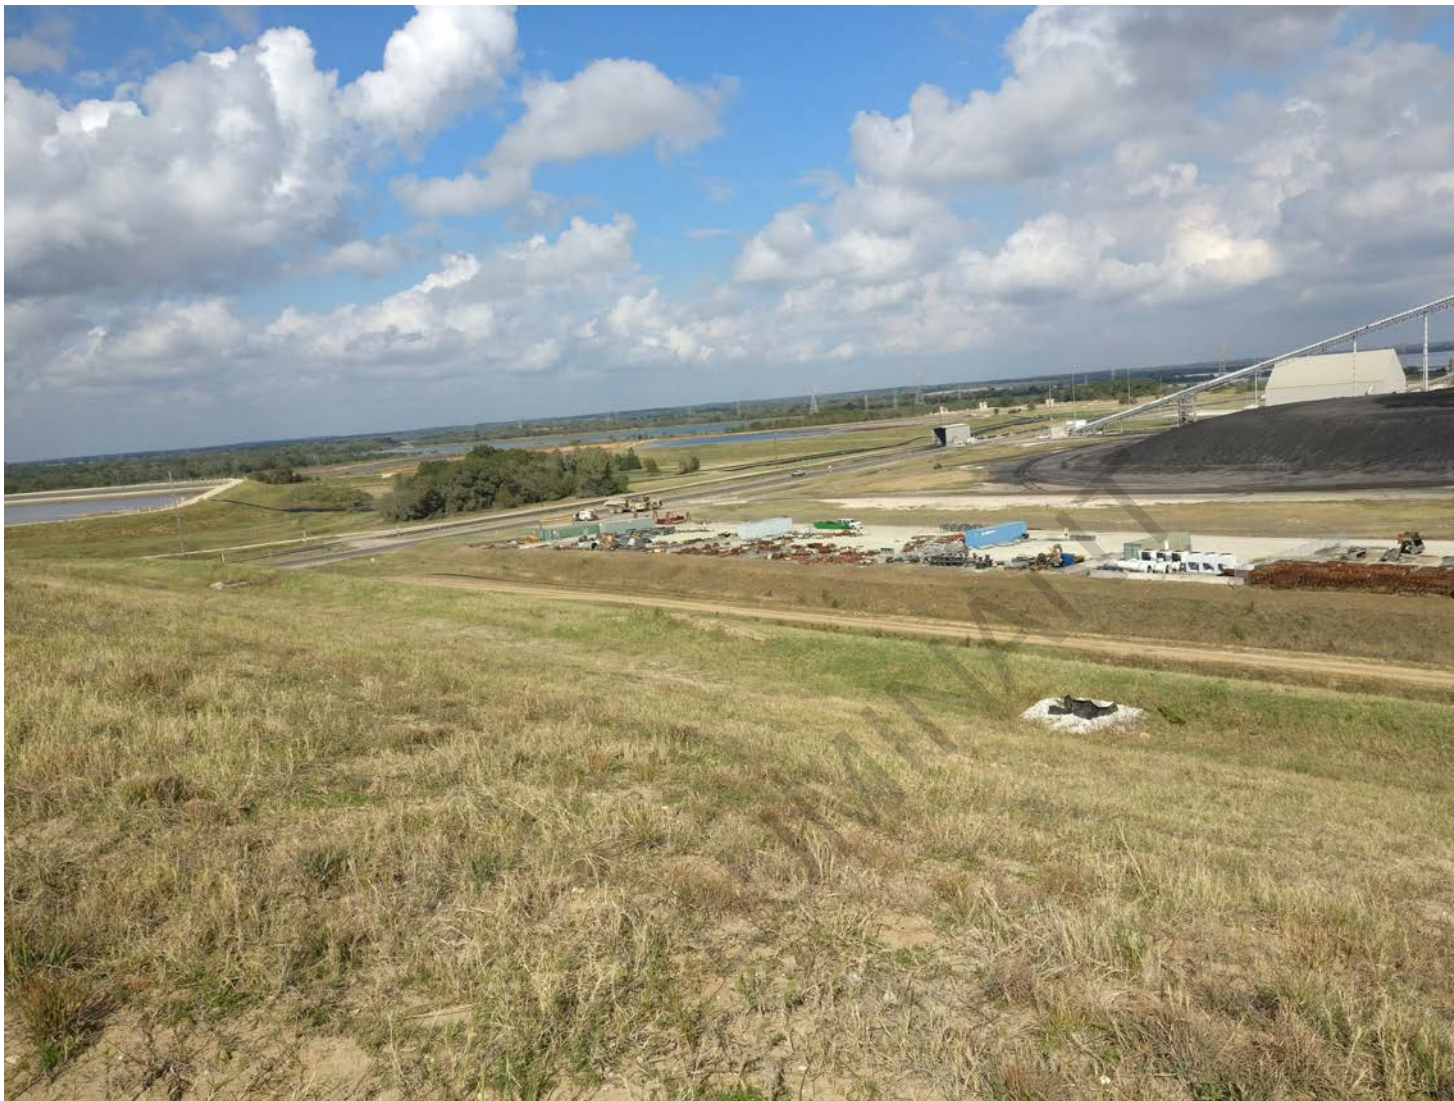
PHOTO DESCRIPTION:
 Repairs filled with gravel on
 eastern lower bench of Cell
 1.
