2021 USEPA CCR RULE PERIODIC OPERATING RECORD RUN-ON AND RUNOFF CONTROL PLAN REVIEW REPORTREV 1 §257.81 CCR LANDFILL Zimmer Power Company, LLC Moscow, Ohio

INITIAL TO PERIODIC SURVEY COMPARISON LANDFILL ZIMMER POWER PLANT MOSCOW, OHIO

SURVEY COMPARISON ISOPACH LANDFILL ZIMMER POWER PLANT MOSCOW, OHIO

INITIAL TO PERIODIC AERIAL IMAGERY COMPARISON LANDFILL ZIMMER POWER PLANT MOSCOW, OHIO

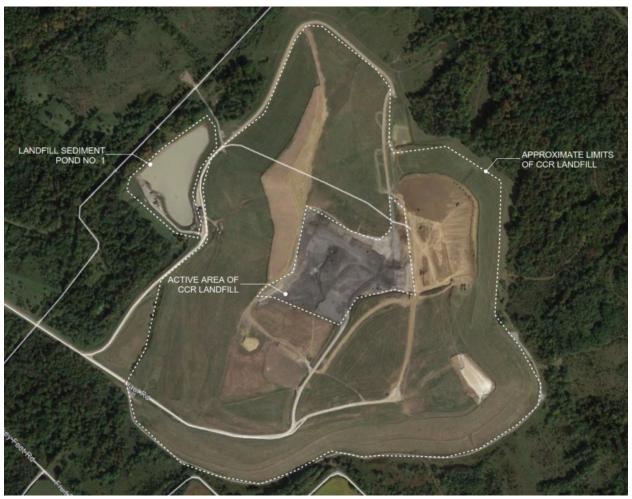
Figure 2 – Site Plan (aerial from Google Earth [3])

The LF is located at 1781 US Route 52 in Moscow, Ohio 45153. The location of LF is illustrated in **Figure 1**, and a site plan showing the location of the LF is provided in **Figure 2**. LF is approximately 3.5 miles east of the ZIM in Washington Township.

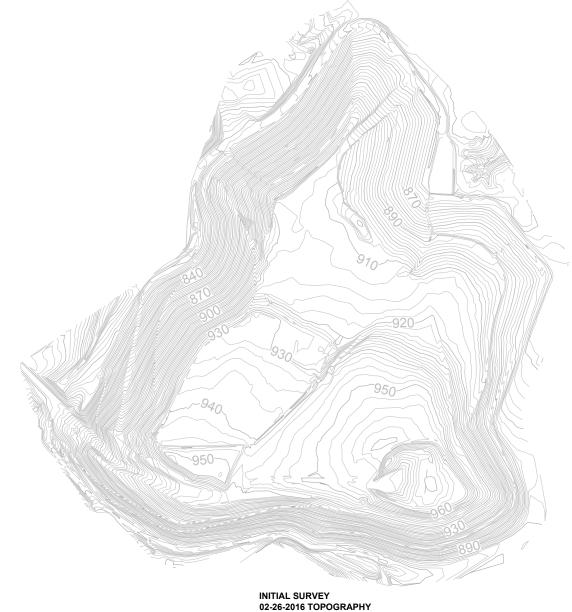
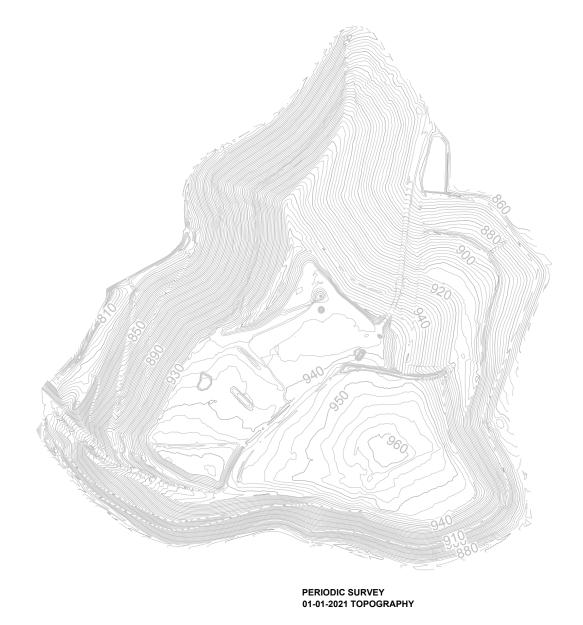
The initial survey of the LF, conducted at the site by Duke Energy (Duke) in 2016 [4], was compared to the periodic survey of the LF, conducted by IngenAE, LLC (IngenAE) in 2020 [11], using AutoCAD Civil3D 2021 software. This comparison was intended to quantify changes in the volume of CCR placed within the LF, evaluate potential changes in surface stormwater drainage around the LF, and evaluate if CCR may have been placed outside of the grades of the LF used for the existing run-on, run-off control plan [2]. This comparison is presented in side-by-side views of each survey in **Drawing 1**, and a plan view isopach map denoting changes in ground surface elevation in **Drawing 2**. A summary of the changes in CCR volumes is provided in **Table 2**.

The comparison indicated that approximately 950,461 CY of CCR was placed in the LF between 2015 to 2021. The comparison did not indicate that CCR had been placed outside the design grades of the LF.

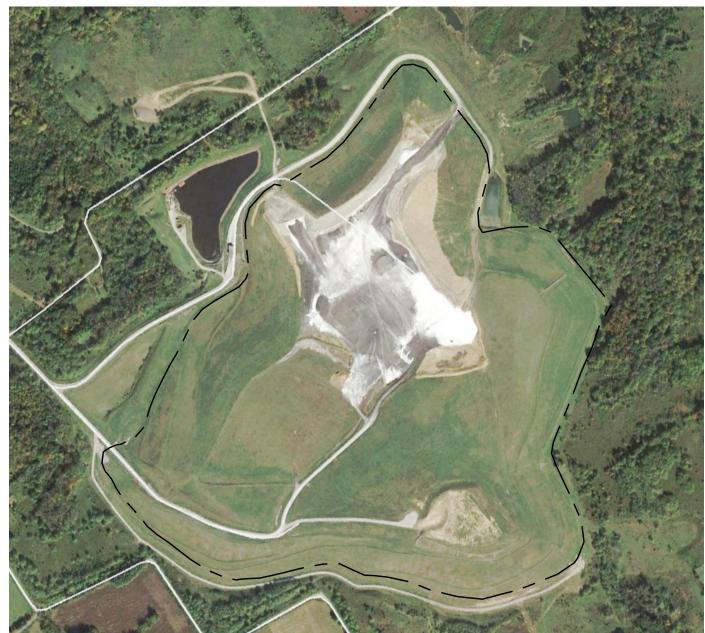
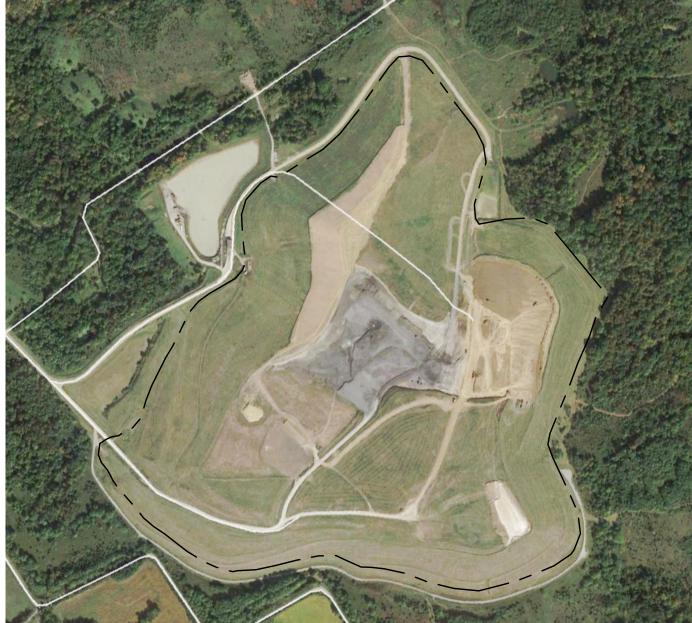
Initial aerial photographs of the CPRP were prepared from Google Earth [3] imagery dated October 2015 and were compared to periodic aerial photographs prepared from Google Earth [3] imagery dated October 2020 to visually evaluate if potential site changes (i.e., construction of new ditches, changes in site operations, or changes to other appurtenances) may have occurred between 2015 and 2020. A comparison of these aerial photographs is provided in **Drawing 3**, and the following changes were identified:

• Additional final cover was placed around the western side and eastern side of the active area of the LF. The limits of the active area appear to have been reduced.

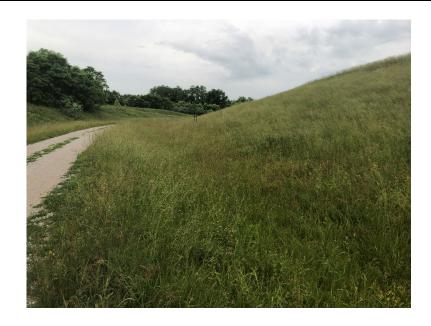
Photo: 01

Photo of the southern slope final cover. Good vegetative cover and perimeter ditch is unobstructed.

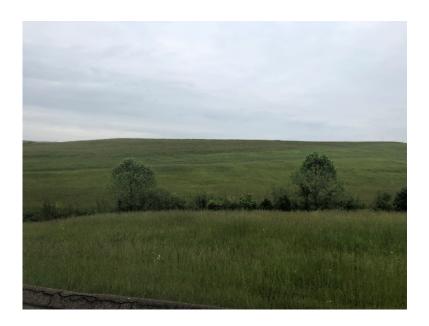
Photo: 02

Eastern slope of the landfill with final cover. Good vegetative cover. Perimeter ditches consistent with the runon and runoff plan (drainage north to south).

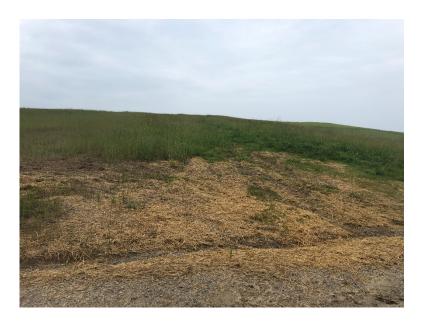
Photo: 04

Photo of the northern tip. Cover is being reseeded to establish vegetation.

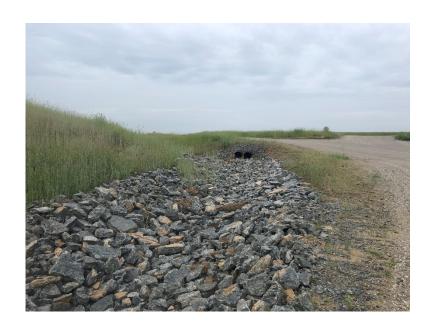
Photo: 05

Photo taken from the southern access road on the landfill. Riprap lined ditch along the southern side of the landfill. Ditch captures water from the active portion of the landfill and is a temporary feature.

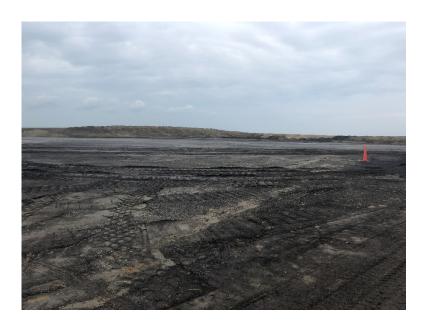
Photo: 06

Active landfill area. No signs of erosion or runoff. Water drains to a chimney drain near the center of the open cell.
