**ANNUAL CCR UNIT INSPECTION REPORT  
LUMINANT – BIG BROWN STEAM ELECTRIC STATION  
NORTH AND SOUTH ASH PONDS & ASH DISPOSAL AREA II  
FREESTONE COUNTY, TEXAS**

January 14, 2016

PBW Project No. 5170A

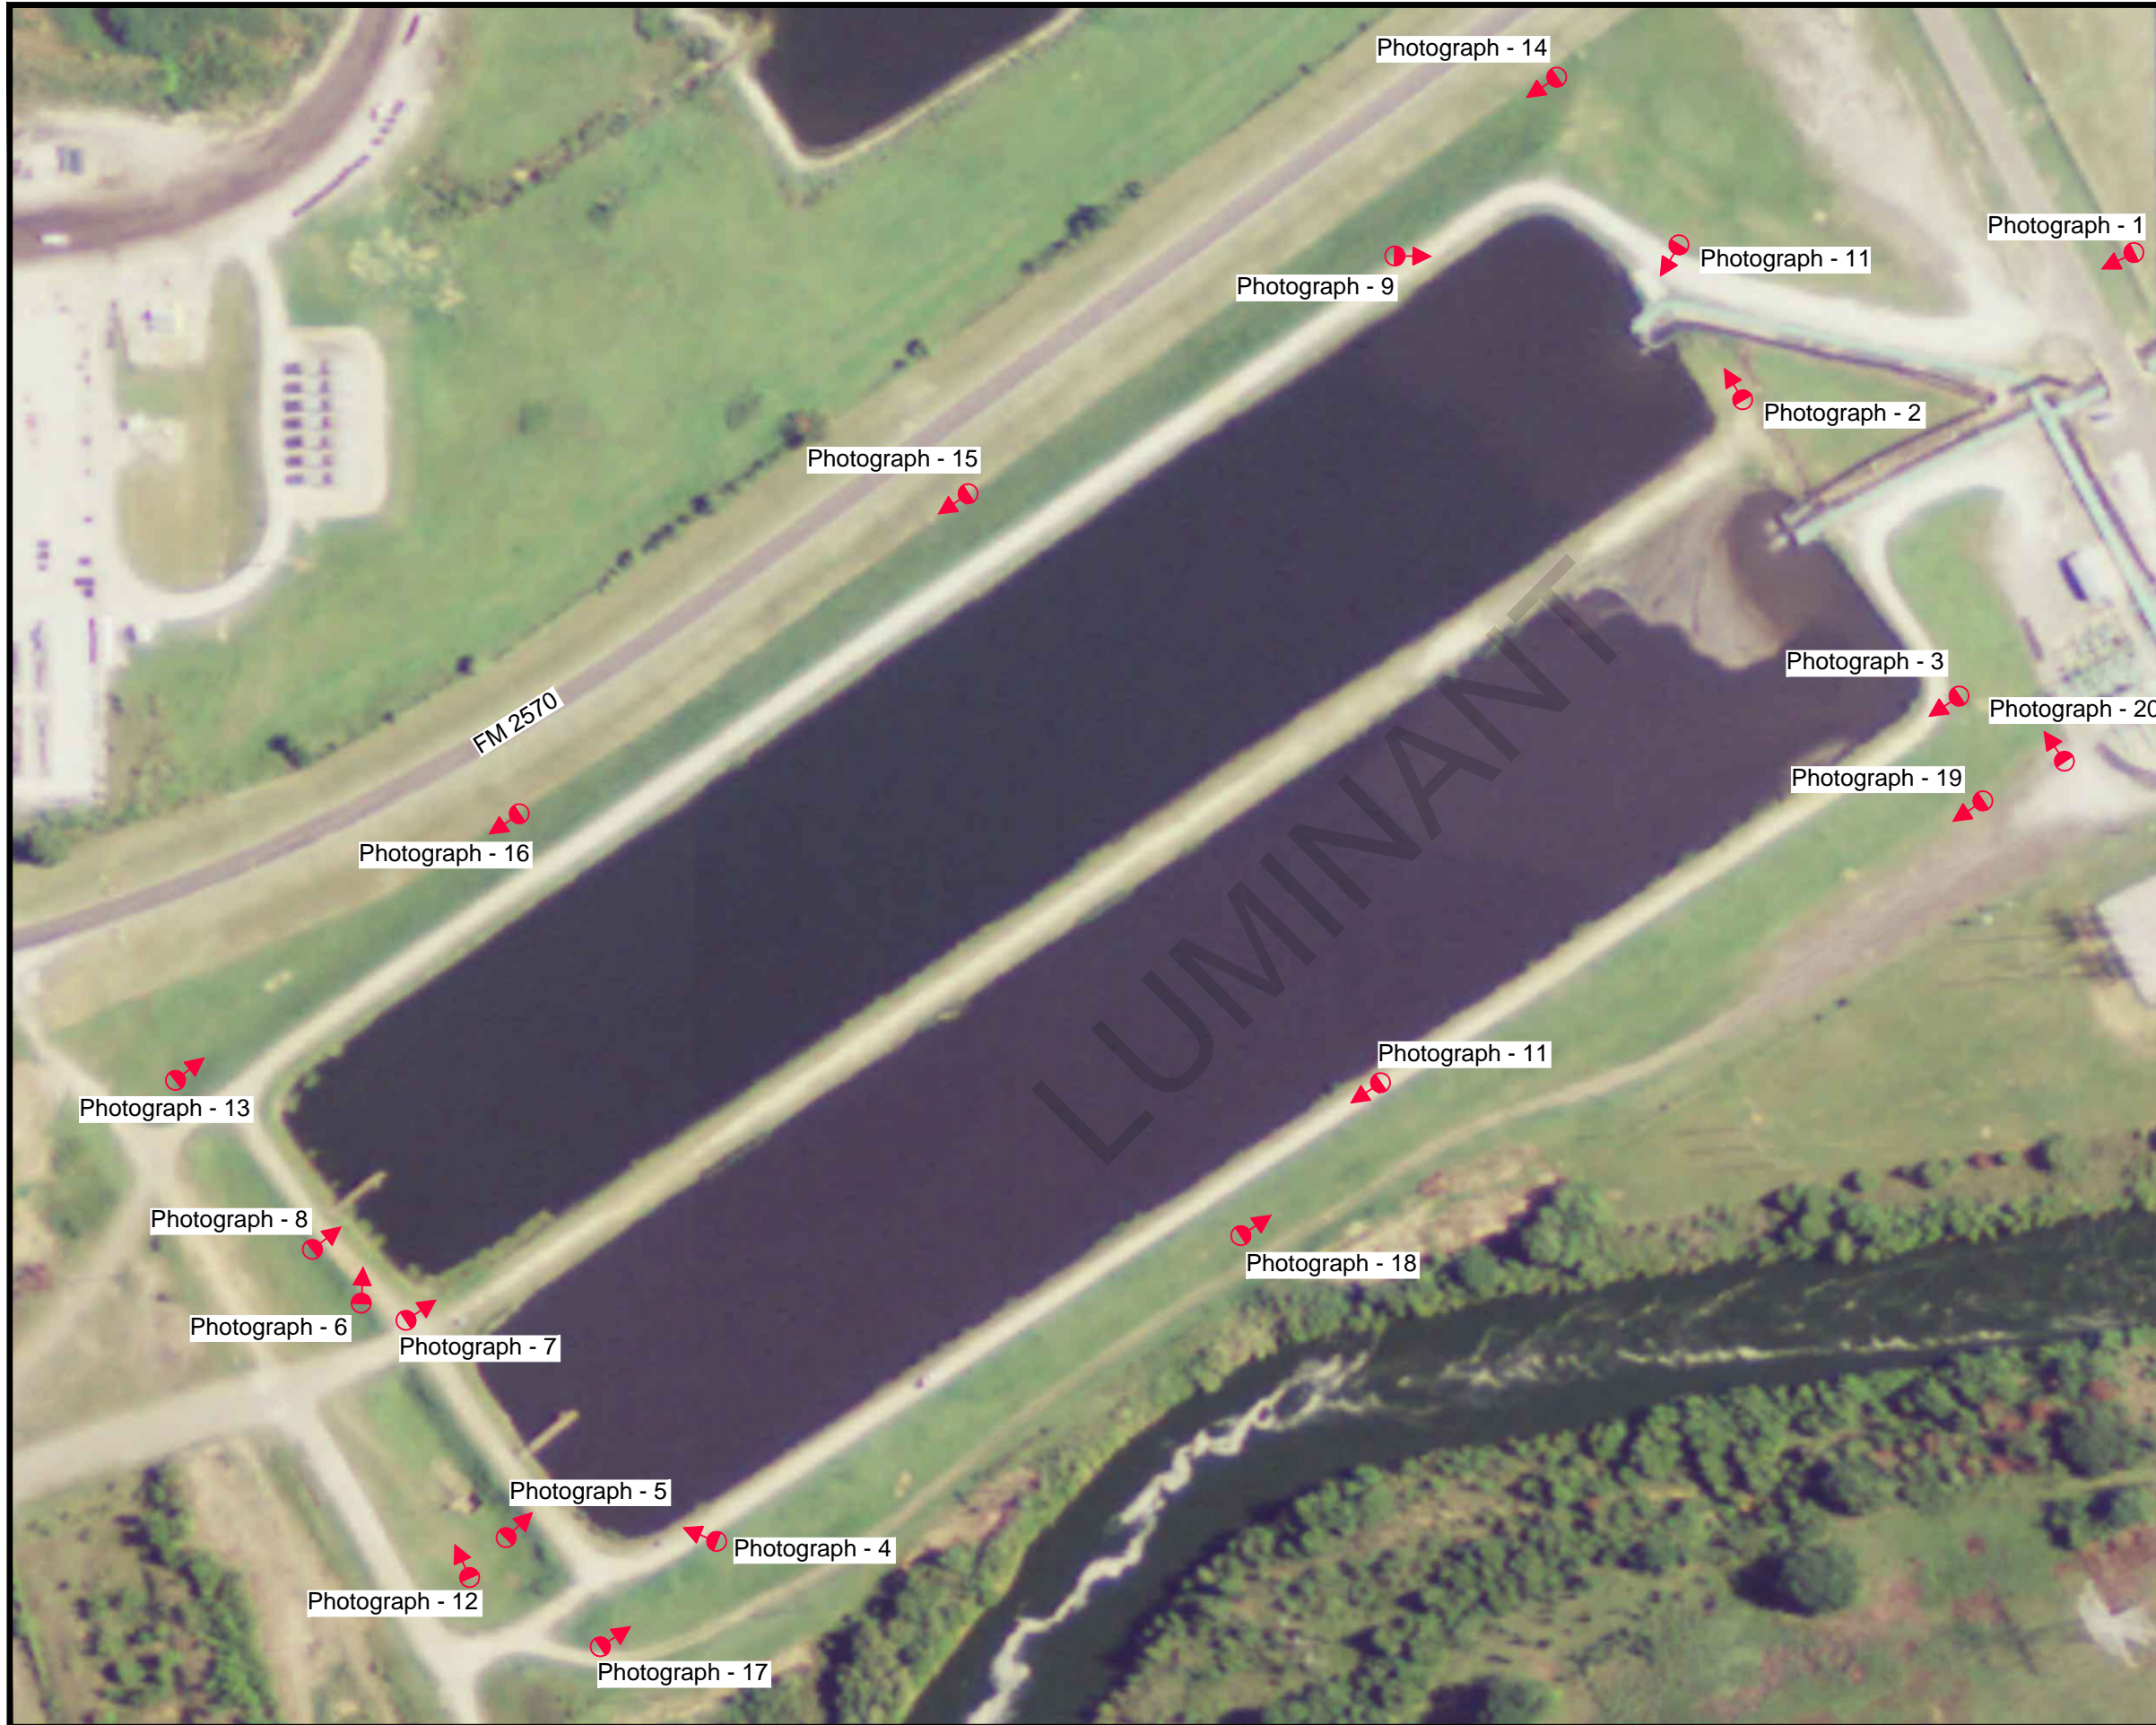
Figure 3  
**ANNUAL INSPECTION FINDINGS  
SUMMARY MAP NORTH AND  
SOUTH BOTTOM ASH PONDS**

Surface conditions near the BAPs were generally wet due to heavy Fall rains. The site had experienced 21.8 inches in the thirty day period prior to the inspection (including 1.08 inches of rain the day before the inspection); consequently, several wet areas near the toe of the embankment slopes were noted. However, no active seepage was observed in these areas during the inspection. Potential seepage was also not identified as part of the previous weekly qualified person inspections. Recommended monitoring of wet areas will allow for identification of potential seepage during weekly inspections performed during seasonally dry periods. As indicated on Figure 3, the following areas were noted for future monitoring or repair:

- Monitor the small area of feral hog damage on the north embankment of the NBAP;

The upstream embankments of the BAPs were generally in good condition and no visual evidence of slope failures or misalignments was noted on the upstream embankment of the BAPs; however, some areas of erosion of the interior slopes via either wave action or erosion from run-off were observed. As indicated on Figure 3, the following areas were noted for future monitoring or repair:

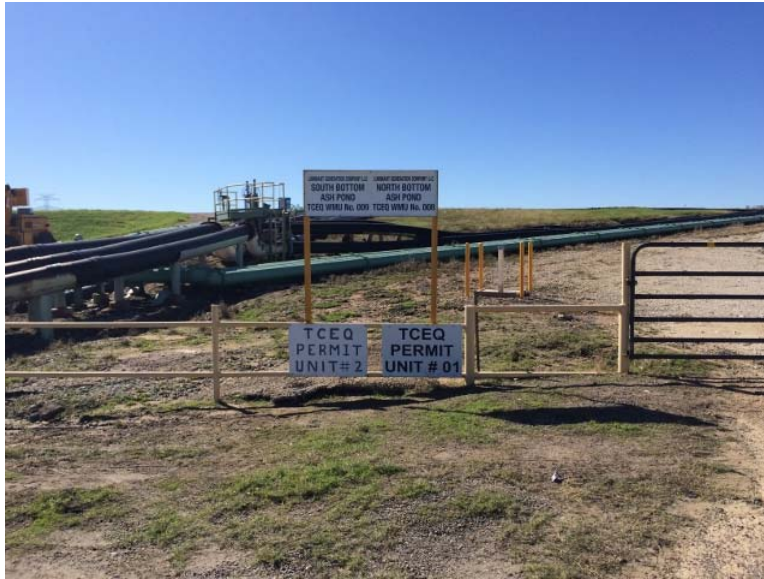
Pastor, Behling & Wheeler	DESCRIPTION	<b>Photograph 1</b> – (View SW) CCR Unit Signs – NBAP and SBAP	
PROJECT NO. 5170A	SITE NAME	Big Brown Steam Electric Station – Bottom Ash Pond Annual Inspection	DATE 11/18/2015

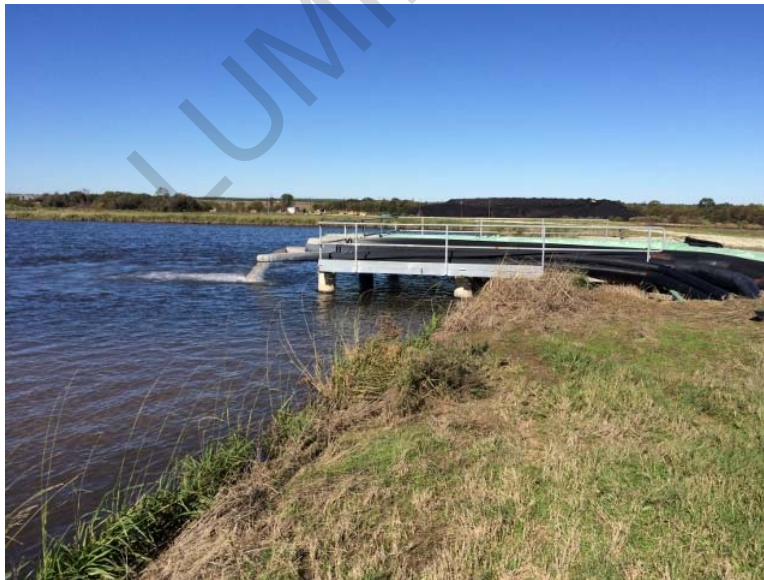
Pastor, Behling & Wheeler	DESCRIPTION	<b>Photograph 2</b> – (View N) Ash slurry inlet piping platform - NBAP	
PROJECT NO. 5170A	SITE NAME	Big Brown Steam Electric Station – Bottom Ash Pond Annual Inspection	DATE 11/18/2015

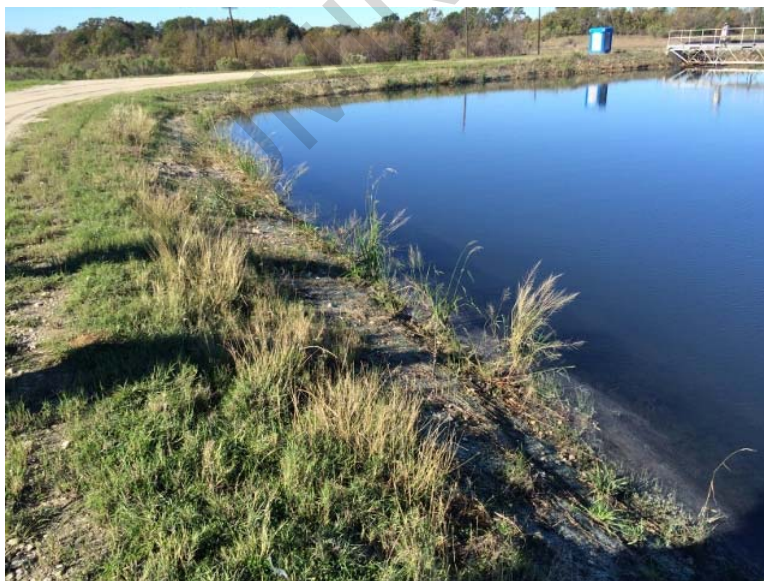
Pastor, Behling & Wheeler	DESCRIPTION	<b>Photograph 4</b> – (View W) View along crest at corner of south and west embankment of SBAP. Pier on right.	
PROJECT NO. 5170A	SITE NAME	Big Brown Steam Electric Station – Bottom Ash Pond Annual Inspection	DATE 11/18/2015

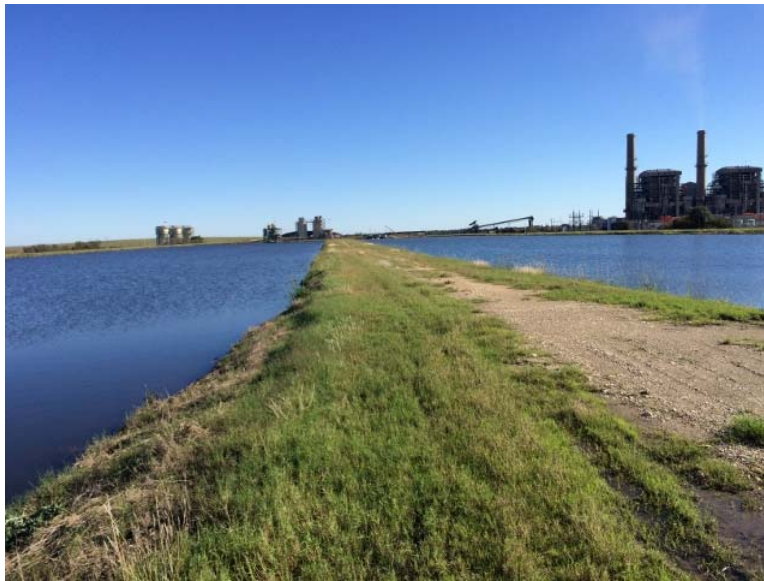
Pastor, Behling & Wheeler	DESCRIPTION	<b>Photograph 7</b> – (View NE) Crest of interior embankment between NBAP and SBAP.	
PROJECT NO. 5170A	SITE NAME	Big Brown Steam Electric Station – Bottom Ash Pond Annual Inspection	DATE 11/18/2015

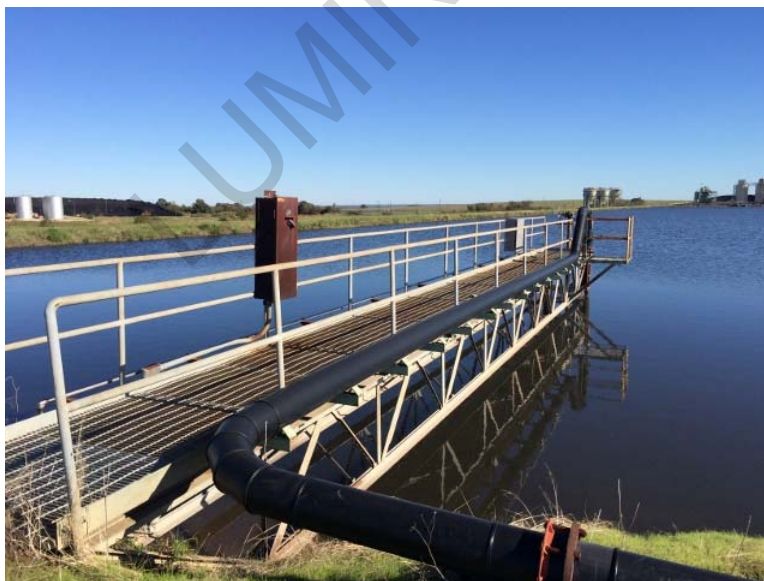
Pastor, Behling & Wheeler	DESCRIPTION	<b>Photograph 8</b> – Pier at west end of NBAP.	
PROJECT NO. 5170A	SITE NAME	Big Brown Steam Electric Station – Bottom Ash Pond Annual Inspection	DATE 11/18/2015

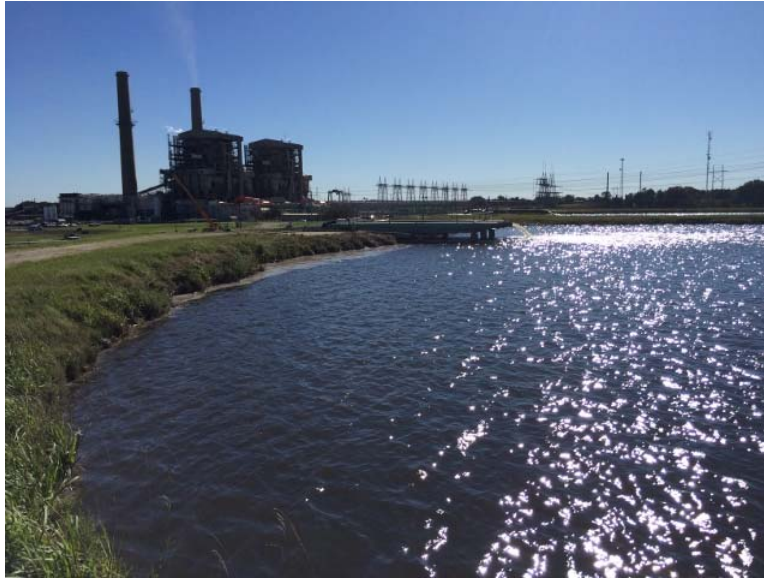
Pastor, Behling & Wheeler	DESCRIPTION	<b>Photograph 9</b> – (View E) View along crest at corner of north and east embankment of NBAP. Ash slurry inlet piping platform in background.	
PROJECT NO. 5170A	SITE NAME	Big Brown Steam Electric Station – Bottom Ash Pond Annual Inspection	DATE 11/18/2015

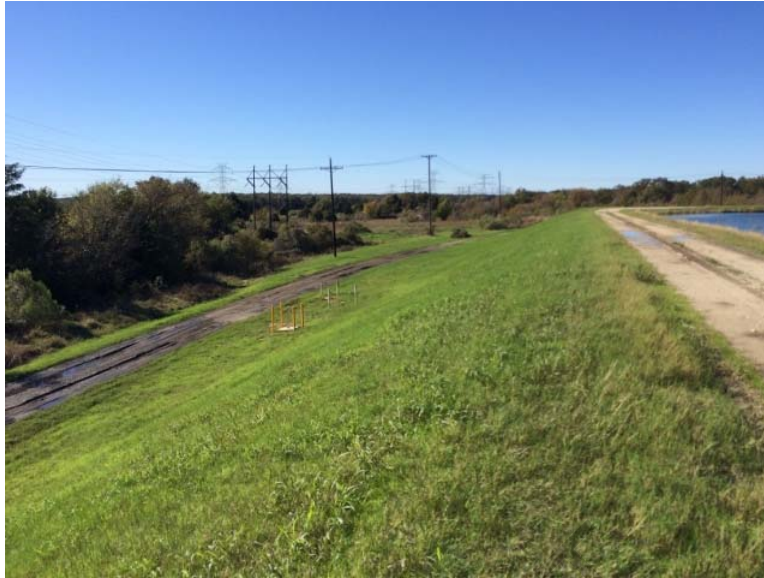
Pastor, Behling & Wheeler	DESCRIPTION	<b>Photograph 11</b> – (View SW) View along crest of south embankment of SBAP.	
PROJECT NO. 5170A	SITE NAME	Big Brown Steam Electric Station – Bottom Ash Pond Annual Inspection	DATE 11/18/2015

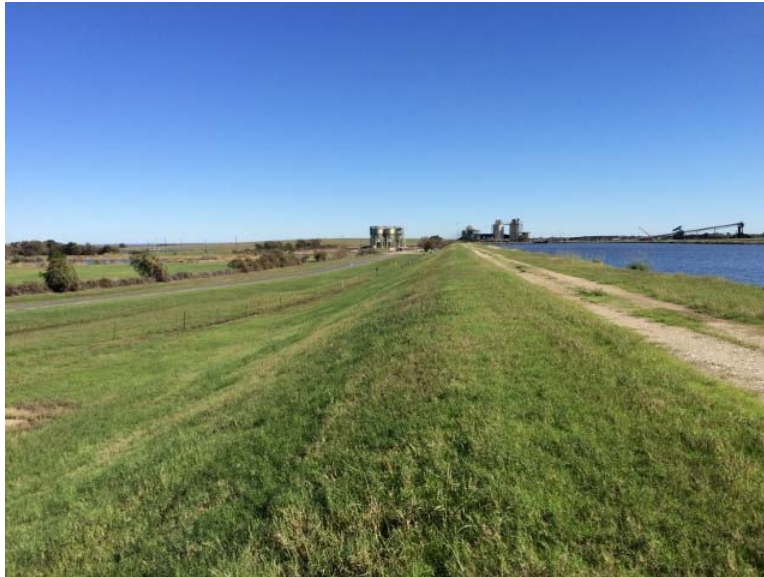
Pastor, Behling & Wheeler	DESCRIPTION	<b>Photograph 13</b> – (View NE) View along crest of north embankment of NBAP.	
PROJECT NO. 5170A	SITE NAME	Big Brown Steam Electric Station – Bottom Ash Pond Annual Inspection	DATE 11/18/2015

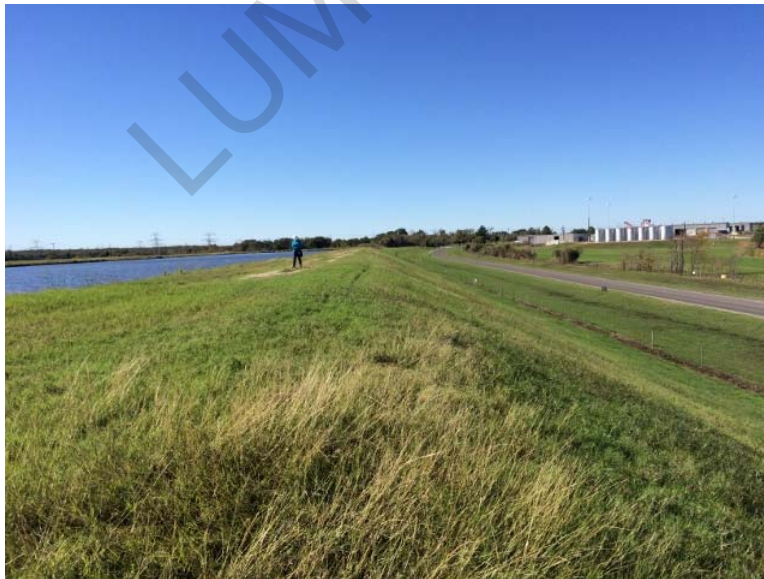
Pastor, Behling & Wheeler	DESCRIPTION	<b>Photograph 14</b> – (View SW) View along crest of north embankment of NBAP.	
PROJECT NO. 5170A	SITE NAME	Big Brown Steam Electric Station – Bottom Ash Pond Annual Inspection	DATE 11/18/2015

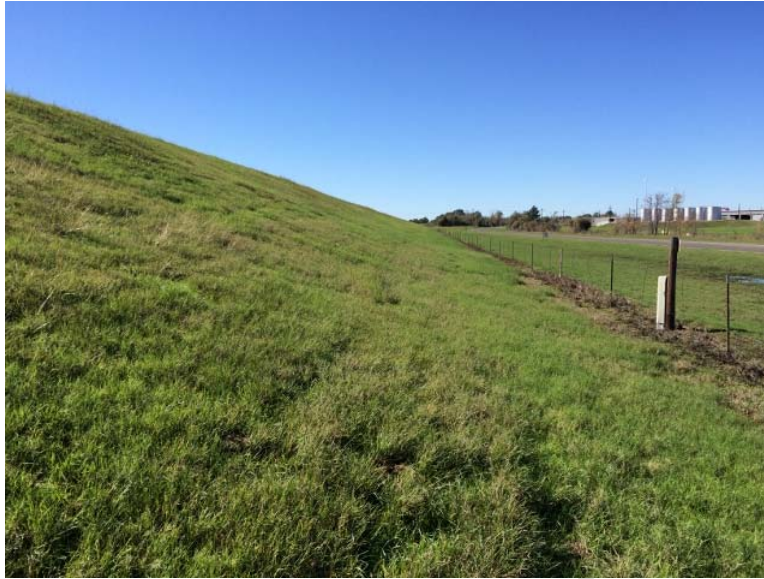
Pastor, Behling & Wheeler	DESCRIPTION	<b>Photograph 15</b> – (View SW) View along toe of north embankment of NBAP.	
PROJECT NO. 5170A	SITE NAME	Big Brown Steam Electric Station – Bottom Ash Pond Annual Inspection	DATE 11/18/2015

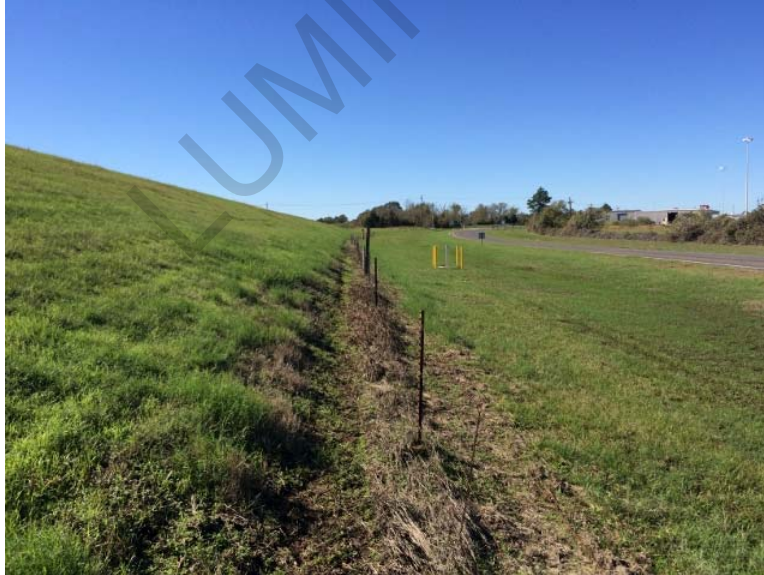
Pastor, Behling & Wheeler	DESCRIPTION	<b>Photograph 16</b> – (View SW) View along toe of north embankment of NBAP.	
PROJECT NO. 5170A	SITE NAME	Big Brown Steam Electric Station – Bottom Ash Pond Annual Inspection	DATE 11/18/2015

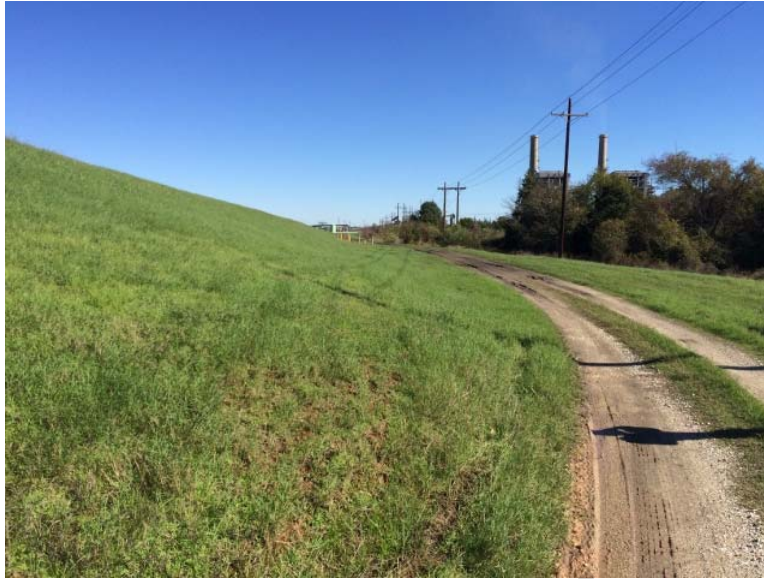
Pastor, Behling & Wheeler	DESCRIPTION	<b>Photograph 17</b> – (View NE) View along toe of south embankment of SBAP.	
PROJECT NO. 5170A	SITE NAME	Big Brown Steam Electric Station – Bottom Ash Pond Annual Inspection	DATE 11/18/2015

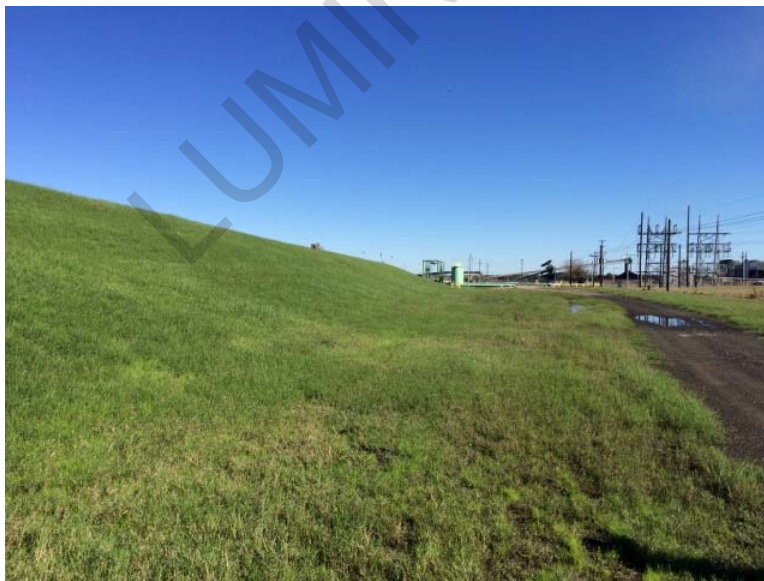
Pastor, Behling & Wheeler	DESCRIPTION	<b>Photograph 18</b> – (View NE) View along toe of south embankment of SBAP.	
PROJECT NO. 5170A	SITE NAME	Big Brown Steam Electric Station – Bottom Ash Pond Annual Inspection	DATE 11/18/2015

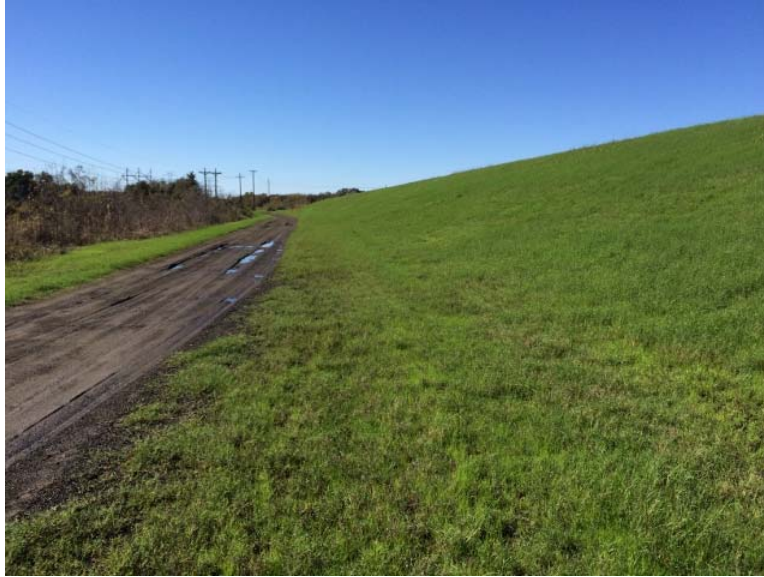
Pastor, Behling & Wheeler	DESCRIPTION	<b>Photograph 19</b> – (View SW) View along toe of south embankment of SBAP.	
PROJECT NO. 5170A	SITE NAME	Big Brown Steam Electric Station – Bottom Ash Pond Annual Inspection	DATE 11/18/2015

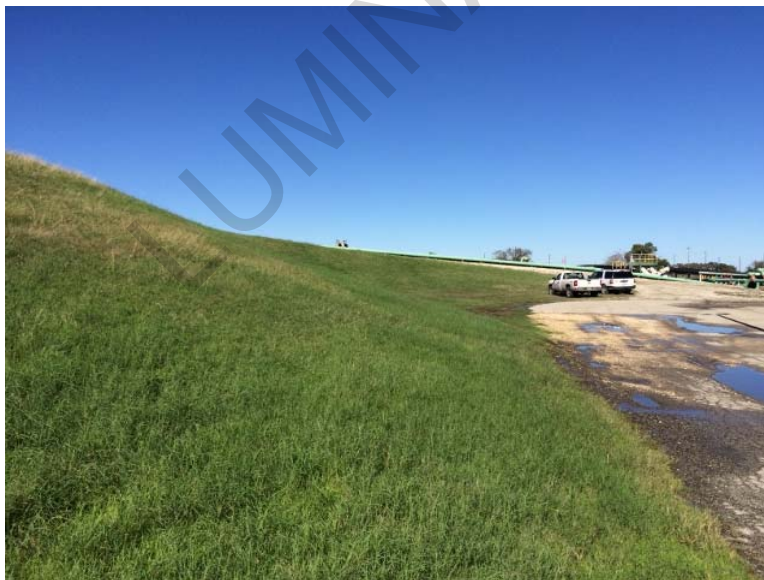
Pastor, Behling & Wheeler	DESCRIPTION	<b>Photograph 20</b> – (View N) View along toe of east embankment of SBAP.	
PROJECT NO. 5170A	SITE NAME	Big Brown Steam Electric Station – Bottom Ash Pond Annual Inspection	DATE 11/18/2015

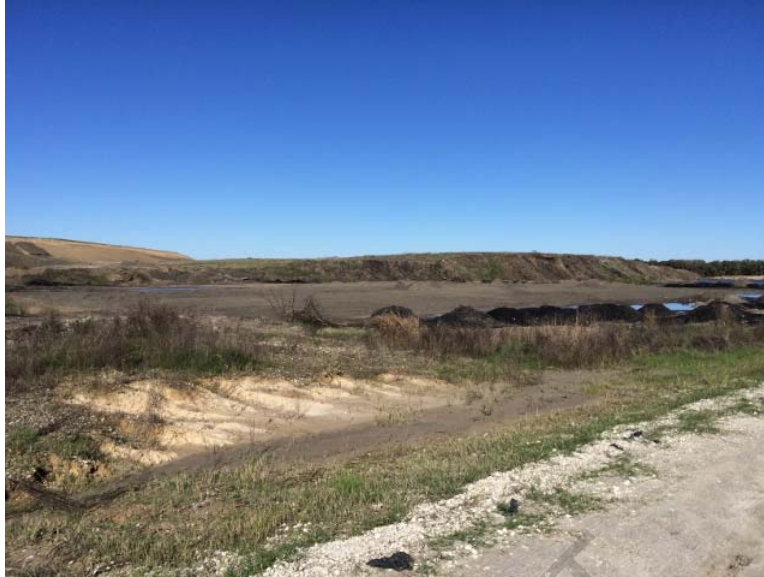
Pastor, Behling & Wheeler	DESCRIPTION	<b>Photograph 1</b> – (View NE) Southeast corner of Cell 10 (active CCR placement area)	
PROJECT NO. 5170A	SITE NAME	Big Brown Steam Electric Station – Ash Disposal Area II Annual Inspection	DATE 11/18/2015

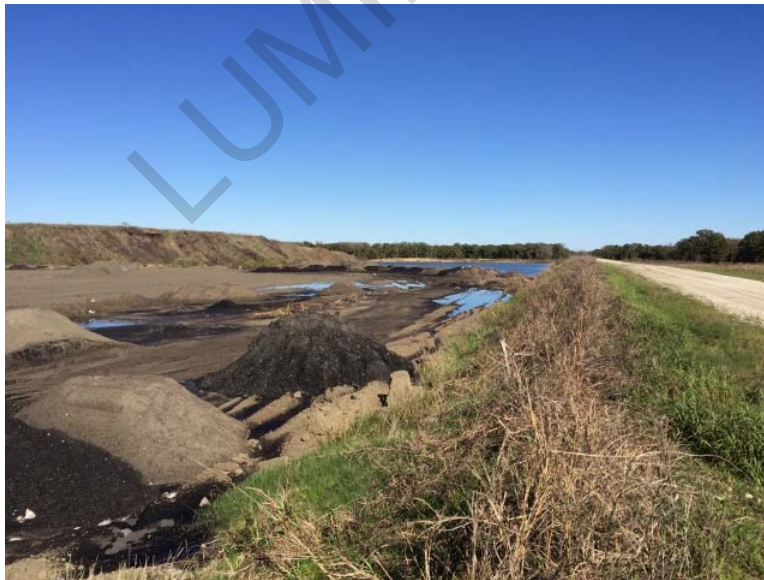
Pastor, Behling & Wheeler	DESCRIPTION	<b>Photograph 2</b> – (View NE) View along crest of south embankment of Cell 10	
PROJECT NO. 5170A	SITE NAME	Big Brown Steam Electric Station – Ash Disposal Area II Annual Inspection	DATE 11/18/2015

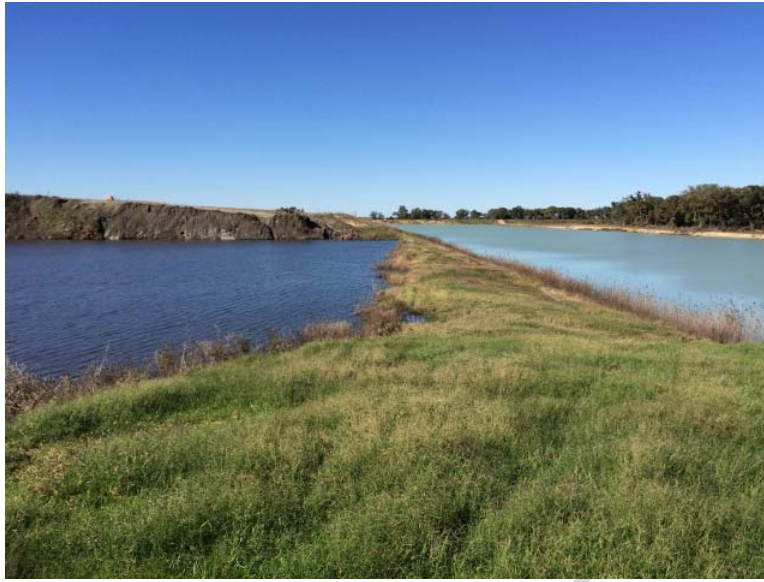
Pastor, Behling & Wheeler  PROJECT NO. 5170A	DESCRIPTION	<b>Photograph 5</b> – (View NW) View along embankment separating Cell 10 (left) from Cell 11 (right) from southwest corner.	
	SITE NAME	Big Brown Steam Electric Station – Ash Disposal Area II Annual Inspection	DATE 11/18/2015

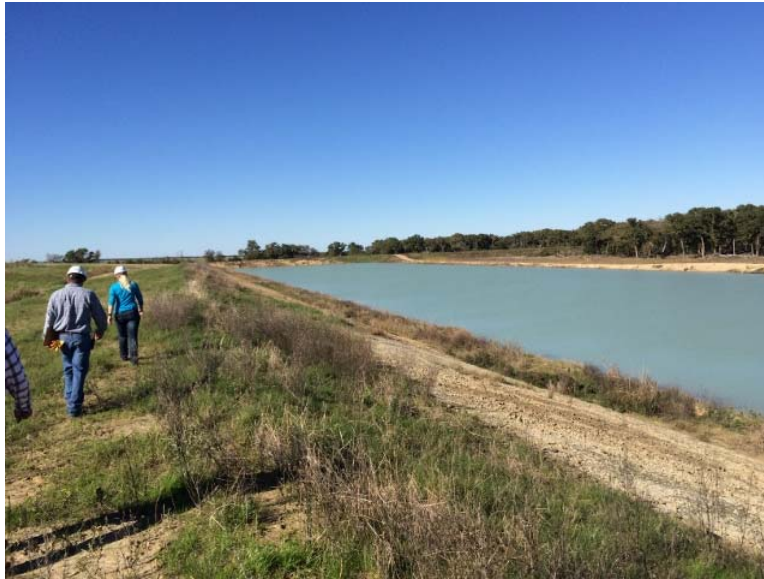
Pastor, Behling & Wheeler	DESCRIPTION	<b>Photograph 7</b> – (View NW) Crest of embankment between former Cells 1-9 and Cell 11. Cell 11 on right.	
PROJECT NO. 5170A	SITE NAME	Big Brown Steam Electric Station – Ash Disposal Area II Annual Inspection	DATE 11/18/2015

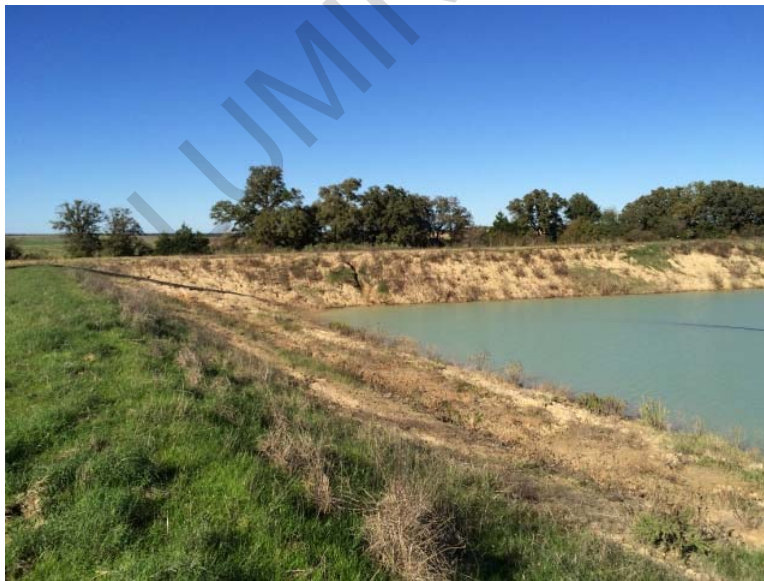
Pastor, Behling & Wheeler	DESCRIPTION	<b>Photograph 8</b> – (View NW) View along crest of embankment between former Cells 1-9 and Cell 11 at northwest corner. Cell 11 on right.	
PROJECT NO. 5170A	SITE NAME	Big Brown Steam Electric Station – Ash Disposal Area II Annual Inspection	DATE 11/18/2015

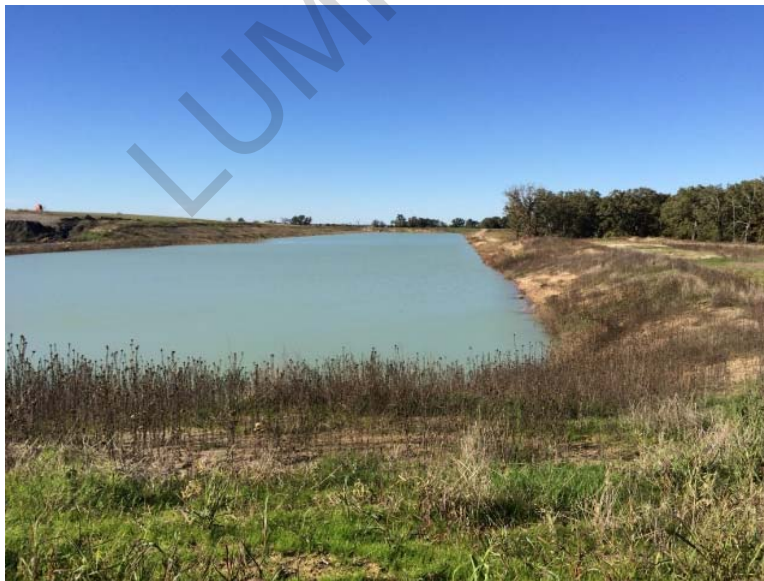
Pastor, Behling & Wheeler	DESCRIPTION	<b>Photograph 12</b> – (View NW) View along crest of north embankment of Cell 11 from southeast corner. Cell 11 on left.	
PROJECT NO. 5170A	SITE NAME	Big Brown Steam Electric Station – Ash Disposal Area II Annual Inspection	DATE 11/18/2015
