**2016 ANNUAL CCR UNIT INSPECTION REPORT  
LUMINANT BIG BROWN STEAM ELECTRIC STATION  
ASH DISPOSAL AREA II  
FREESTONE COUNTY, TEXAS**

January 13, 2017

**PASTOR, BEHLING & WHEELER, LLC**  
2201 Double Creek Drive, Suite 4004  
Round Rock, Texas 78664  
Texas Engineering Firm No. 4760

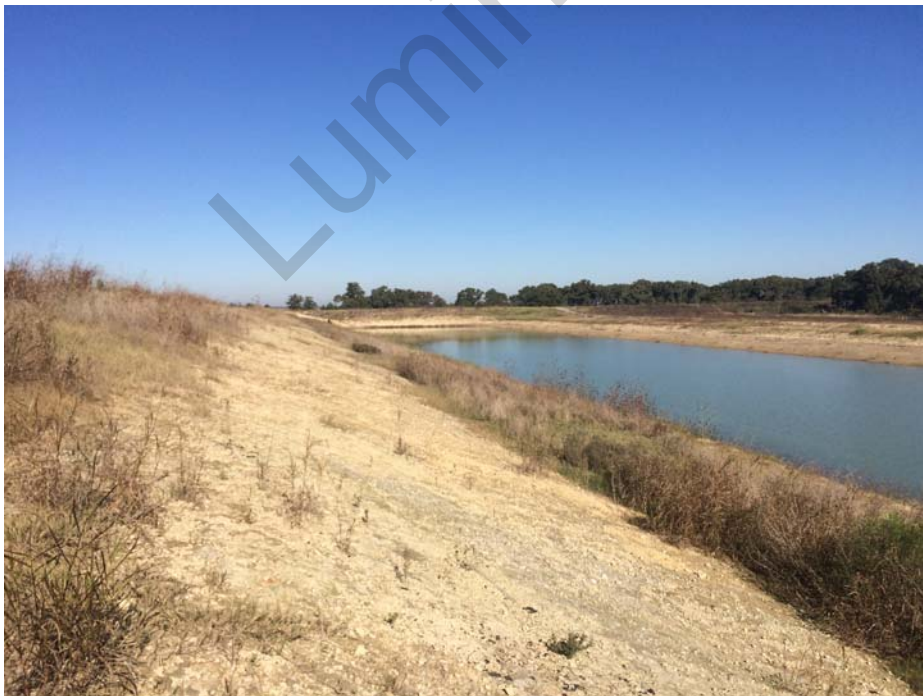
Pastor, Behling & Wheeler	DESCRIPTION	<b>Photograph 1</b> – (View NW) Southwest corner Cell 11, along repaired dike between Cells 10 and 11. Cell 10 on left, Cell 11 on right.	
PROJECT NO. 5255	SITE NAME	Big Brown Steam Electric Station – Ash Disposal Area II Annual Inspection	DATE 11/15/2016

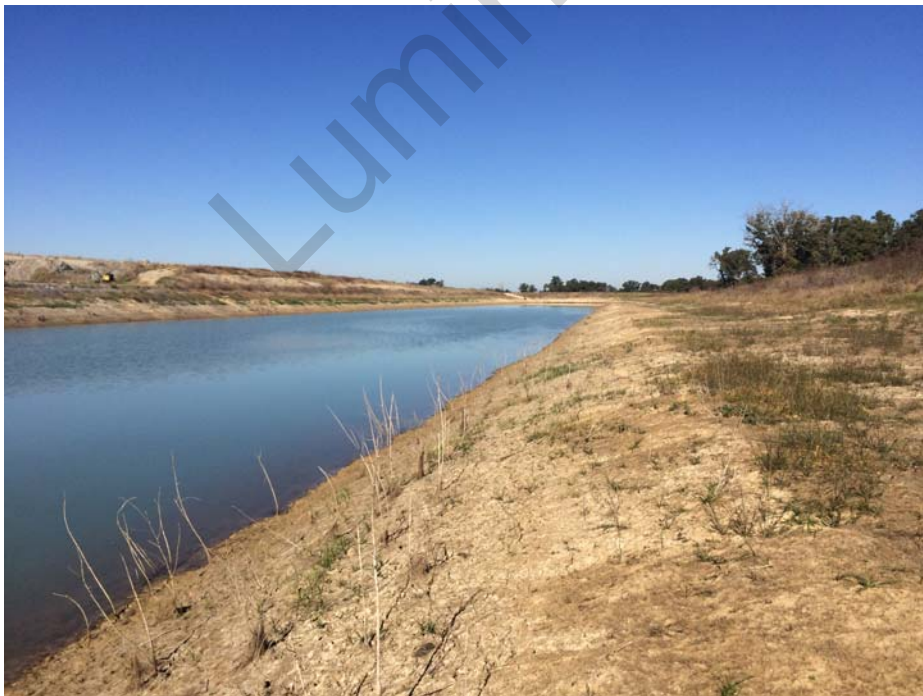
Pastor, Behling & Wheeler	DESCRIPTION	<b>Photograph 7</b> – (View W) View along south dike of Cell 11. Minor erosion on west dike of Cell 11 in background.	
PROJECT NO. 5255	SITE NAME	Big Brown Steam Electric Station – Ash Disposal Area II Annual Inspection	DATE 11/15/2016

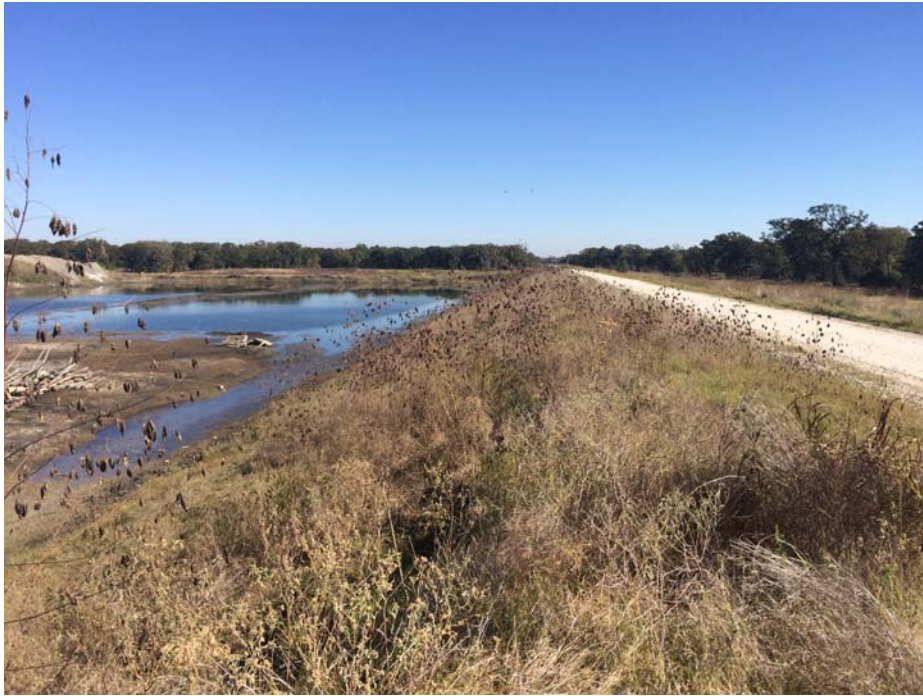
Pastor, Behling & Wheeler	DESCRIPTION	<b>Photograph 8</b> – (View NW) View along east dike of Cell 11.	
PROJECT NO. 5255	SITE NAME	Big Brown Steam Electric Station – Ash Disposal Area II Annual Inspection	DATE 11/15/2016

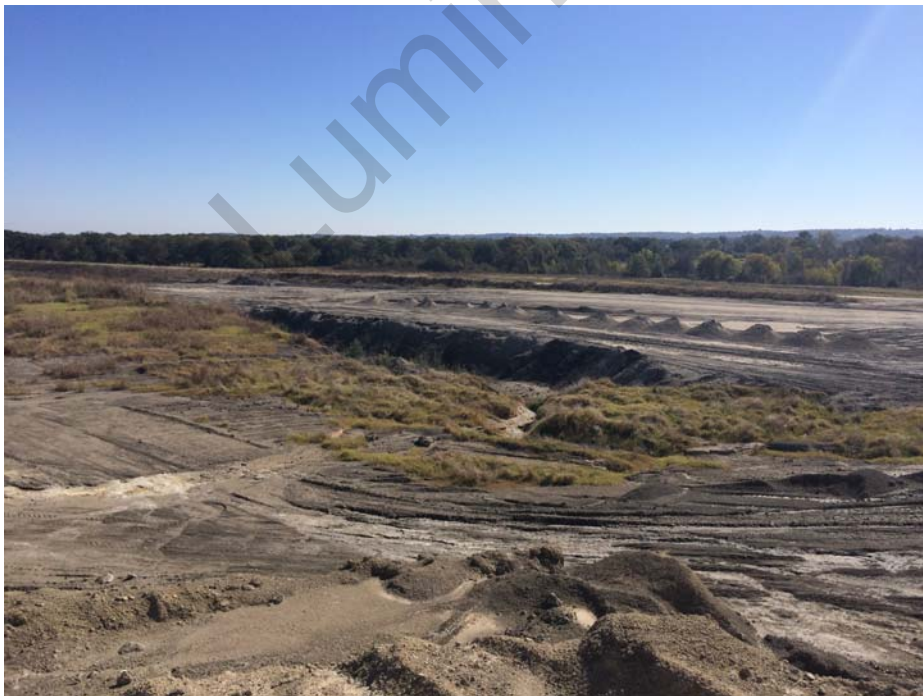
Pastor, Behling & Wheeler	DESCRIPTION	<b>Photograph 11</b> – (View N) Minor erosion of capped area.	
PROJECT NO. 5255	SITE NAME	Big Brown Steam Electric Station – Ash Disposal Area II Annual Inspection	DATE 11/15/2016

- Monitor/repair feral hog damage;
- Monitor/repair interior slope erosion on face of Cell 11 embankment;
- Monitor/repair erosion along access road along north side; and
- Monitor/repair erosion on capped area in north part of landfill.
