ANNUAL INSPECTION OF CCR UNITS

**Oak Grove Steam Electric Station
Robertson County, Texas**

January 2018

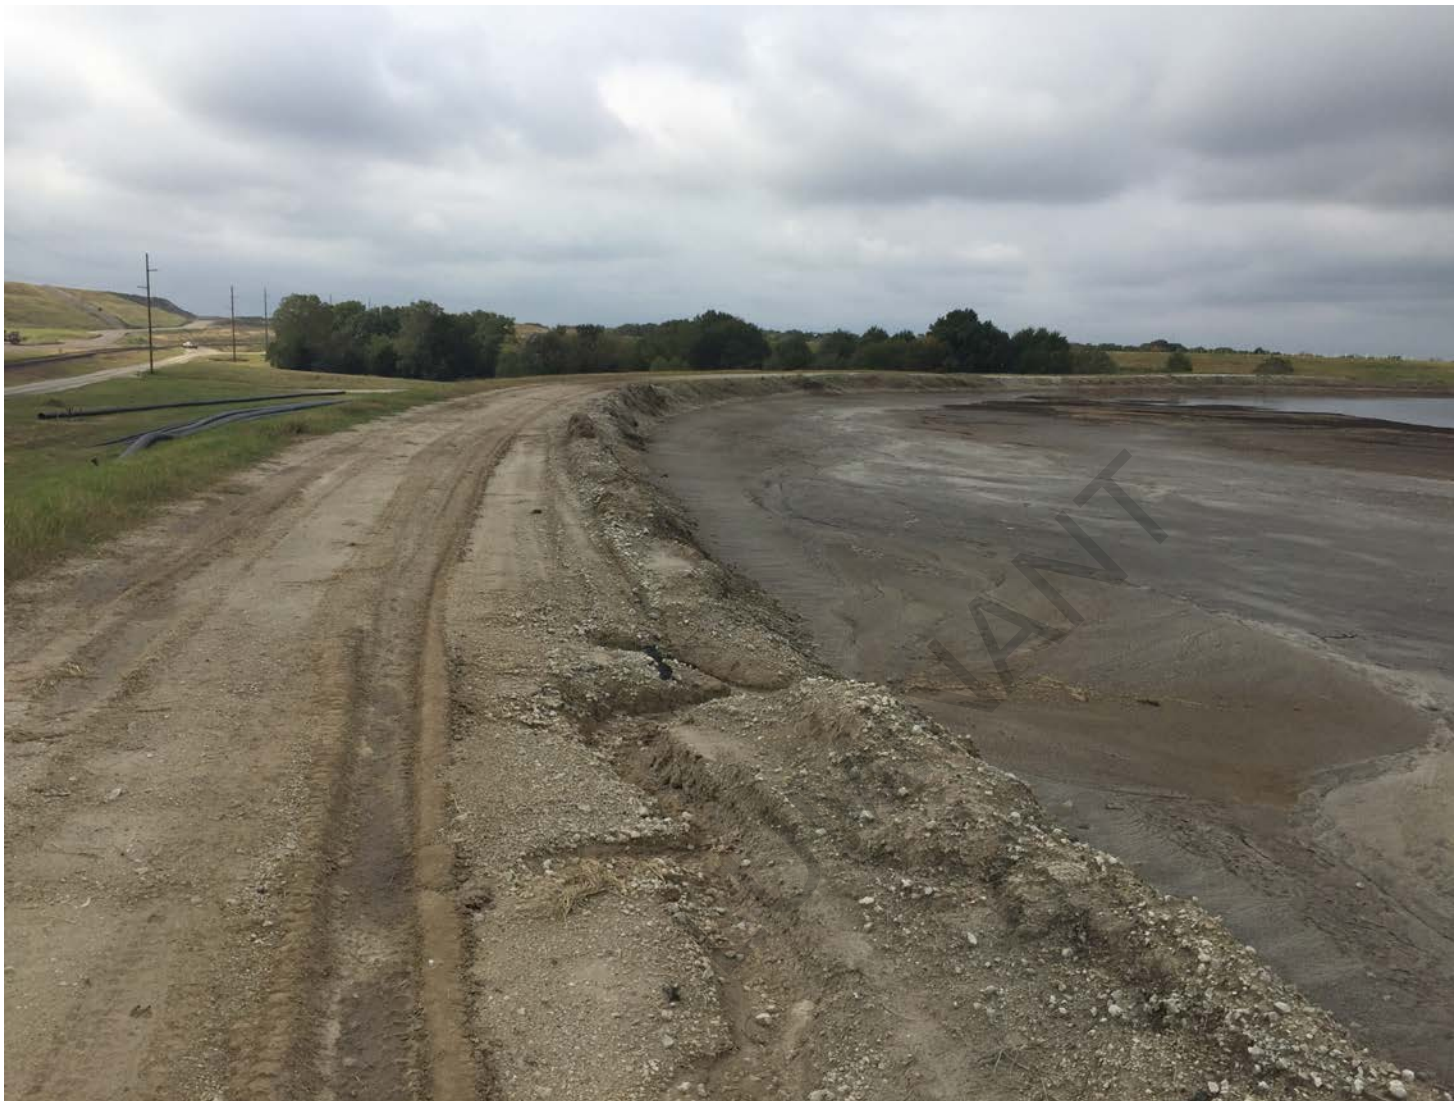
PHOTO DESCRIPTION:
 Southeastern crest and
 upstream slope. Minor
 rutting. Erosion rill due to
 ponding water.

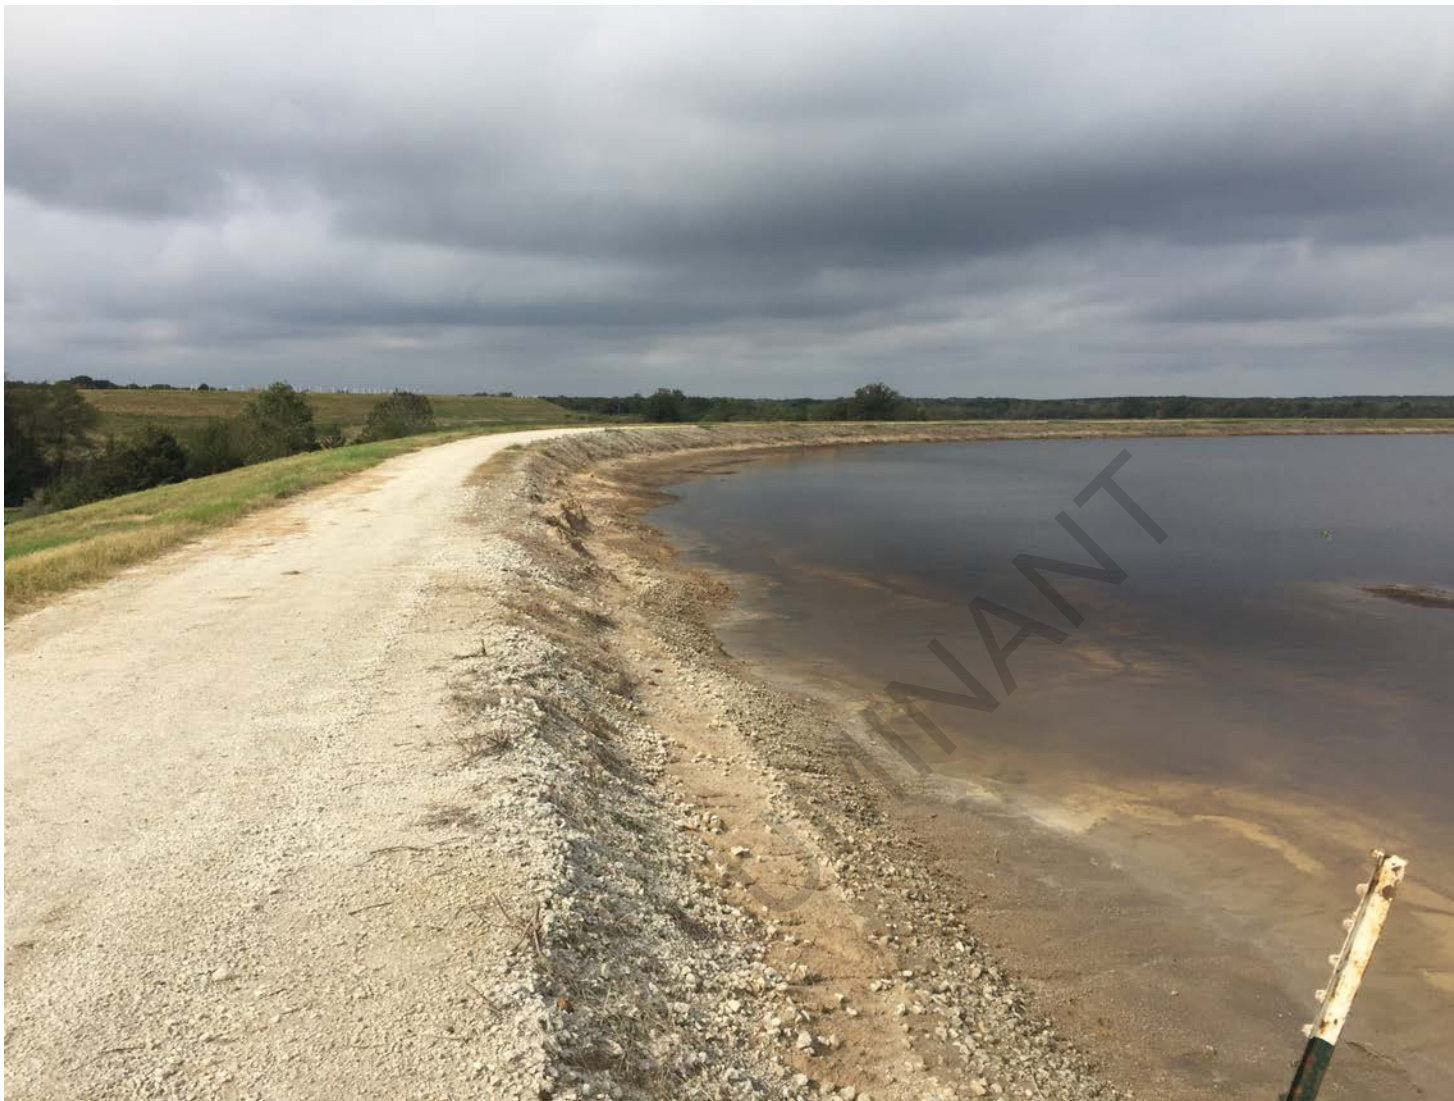
PHOTO DESCRIPTION:
 Southern crest and upstream
 slope.

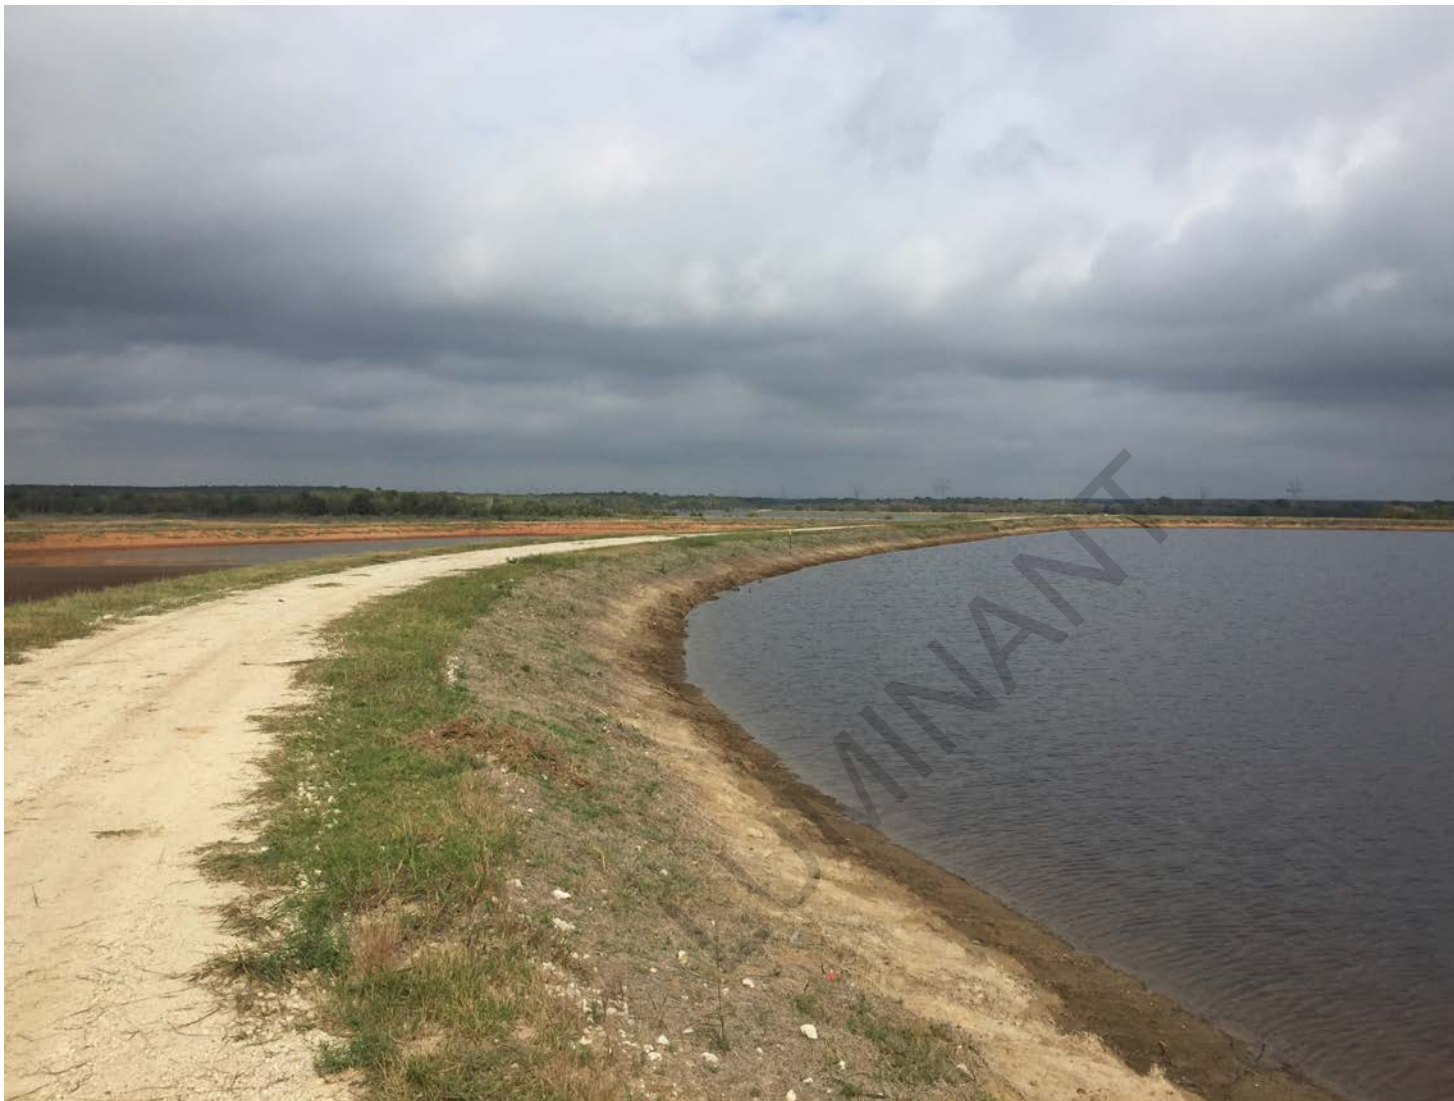
PHOTO DESCRIPTION:
 Western crest and upstream
 slope.

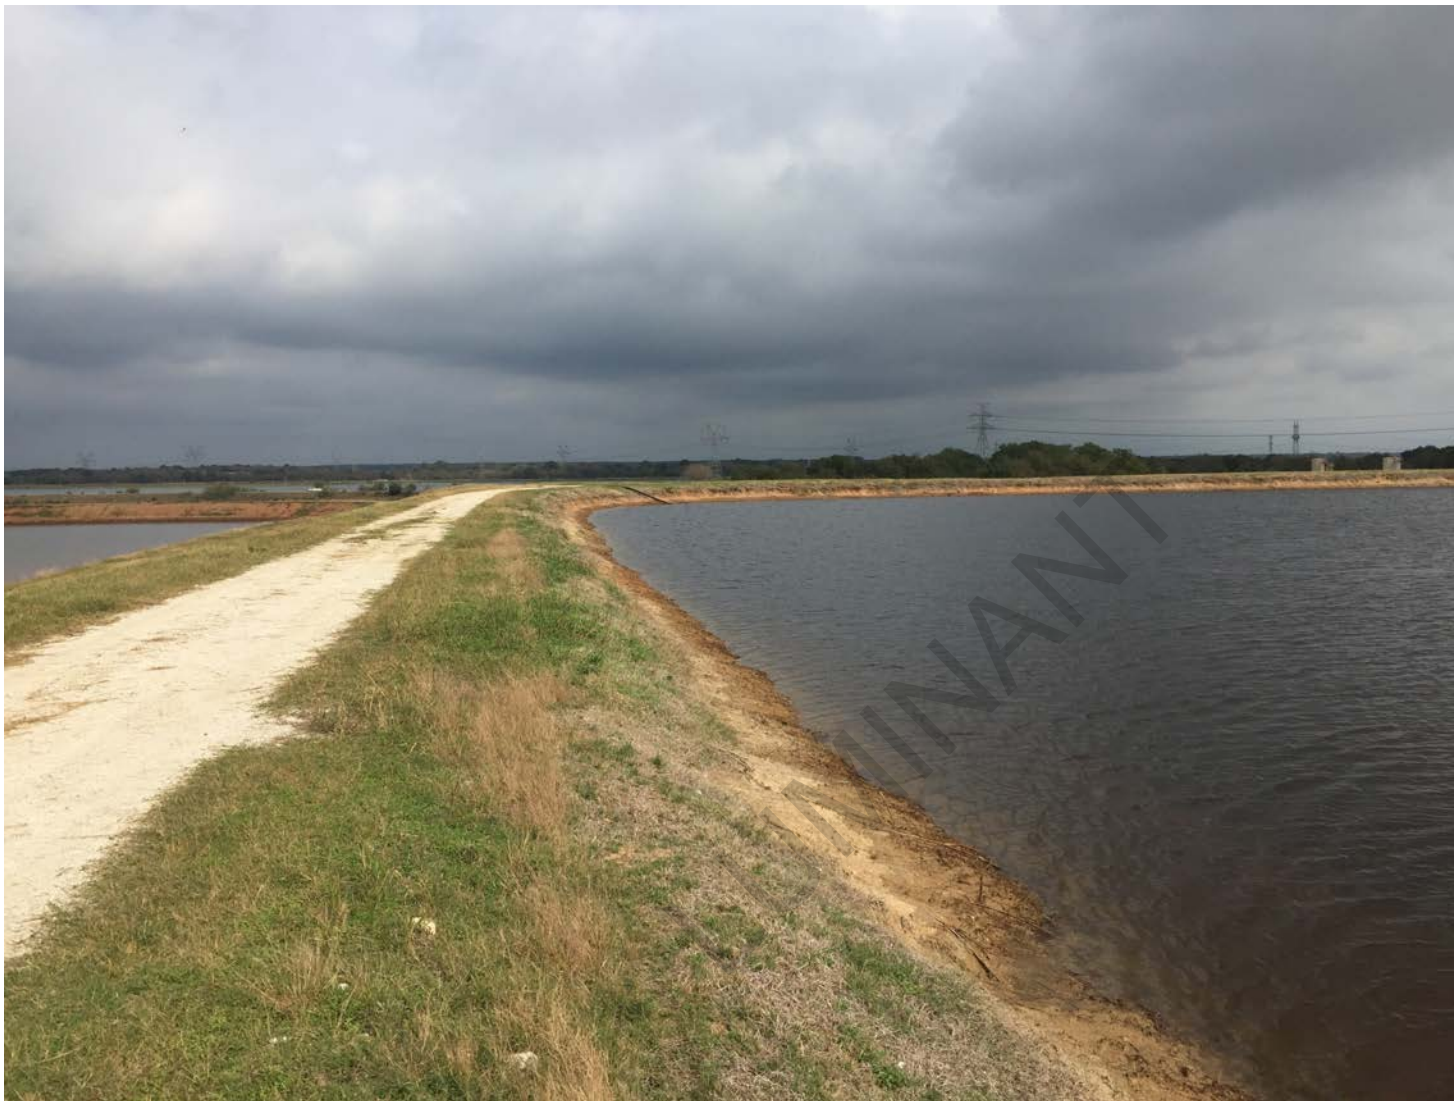
PHOTO DESCRIPTION:
 Northwestern crest and
 upstream slope – looking NE.

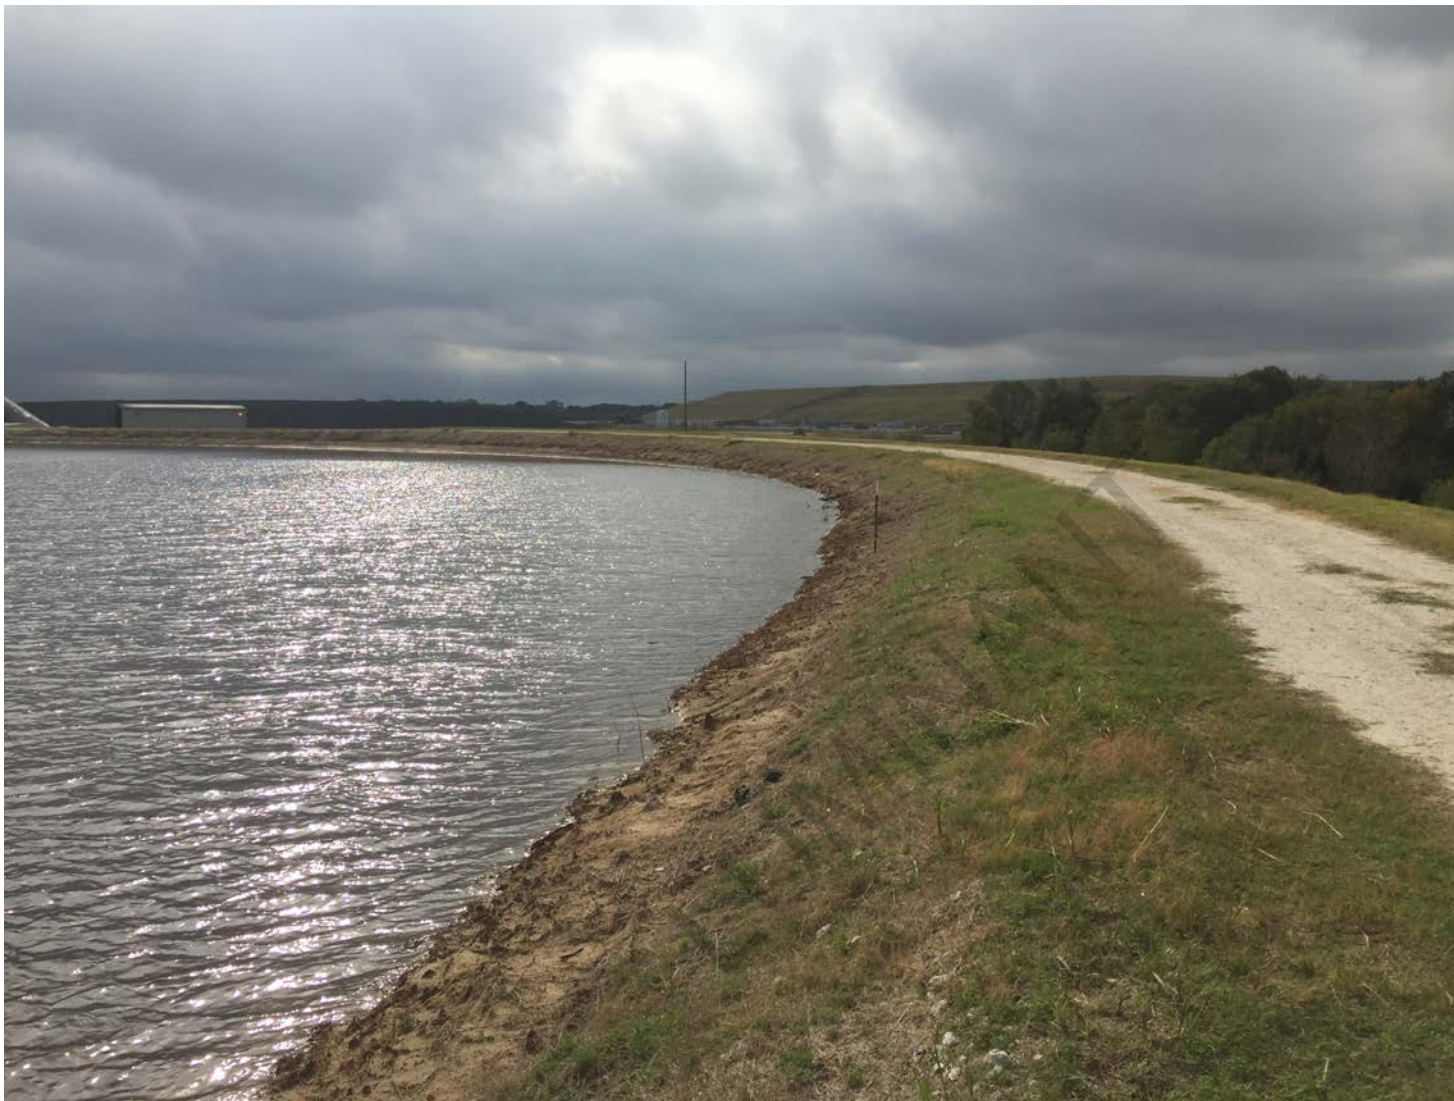
PHOTO DESCRIPTION:
 Northwestern crest and
 upstream slope – looking SW.

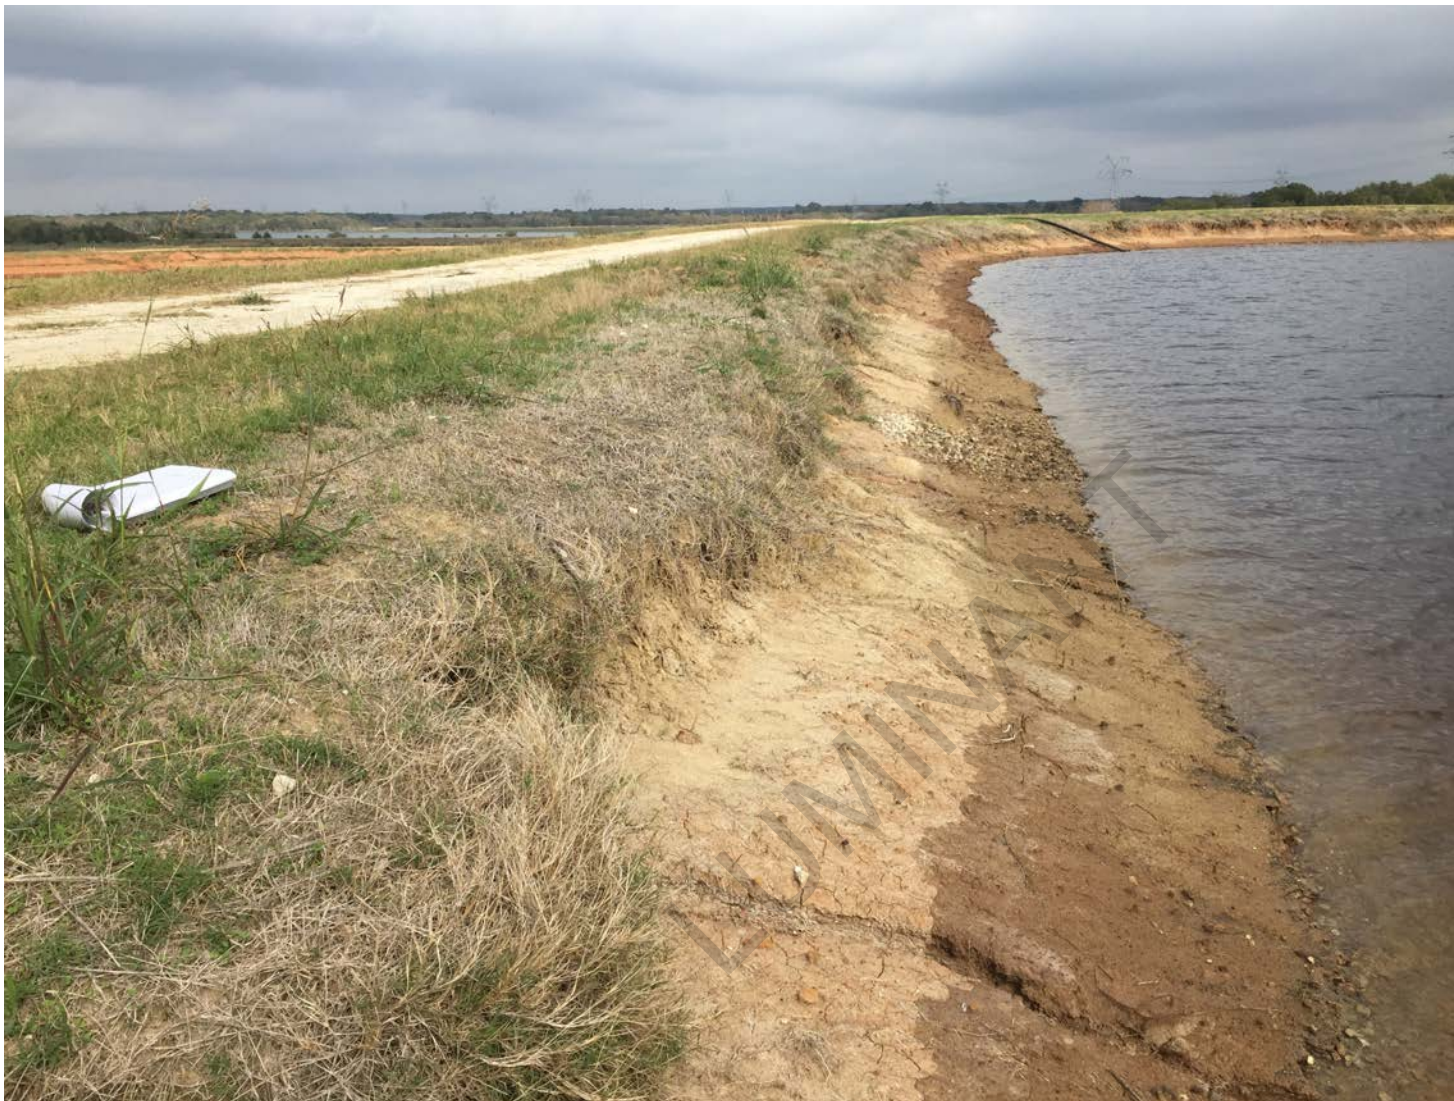
PHOTO DESCRIPTION:
 Northwestern crest and
 upstream slope. Wave action
 erosion and rills from
 ponding water.

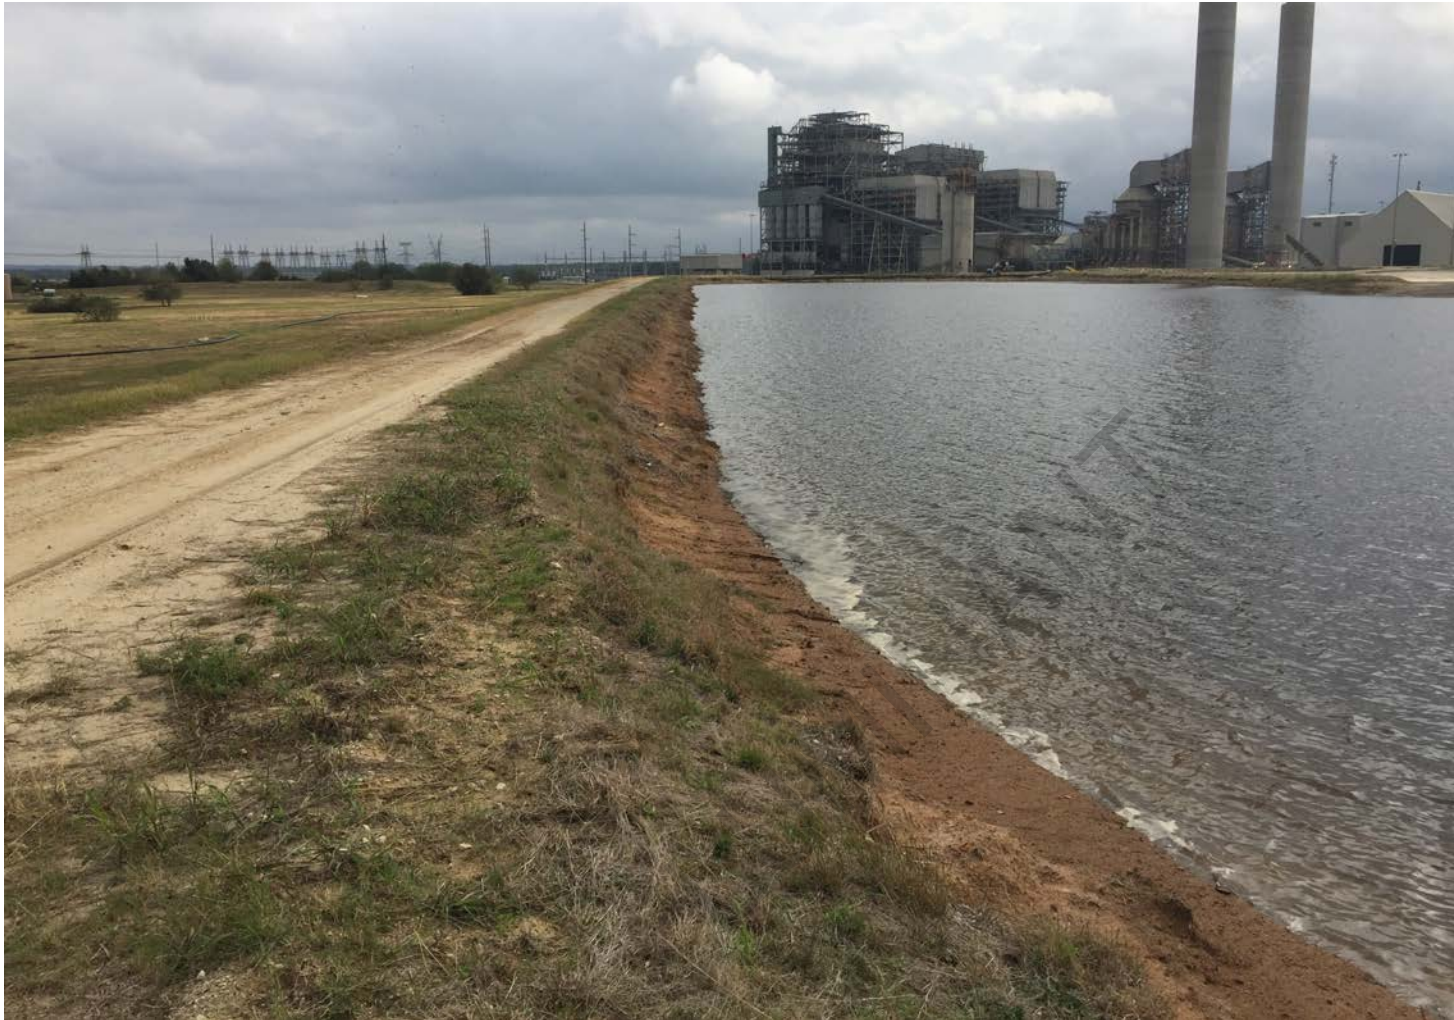
PHOTO DESCRIPTION:
 Northeastern crest and
 upstream slope.

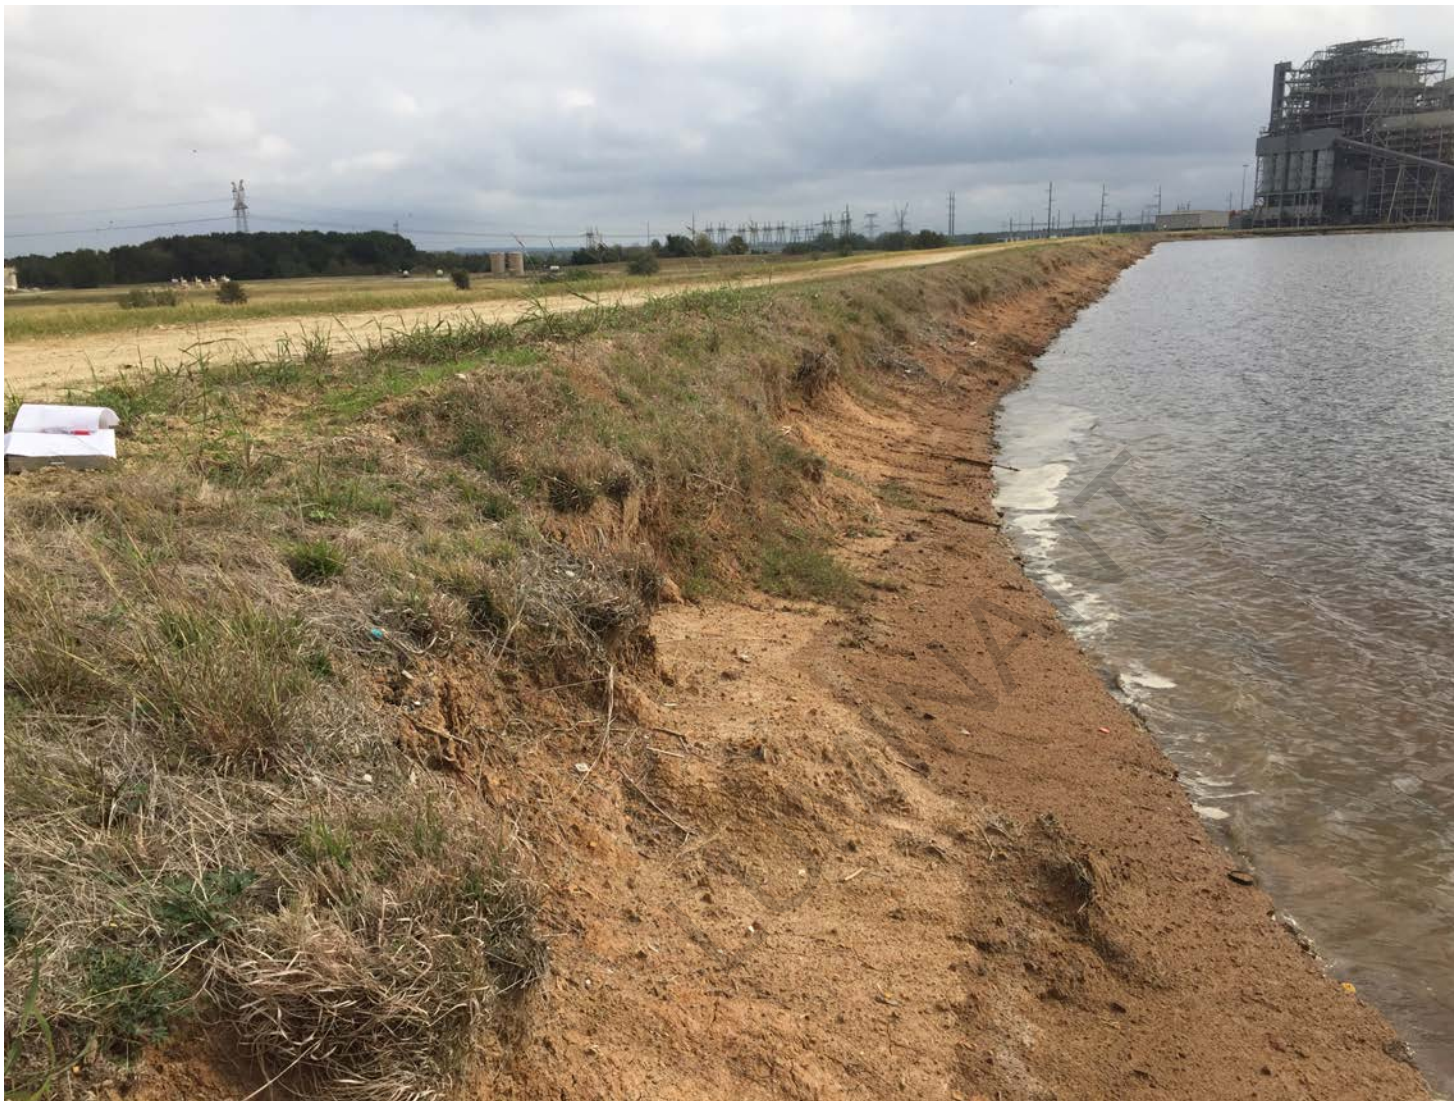
PHOTO DESCRIPTION:
 Northeastern crest and
 upstream slope. Wave action
 erosion

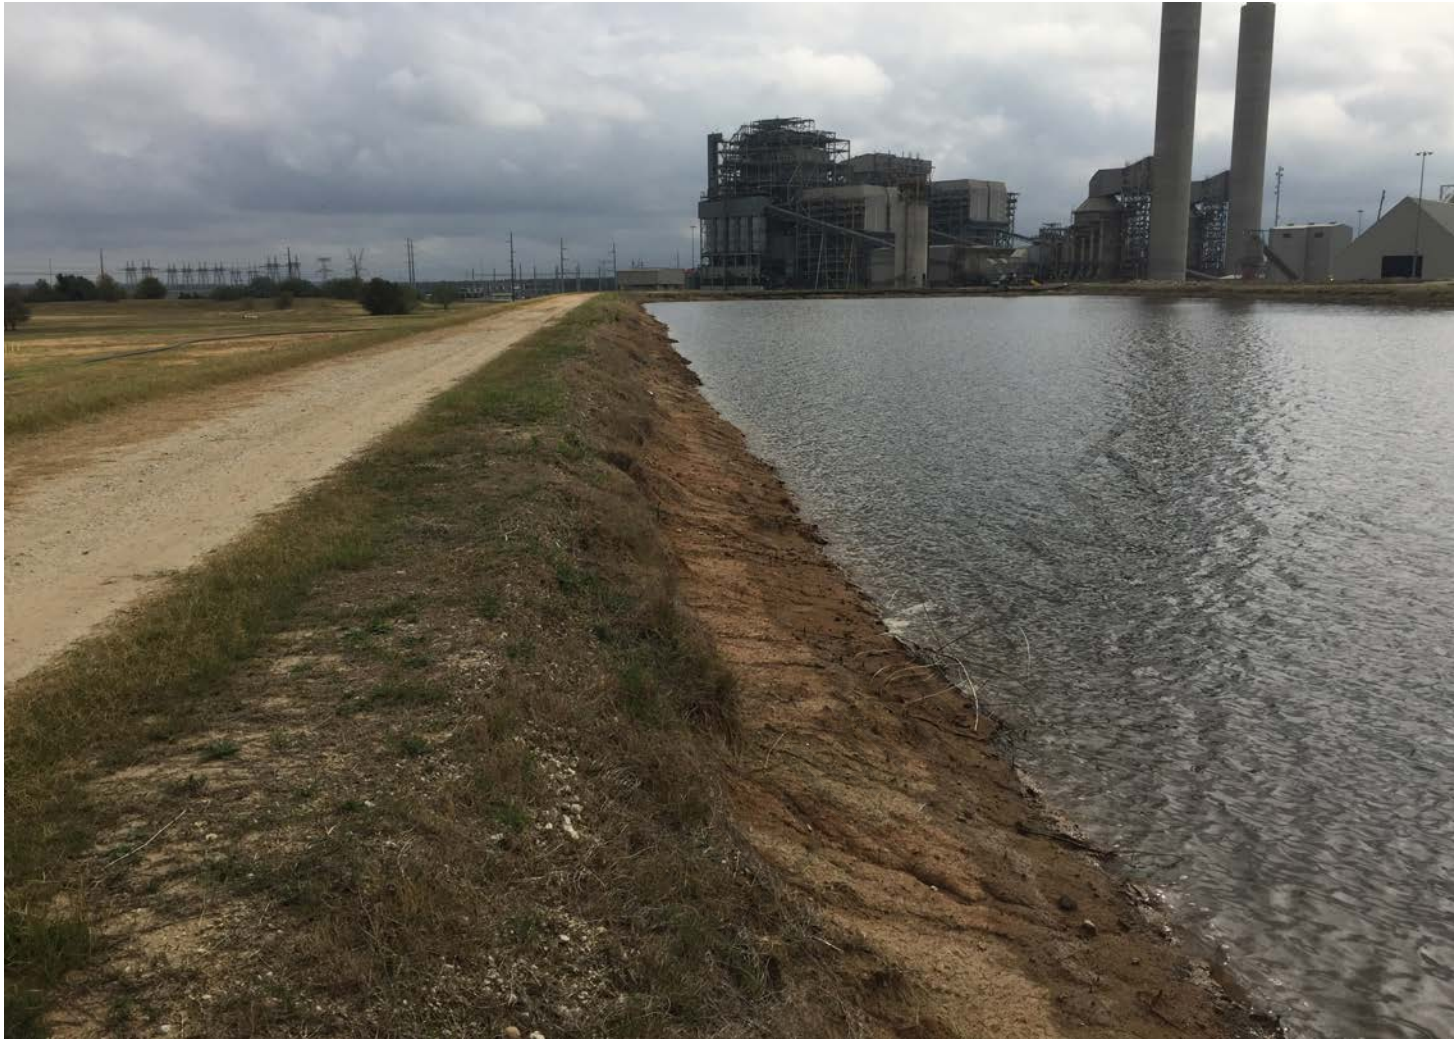
PHOTO DESCRIPTION:
 Northeastern crest and
 upstream slope. Erosion
 rills due to ponding water.

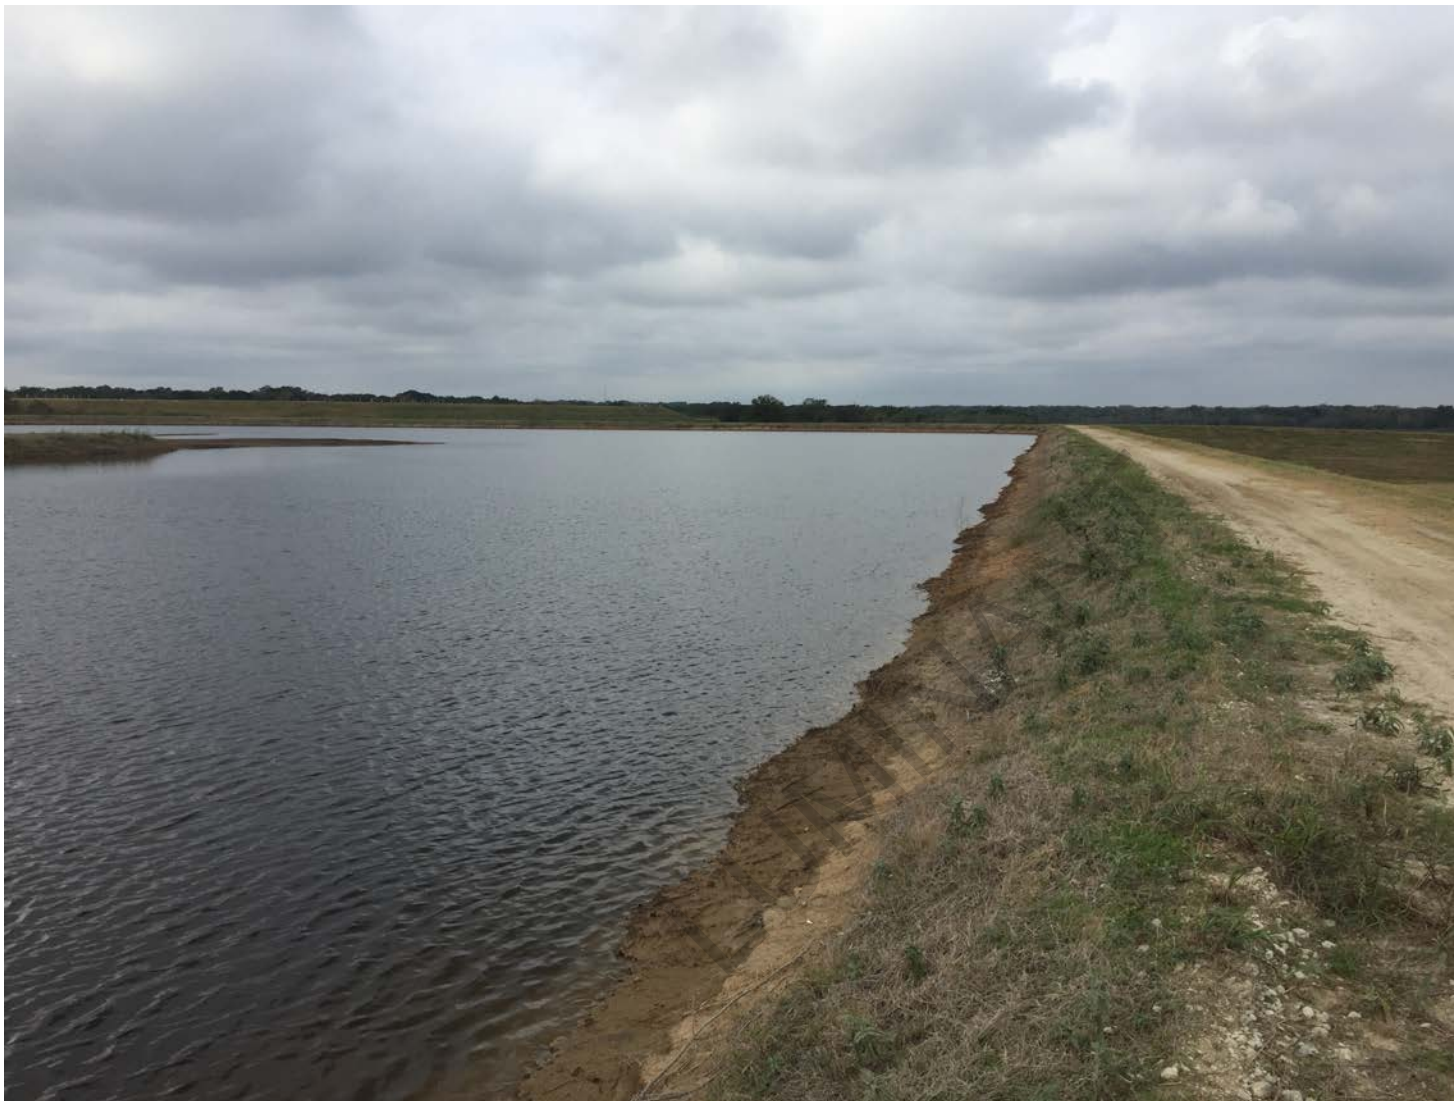
PHOTO DESCRIPTION:
 Northeastern crest and
 upstream slope – looking NW.

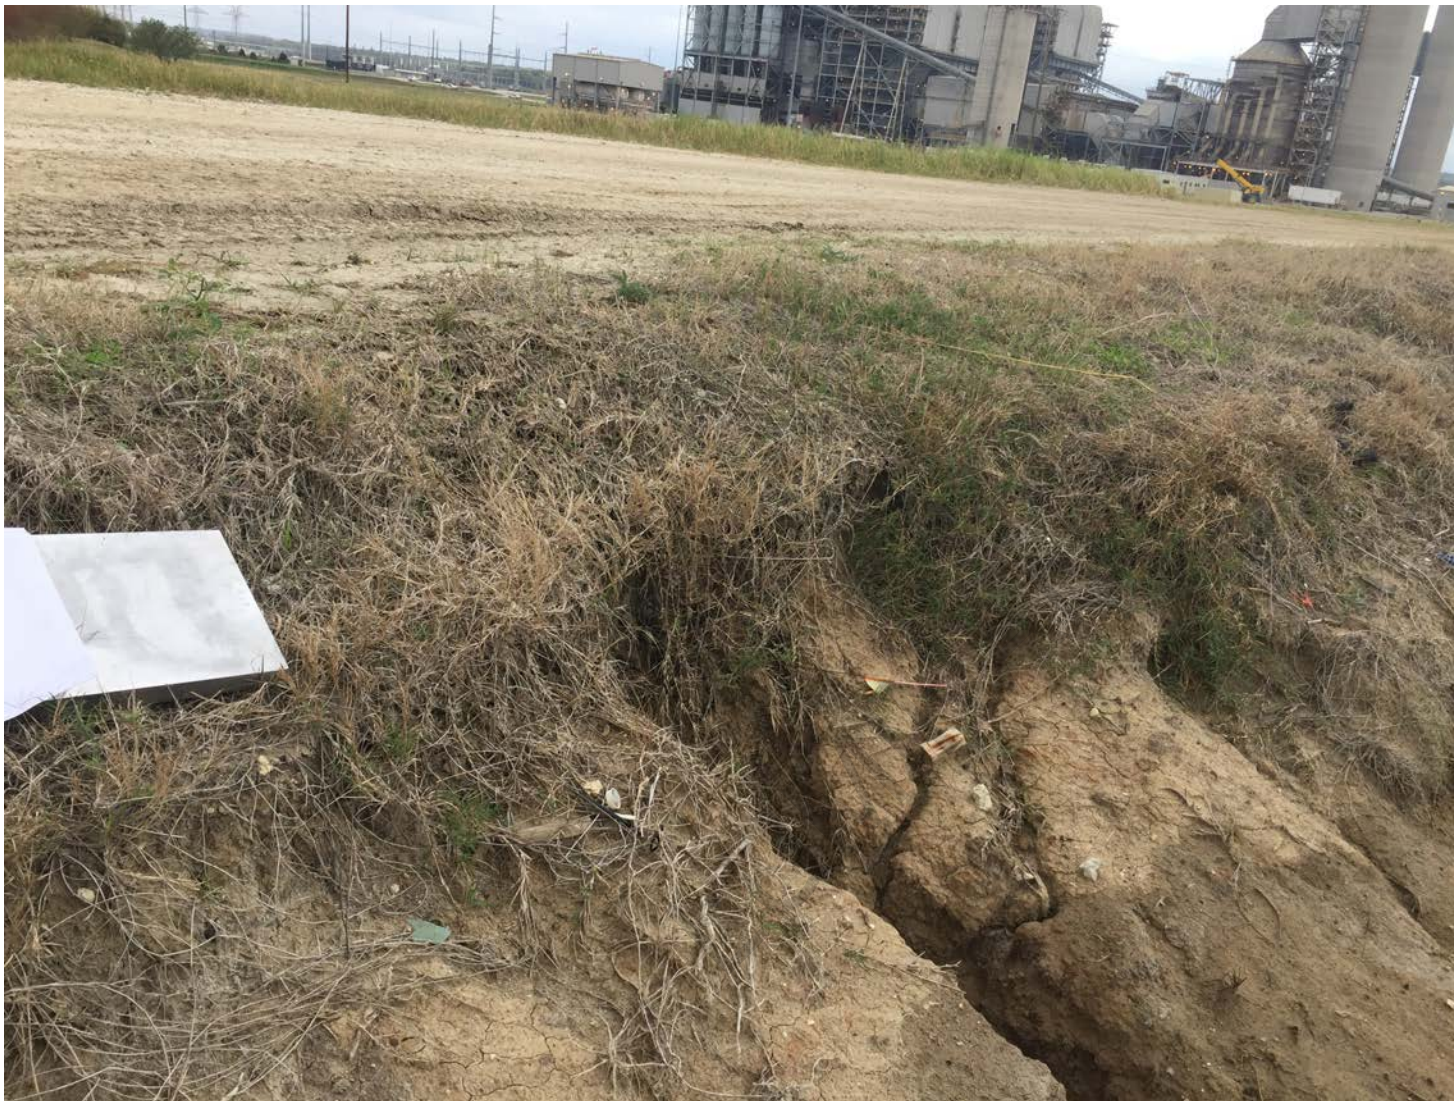
PHOTO DESCRIPTION:
 Southeastern crest and
 upstream slope. Erosion
 rills due to ponding water.

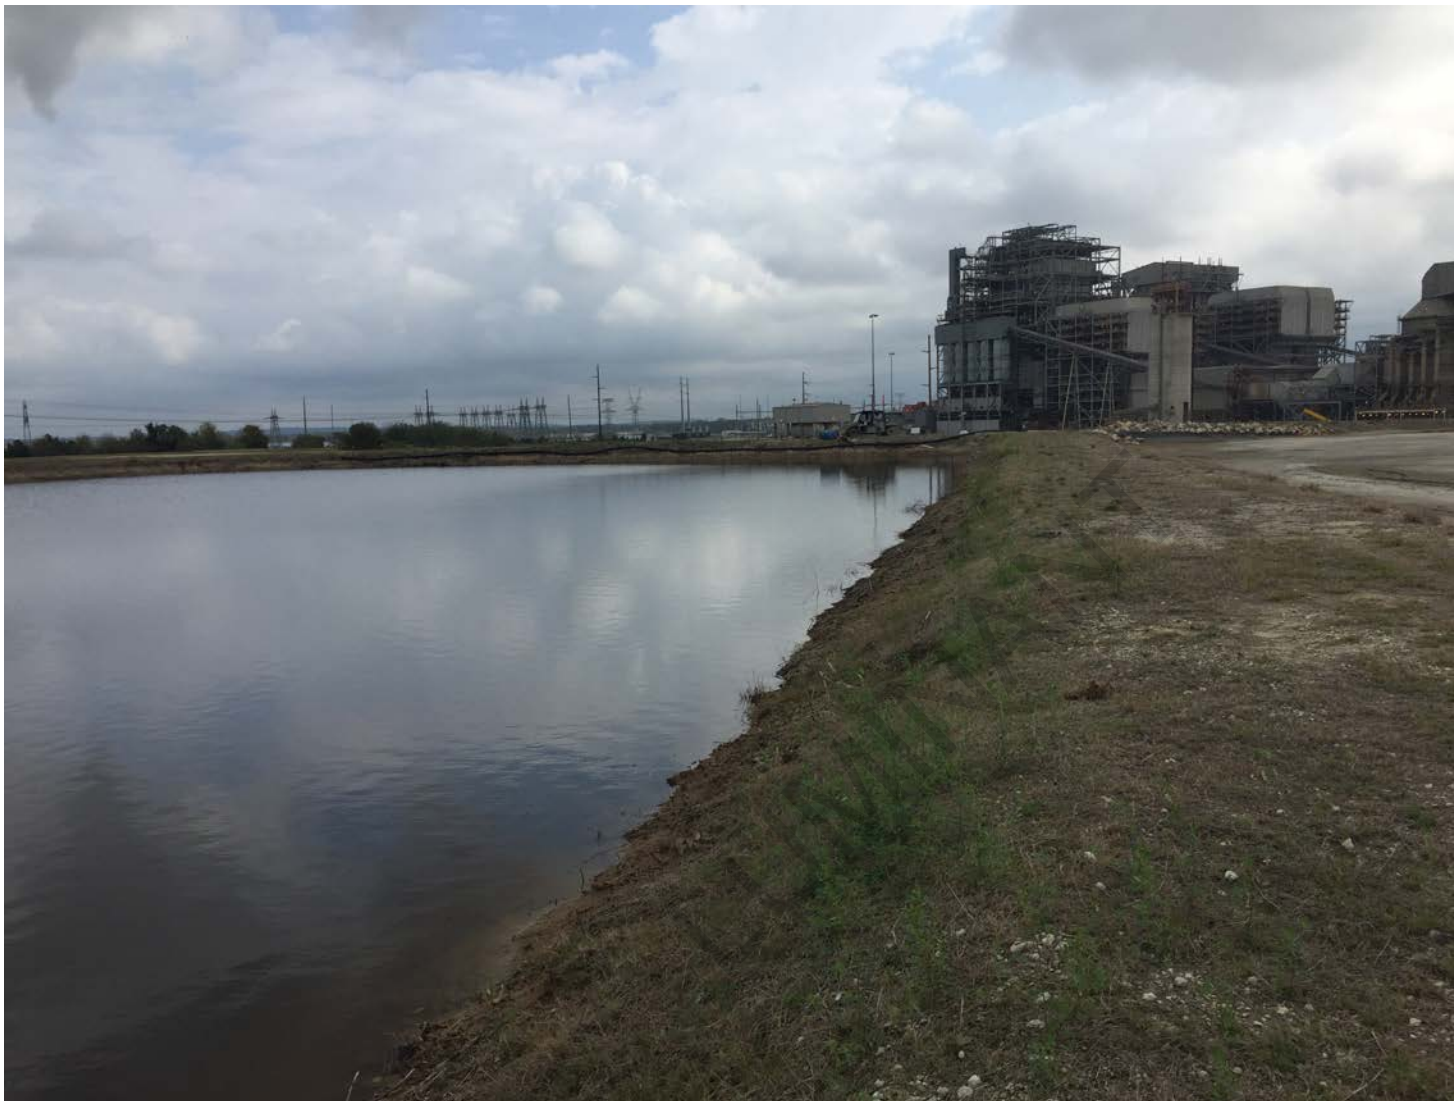
PHOTO DESCRIPTION:
 Divider Berm.

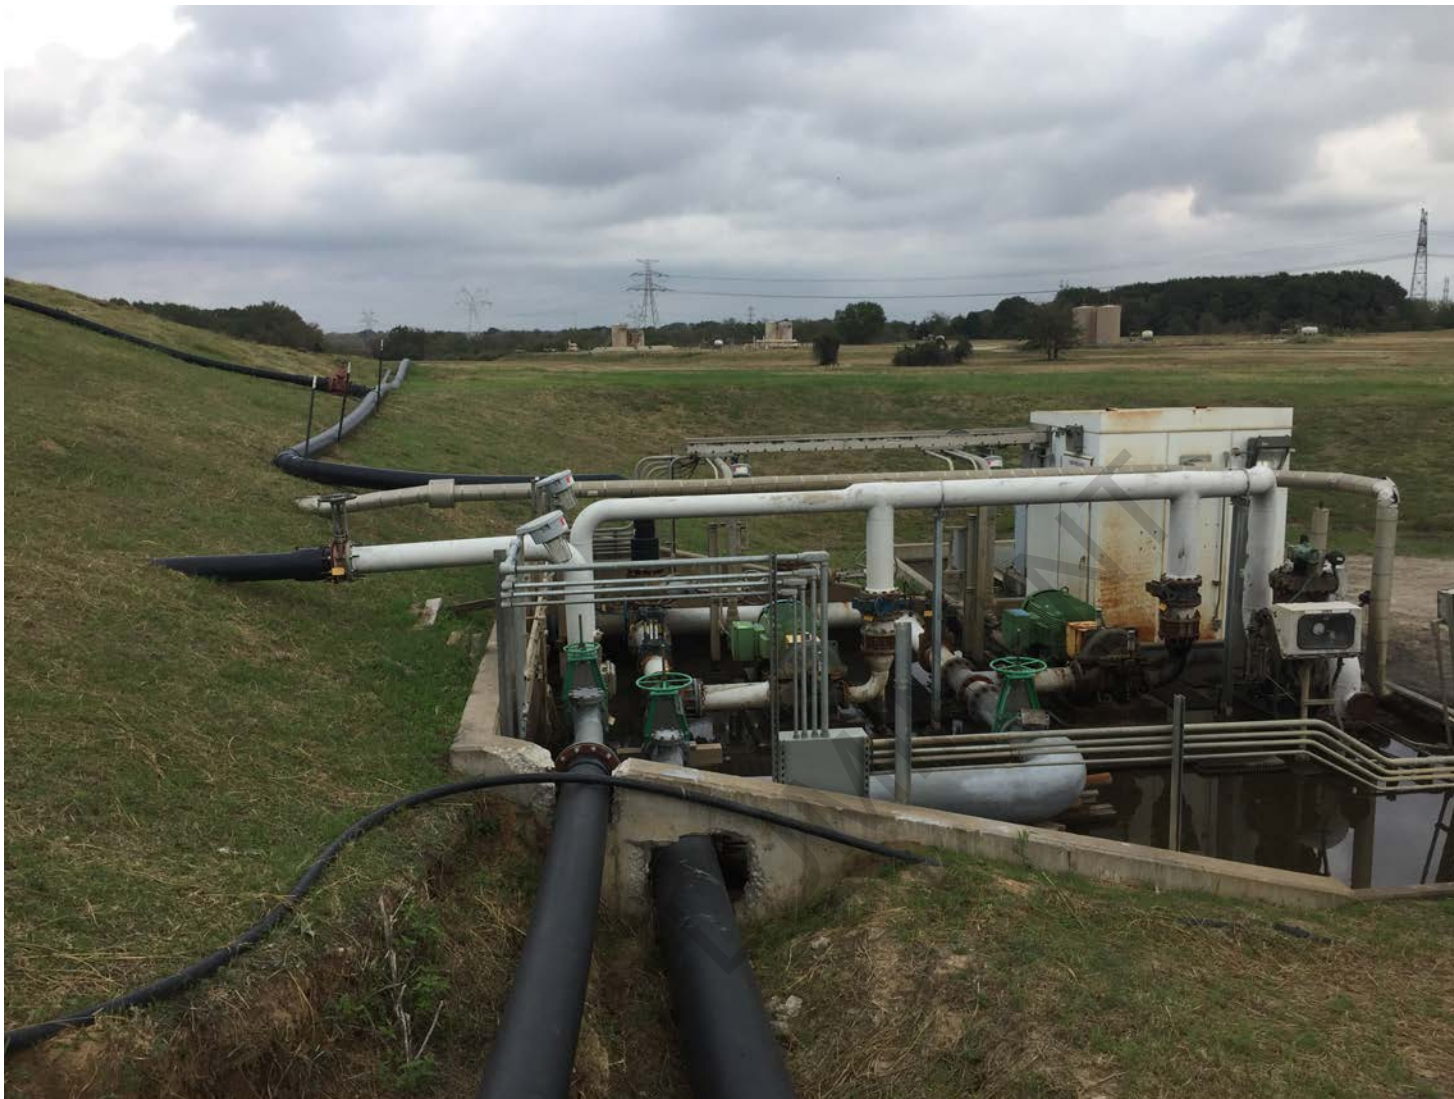
PHOTO DESCRIPTION:
 Reclaim/recycling pump
 station.

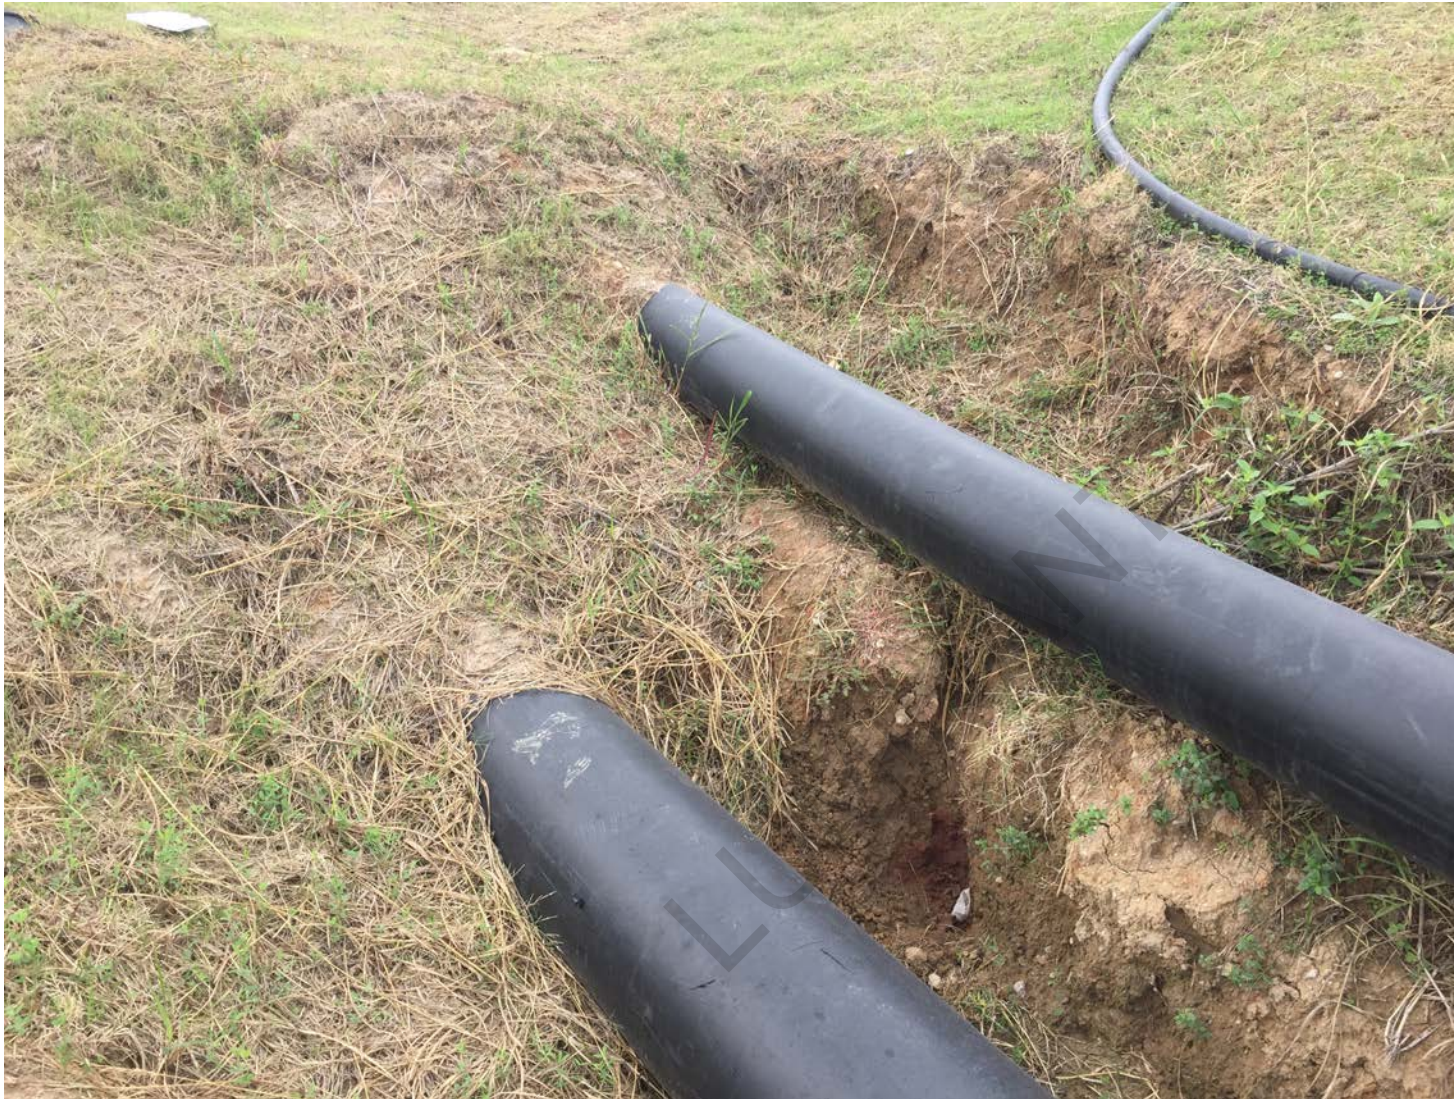
PHOTO DESCRIPTION:
 Pipes added along SW corner
 of pump station during FGD-C
 construction.
