ANNUAL INSPECTION OF CCR UNITS

**Oak Grove Steam Electric Station
Robertson County, Texas**

January 2018

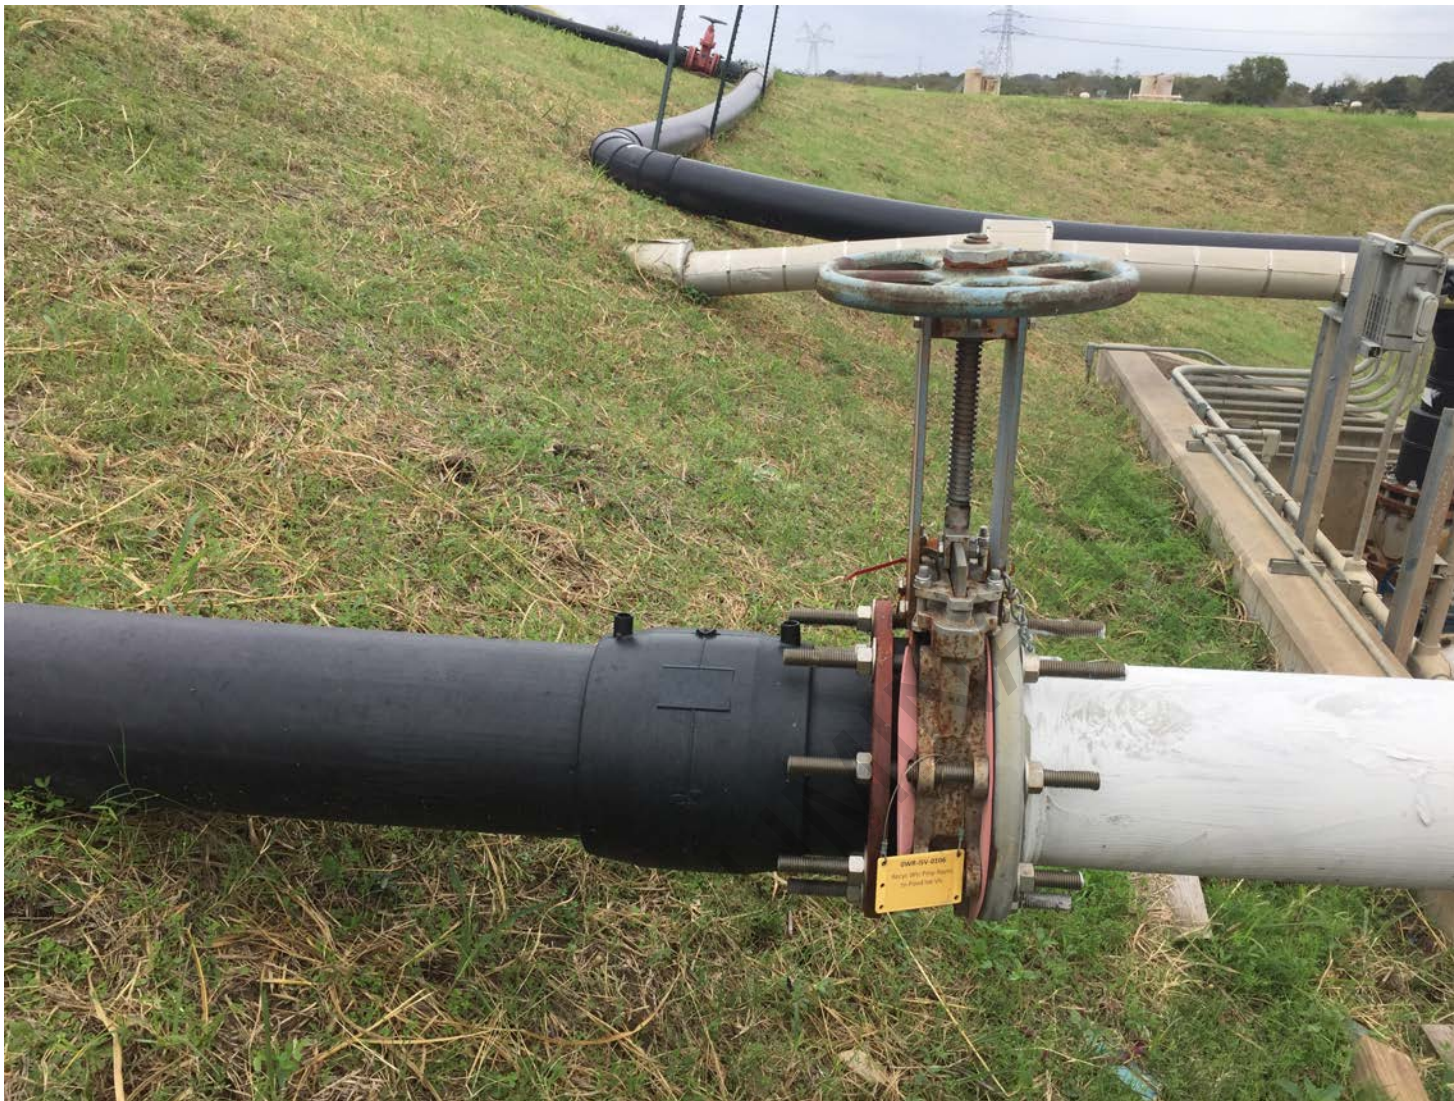
PHOTO DESCRIPTION:
 West side of pump station.
 New HDPE pipe in background.

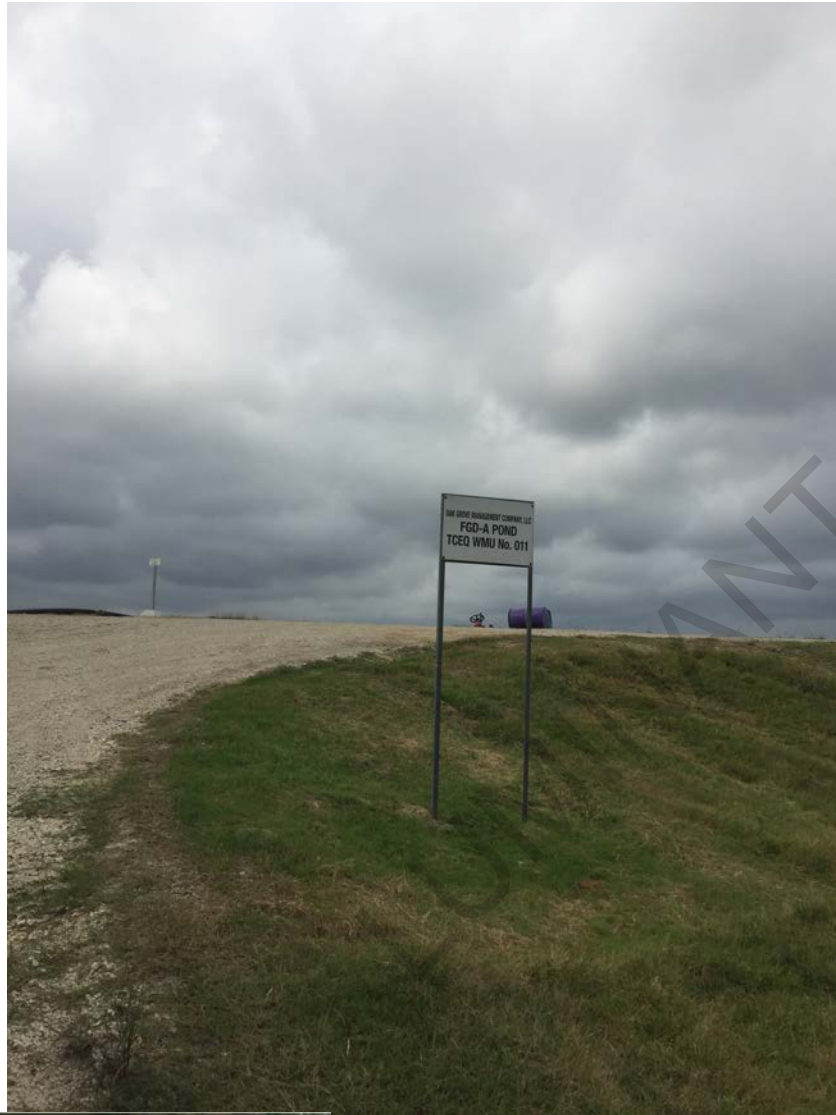
PHOTO DESCRIPTION:
 Access ramp to FGD-A.

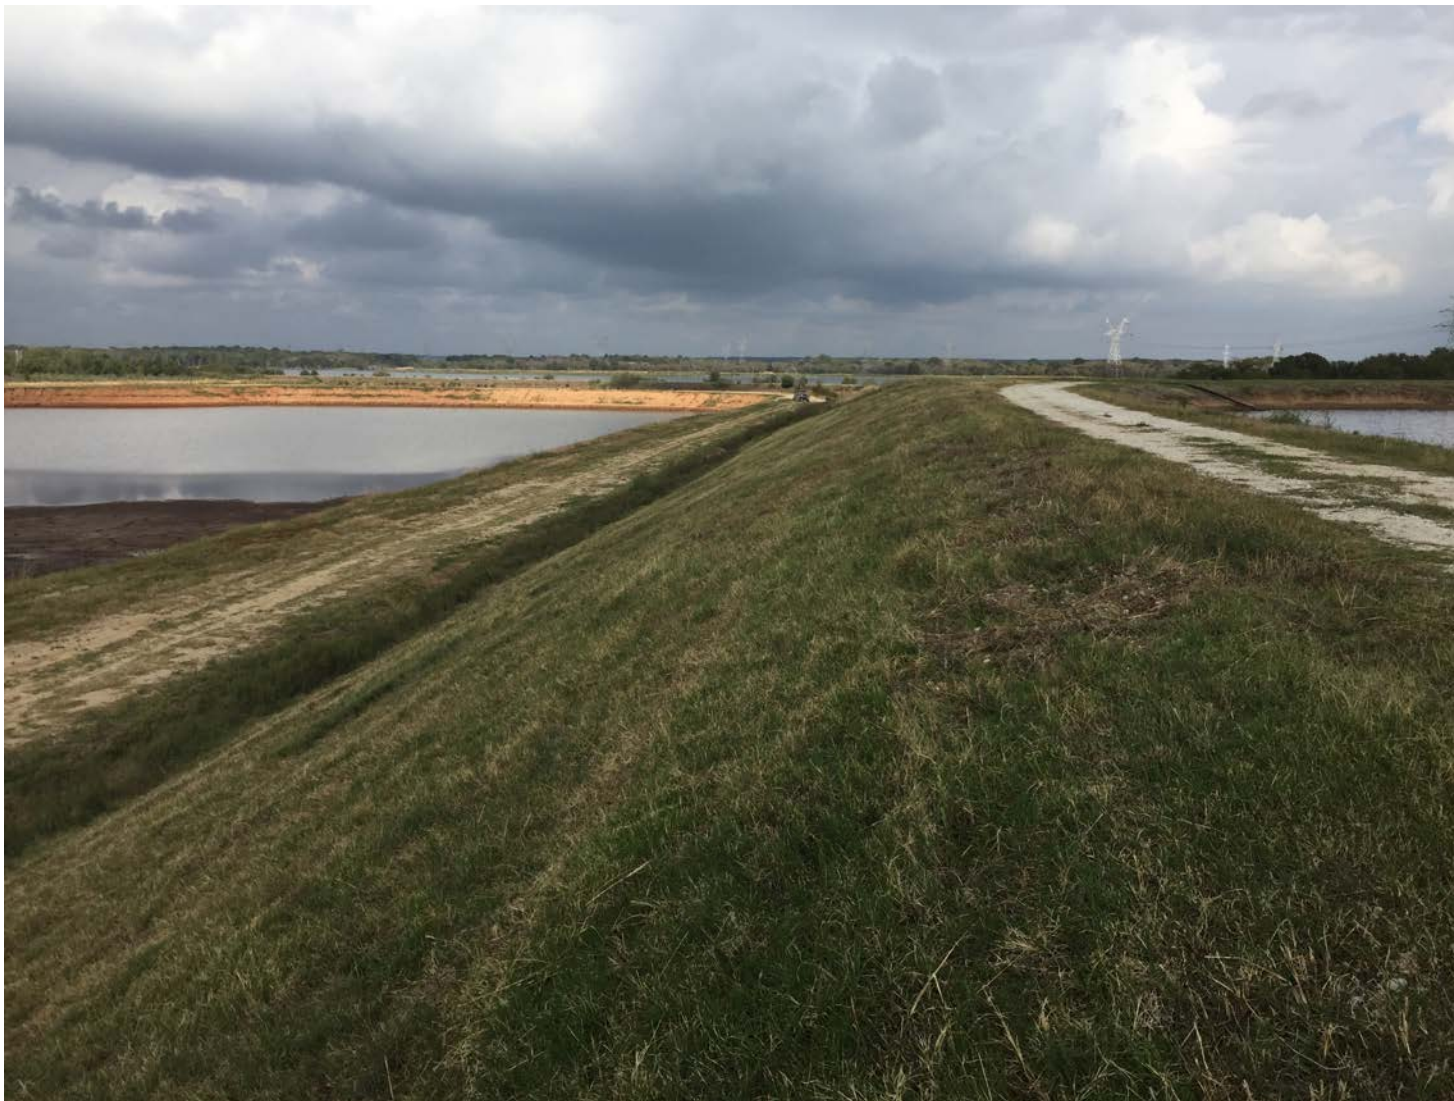
PHOTO DESCRIPTION:
 Northwestern downstream
 slope.

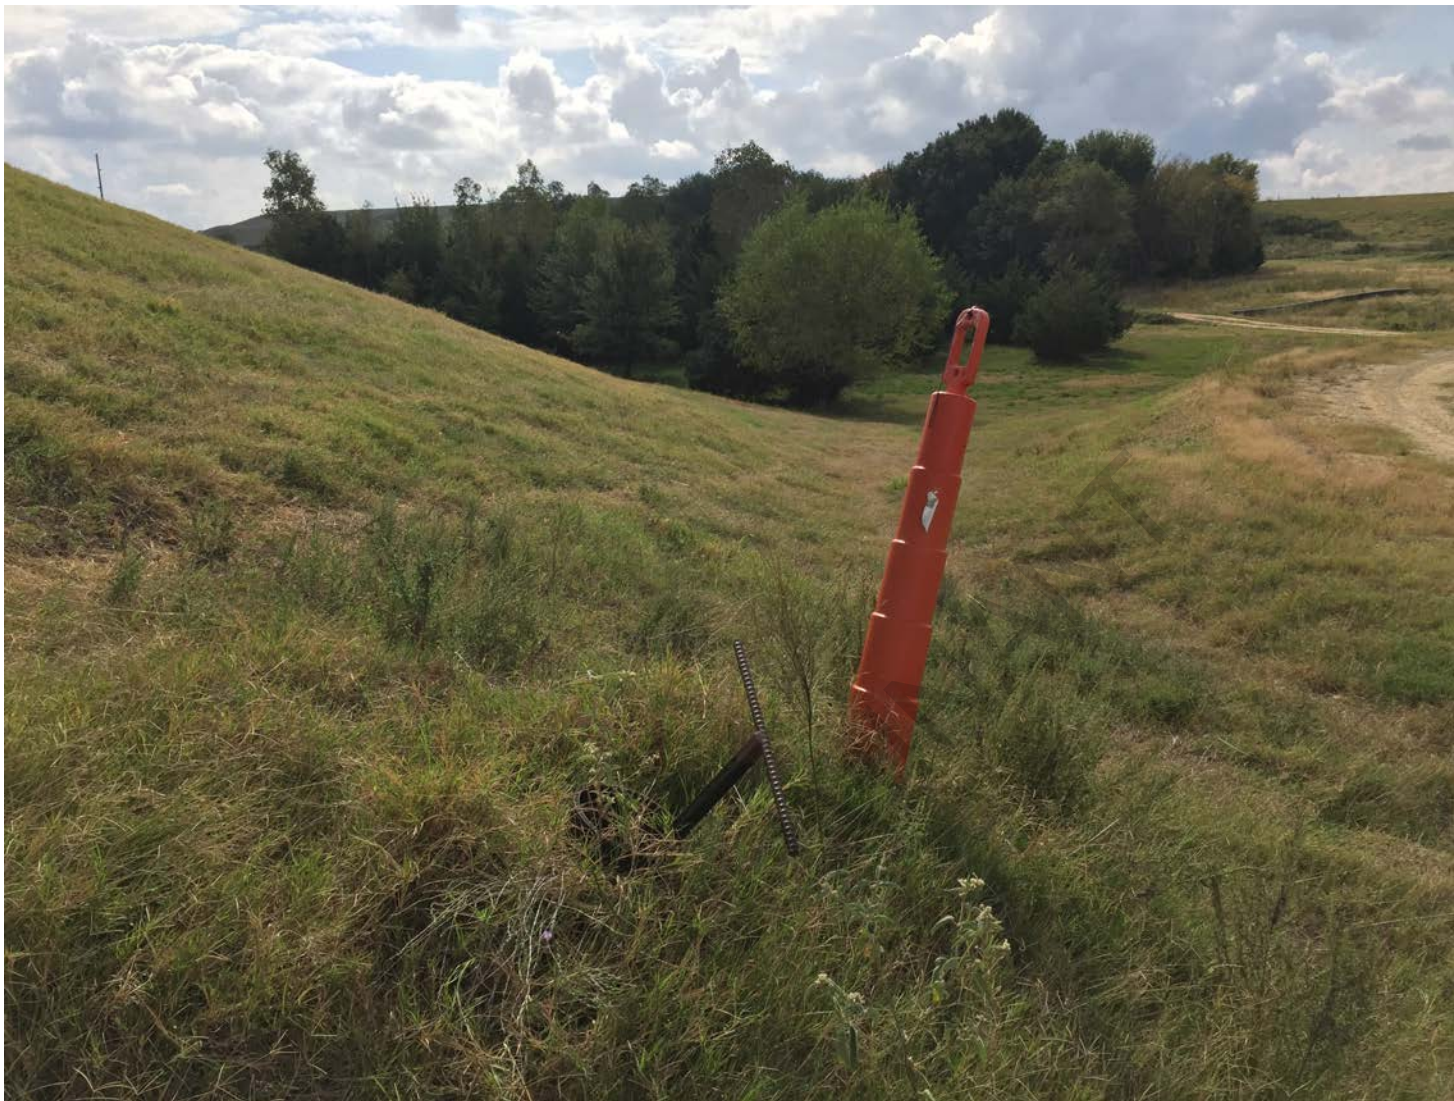
PHOTO DESCRIPTION:
 Valve box for overflow pipe
 from FGD-A to FGD-B.

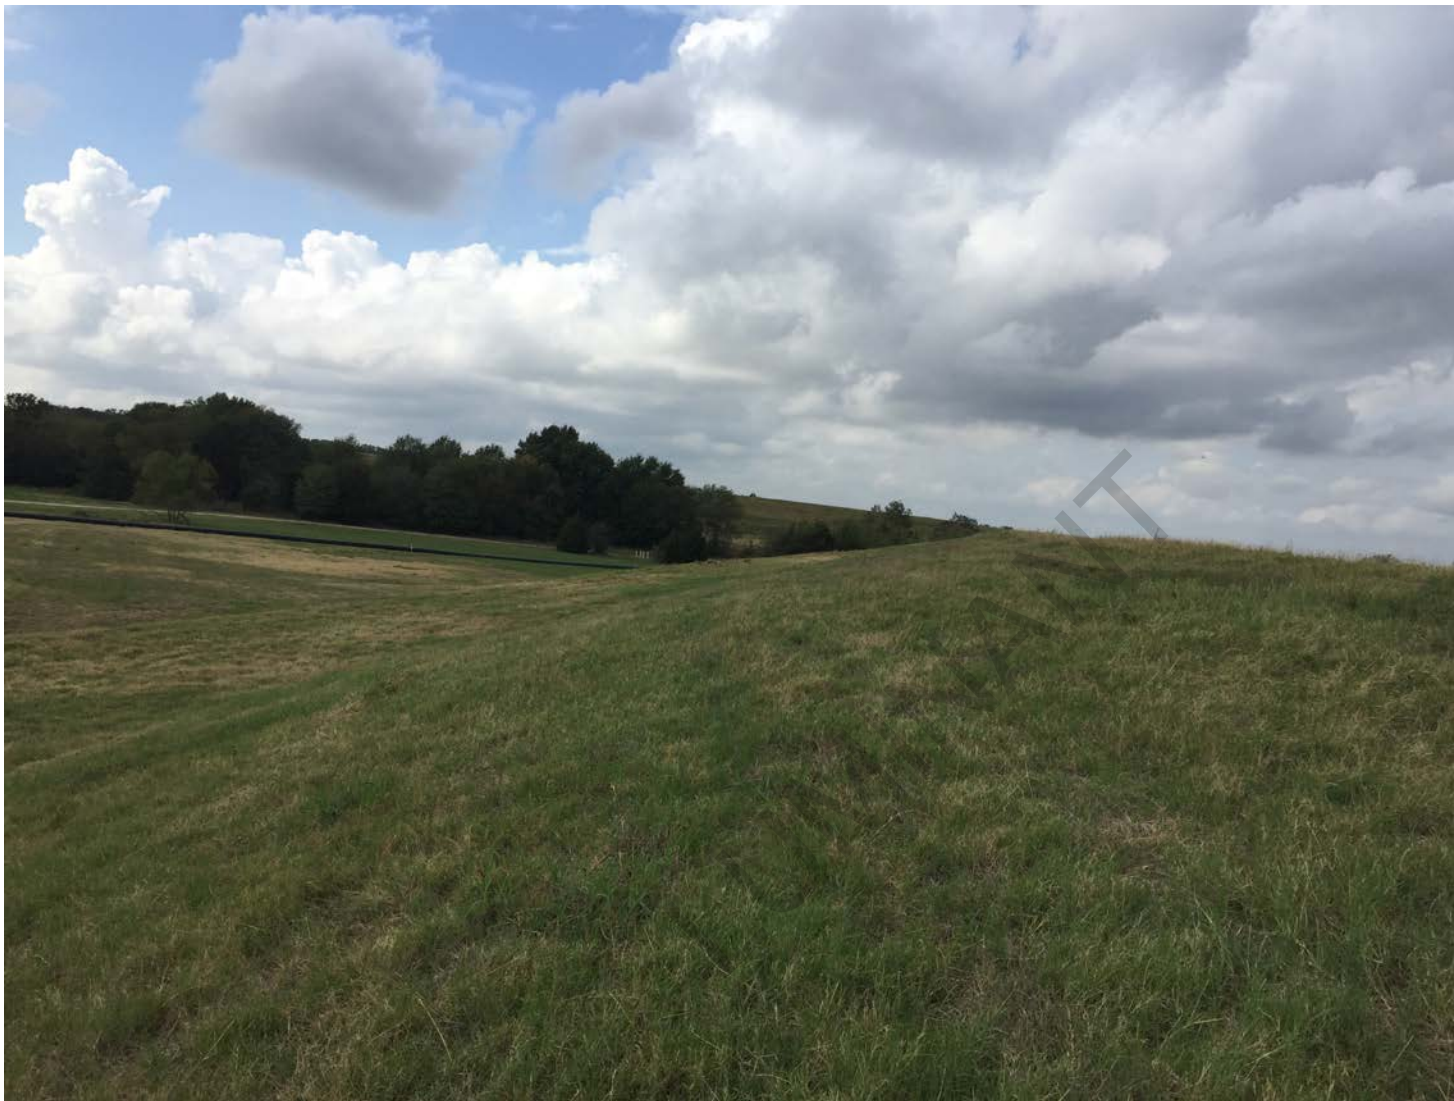
PROJECT NO. 1782004		FILE REF. Nov 2017 download 135.JPG	
	DESIGN	VK	11/09/2017	SCALE: NTS
	CHECK	VK	11/09/2017	REV: 0
	REVIEW	JBF	11/09/2017	PHOTO 20

PHOTO DESCRIPTION:
 Southern downstream slope.

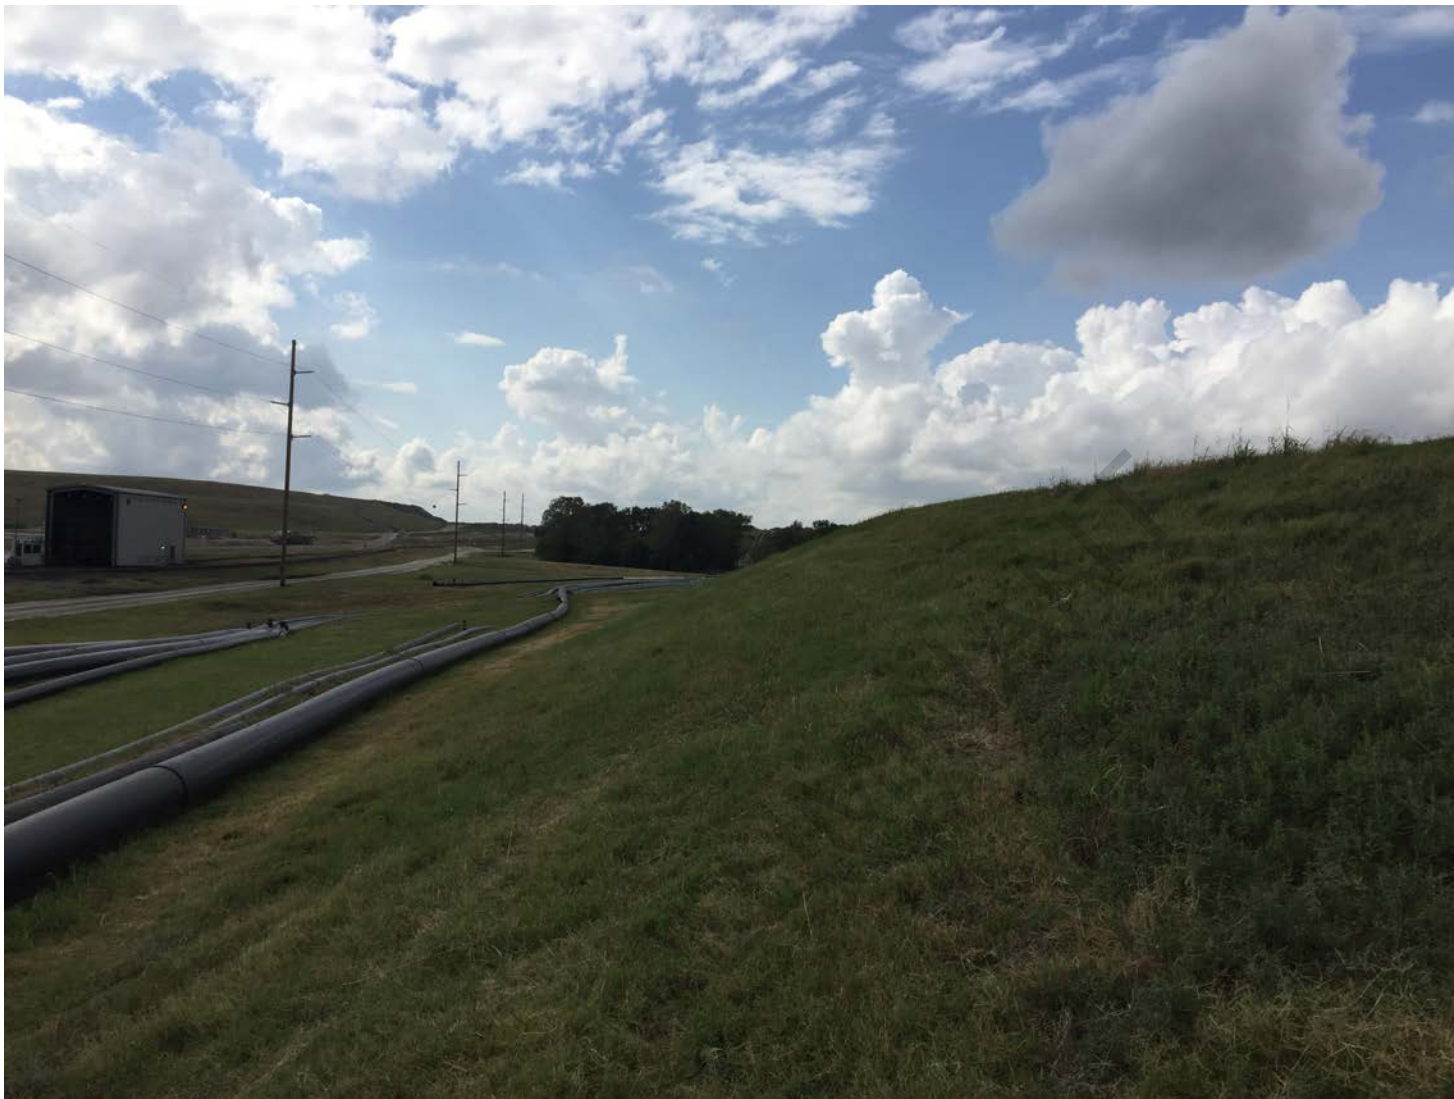
PROJECT NO. 1782004		FILE REF. Nov 2017 download 137.JPG	
	DESIGN	VK	11/09/2017	SCALE: NTS
	CHECK	VK	11/09/2017	REV: 0
	REVIEW	JBF	11/09/2017	PHOTO 21

PHOTO DESCRIPTION:
 Southeastern downstream
 slope. New pipes added for
 FGD-C.

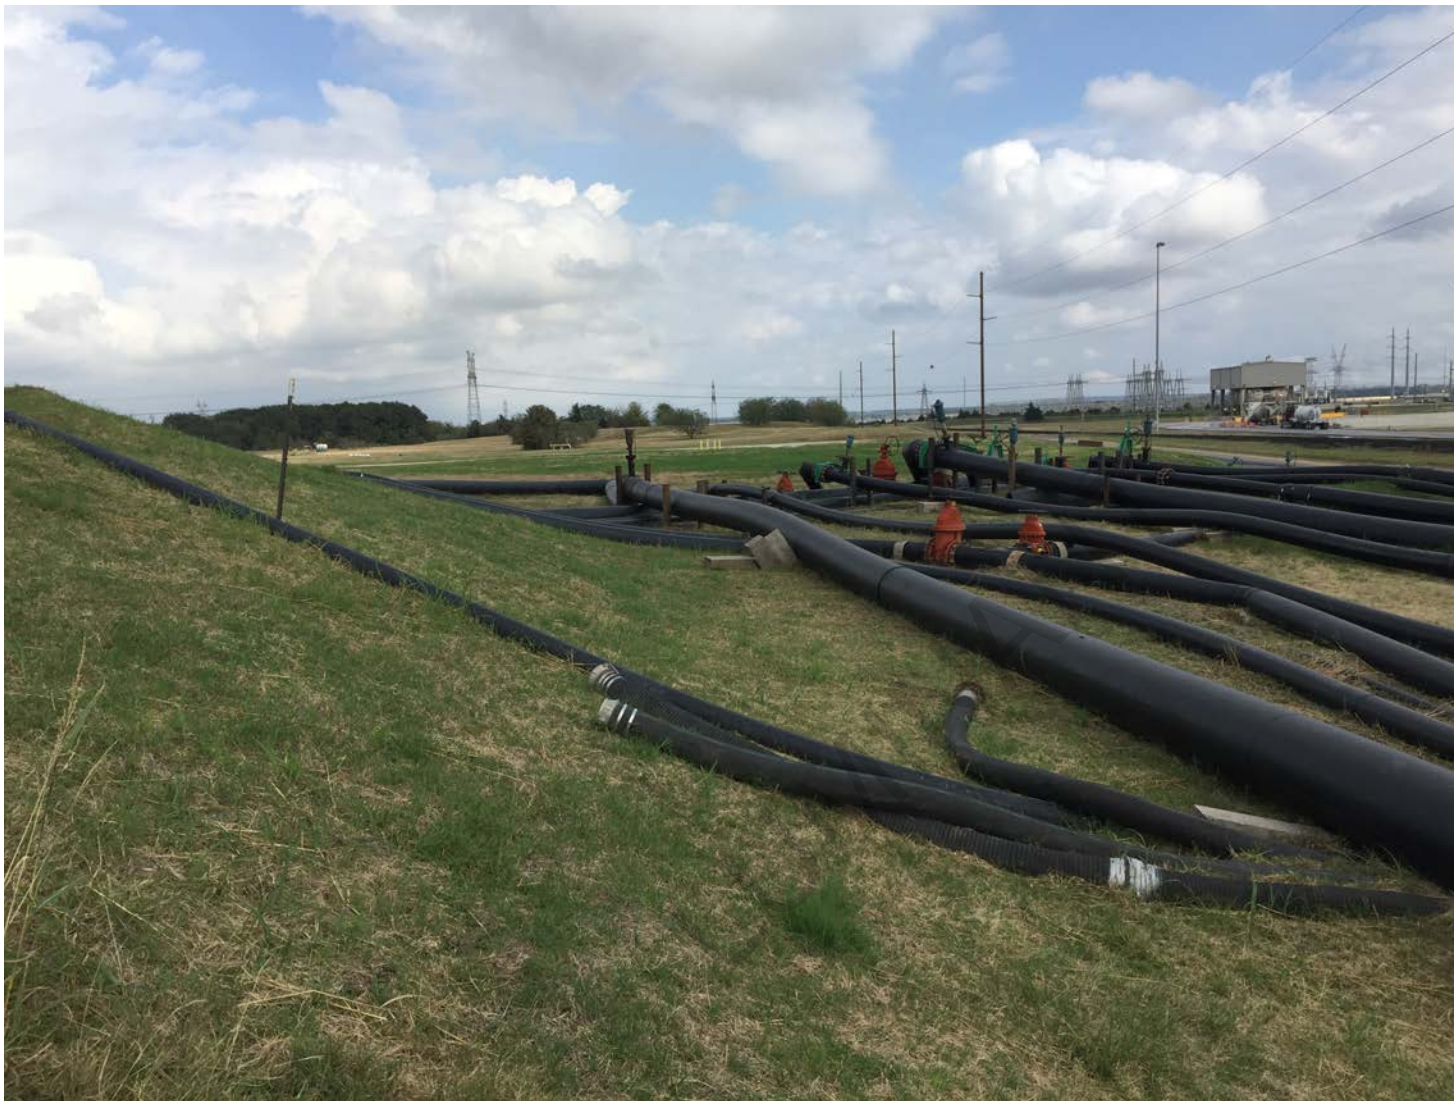
PROJECT NO. 1782004		FILE REF. Nov 2017 download 139.JPG	
	DESIGN	VK	11/09/2017	SCALE: NTS
	CHECK	VK	11/09/2017	REV: 0
	REVIEW	JBF	11/09/2017	PHOTO 22

PHOTO DESCRIPTION:
 Southeastern downstream
 slope. New pipes added for
 FGD-C.

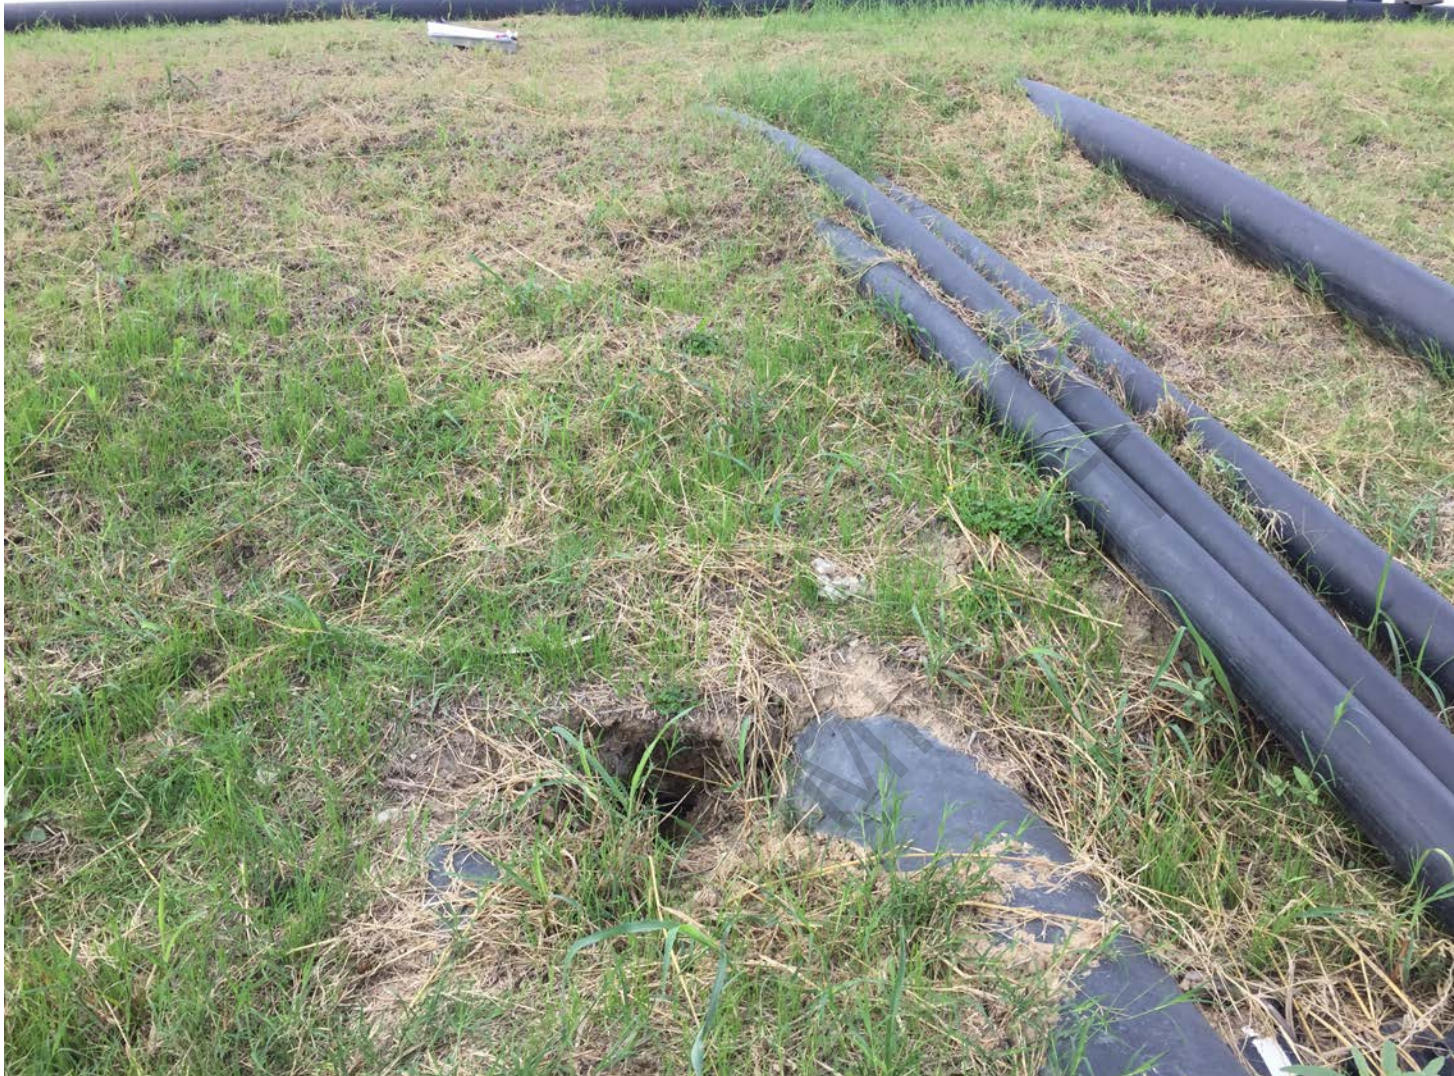
PROJECT NO. 1782004		FILE REF. Nov 2017 download 140.JPG	
	DESIGN	VK	11/09/2017	SCALE: NTS
	CHECK	VK	11/09/2017	REV: 0
	REVIEW	JBF	11/09/2017	PHOTO 23

PHOTO DESCRIPTION:
 Depression between HDPE
 pipes.

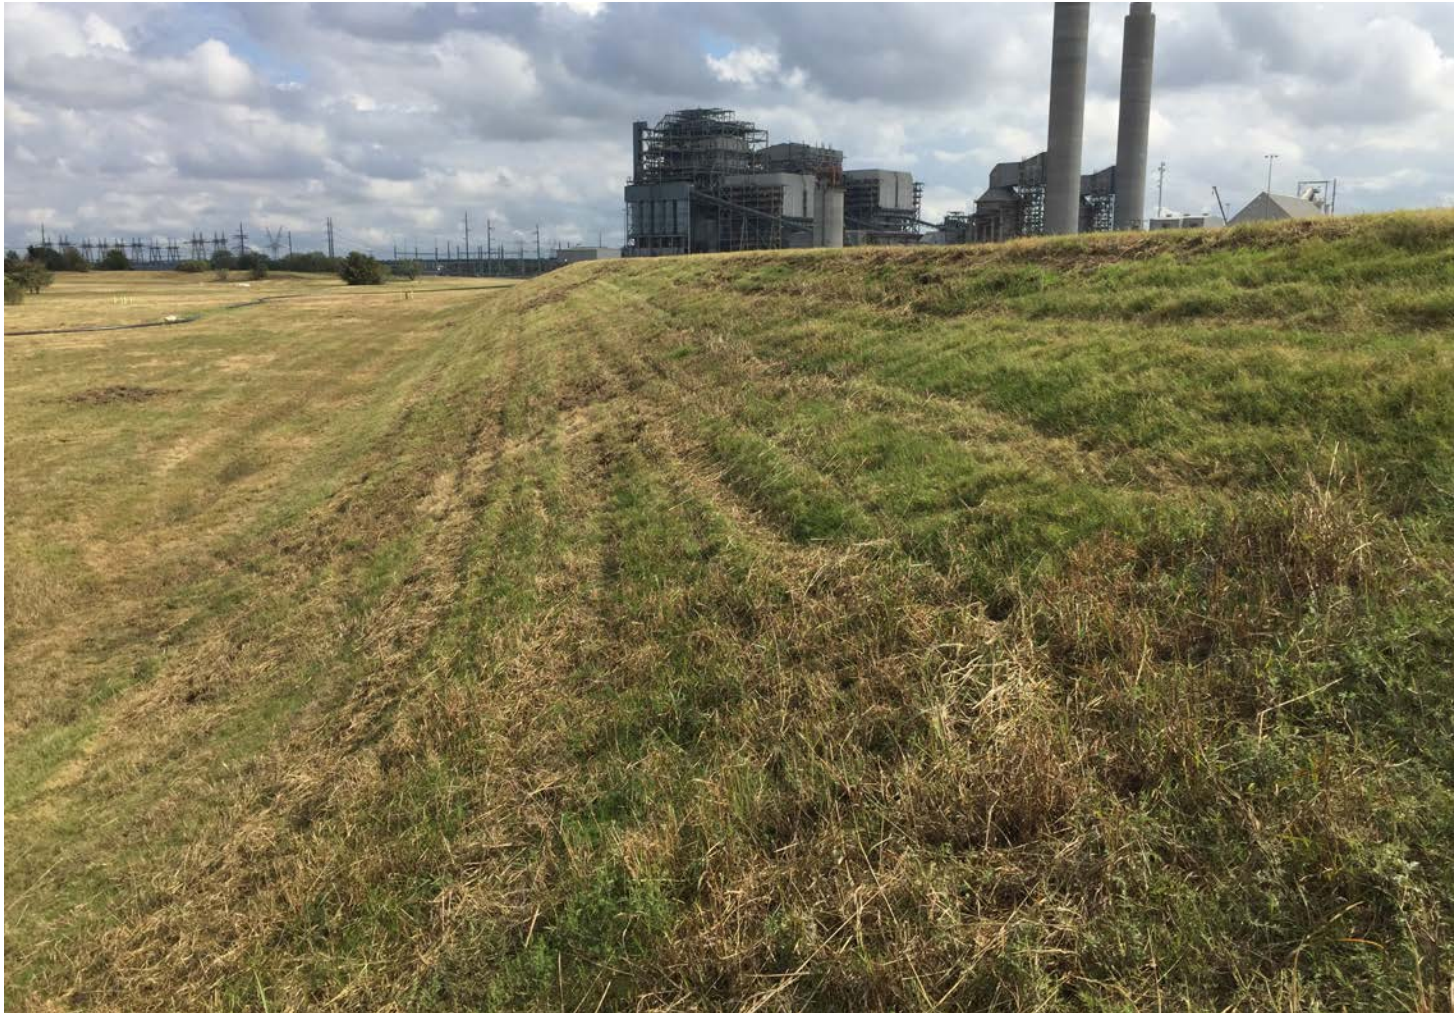
PROJECT NO. 1782004		FILE REF. Nov 2017 download 145.JPG	
	DESIGN	VK	11/09/2017	SCALE: NTS
	CHECK	VK	11/09/2017	REV: 0
	REVIEW	JBF	11/09/2017	PHOTO 26

PHOTO DESCRIPTION:
 Western end of northeastern
 downstream slope.

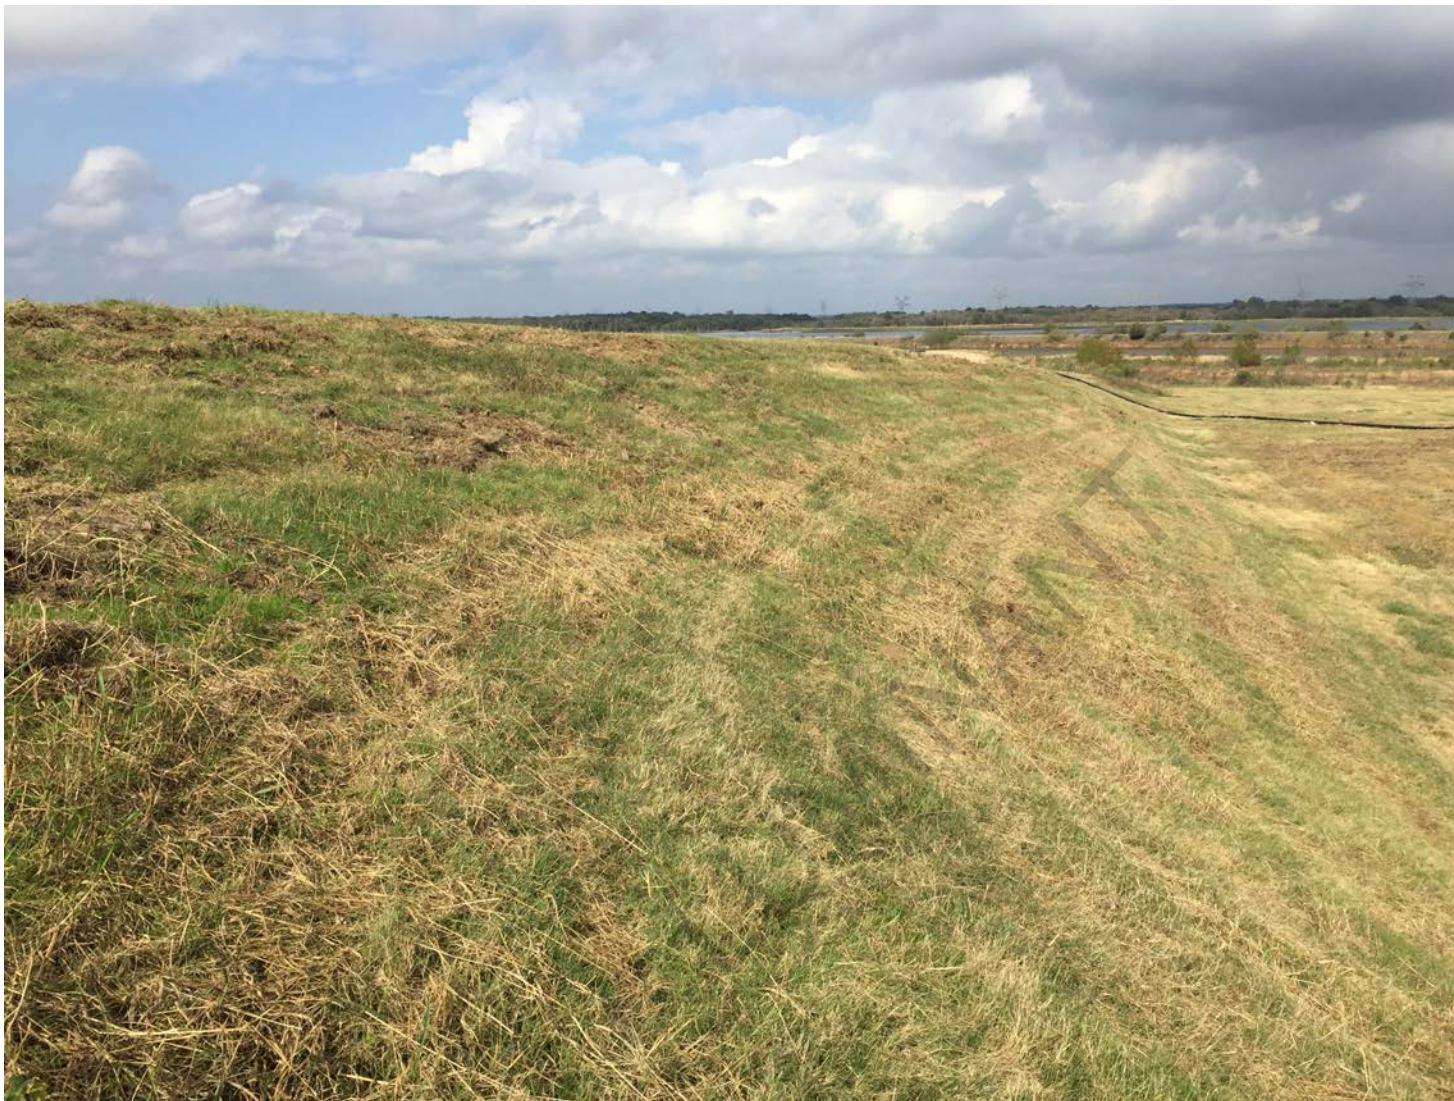
PROJECT NO. 1782004		FILE REF. Nov 2017 download 147.JPG	
	DESIGN	VK	11/09/2017	SCALE: NTS
	CHECK	VK	11/09/2017	REV: 0
	REVIEW	JBF	11/09/2017	PHOTO 27

PHOTO DESCRIPTION:
 Eastern slope of access road
 from FGD-A to FGD-B.

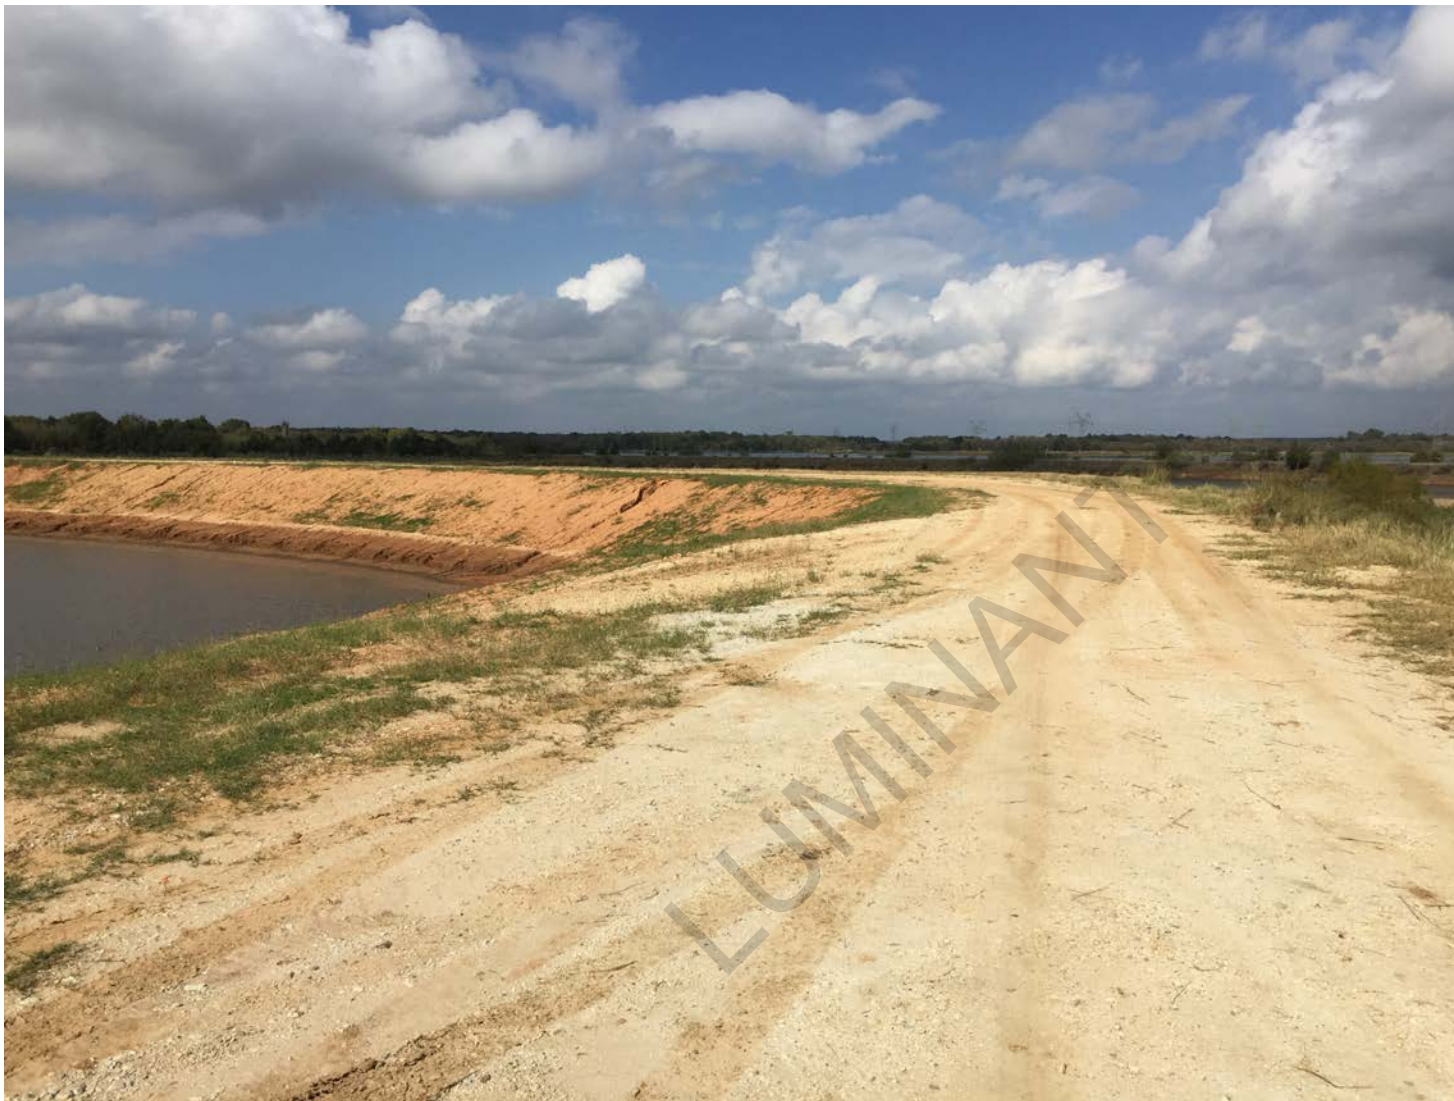
PROJECT NO. 1782004		FILE REF. Nov 2017 download 148.JPG	
	DESIGN	VK	11/09/2017	SCALE: NTS
	CHECK	VK	11/09/2017	REV: 0
	REVIEW	JBF	11/09/2017	PHOTO 28

PHOTO DESCRIPTION:
 Northeastern corner of FGD-B.

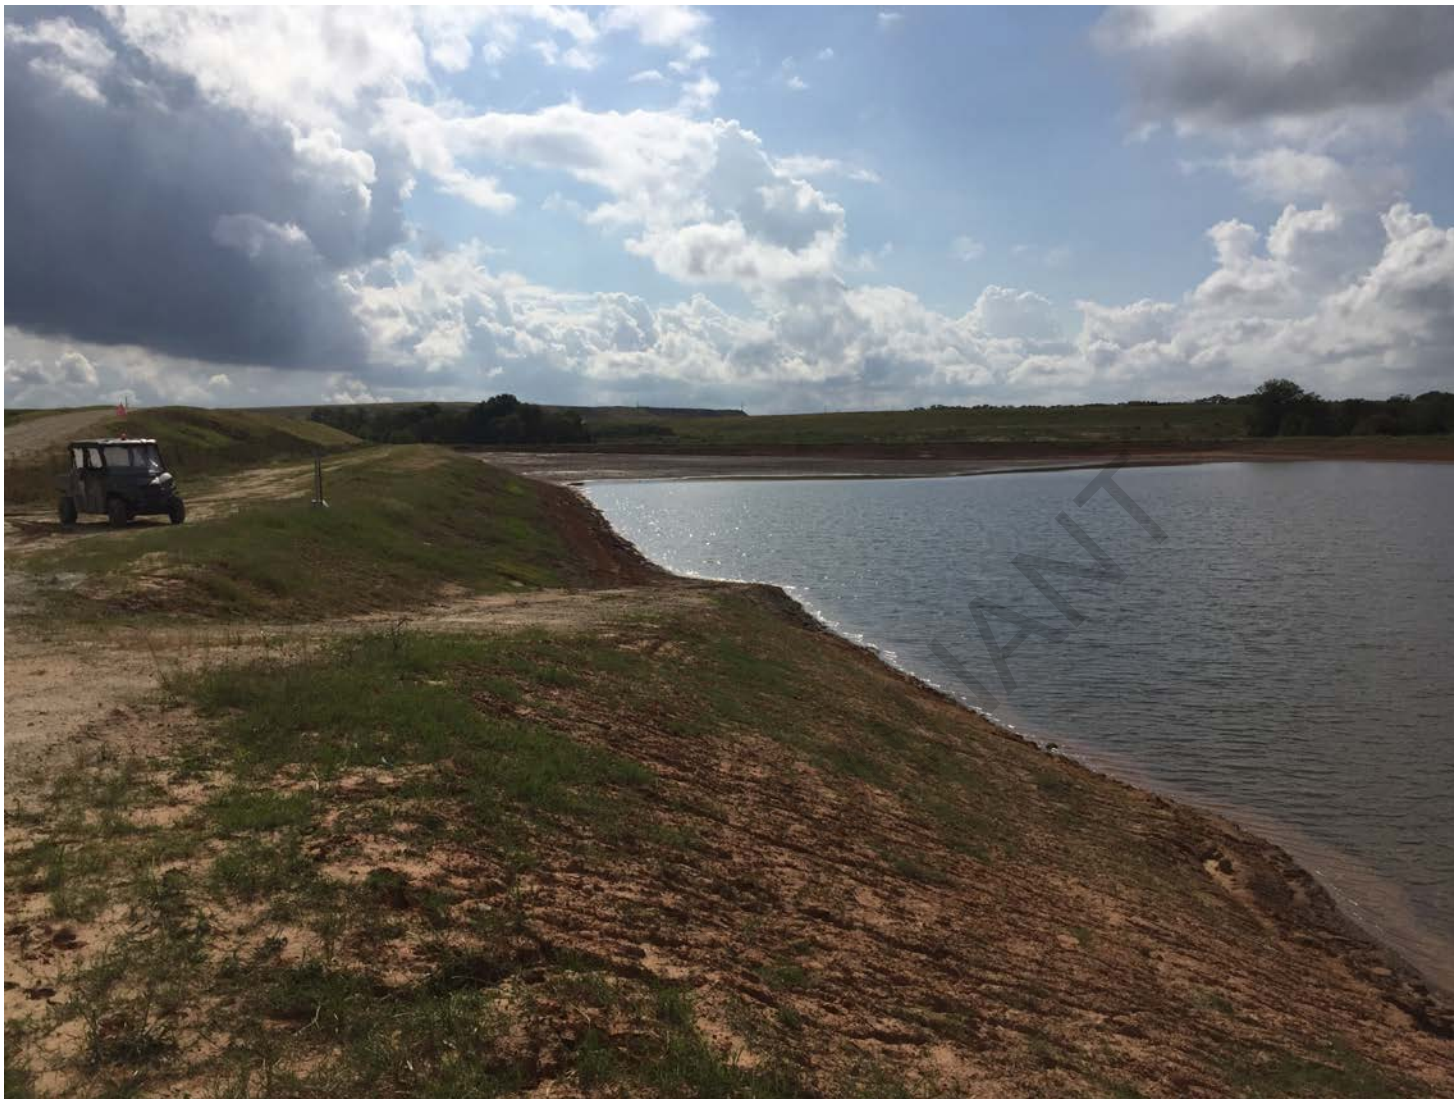
PROJECT NO. 1782004		FILE REF. Nov 2017 download 150.JPG	
	DESIGN	VK	11/09/2017	SCALE: NTS
	CHECK	VK	11/09/2017	REV: 0
	REVIEW	JBF	11/09/2017	PHOTO 29

PHOTO DESCRIPTION:
 Eastern portion of FGD-B.

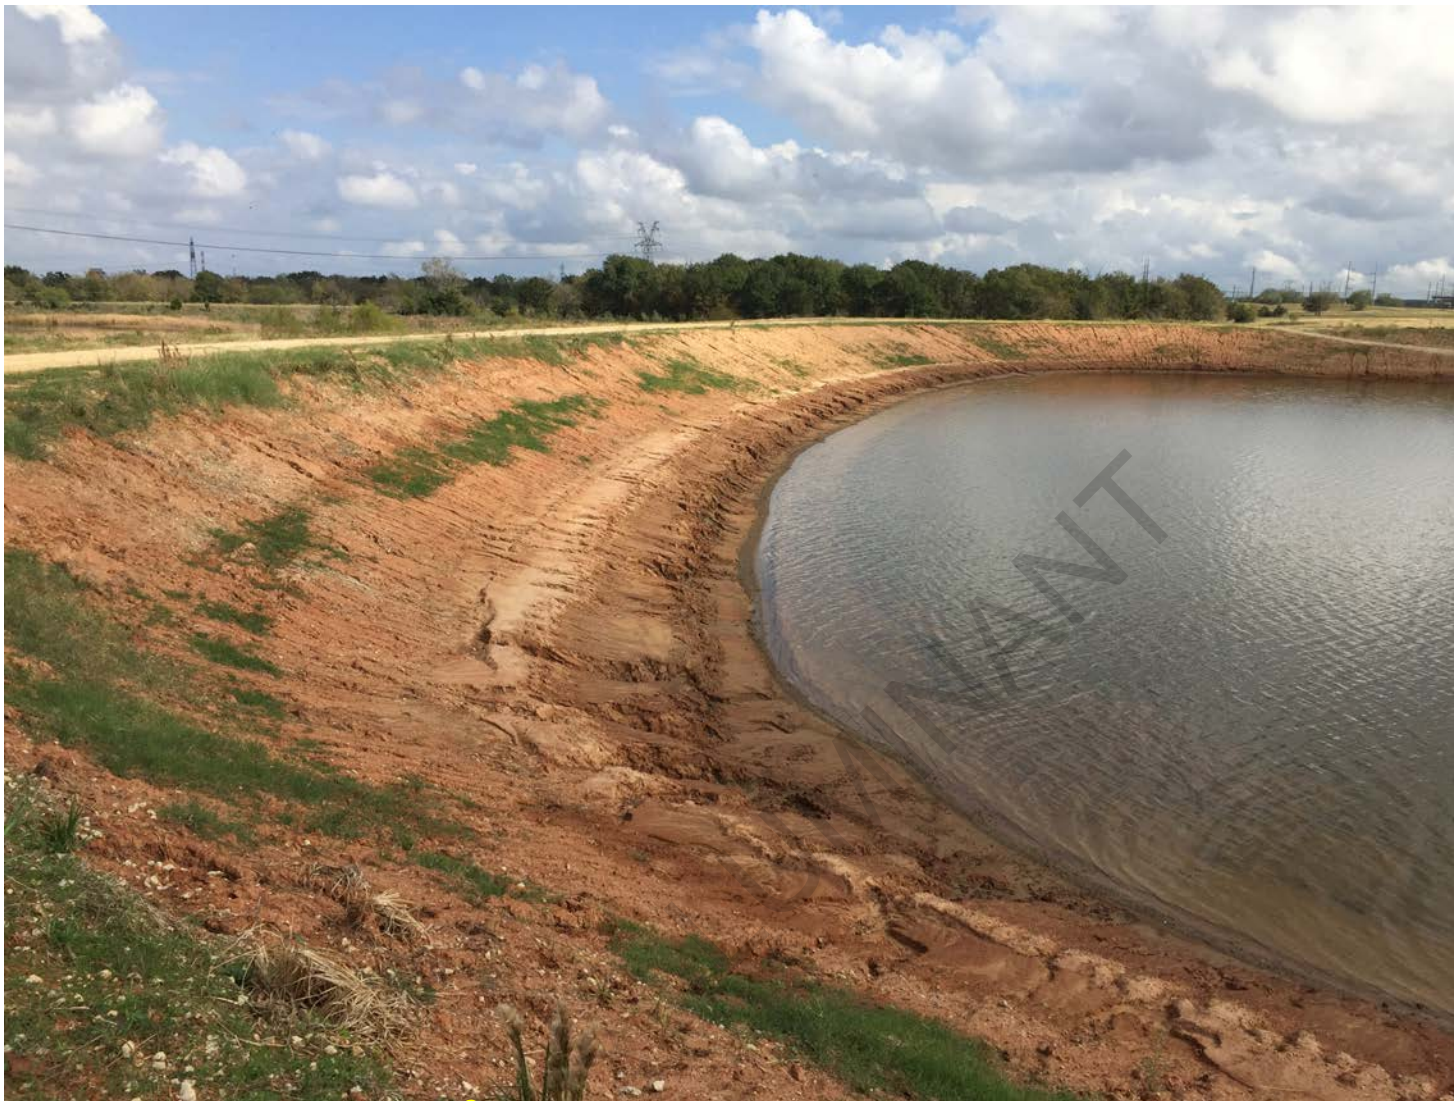
PROJECT NO. 1782004		FILE REF. Nov 2017 download 152.JPG	
	DESIGN	VK	11/09/2017	SCALE: NTS
	CHECK	VK	11/09/2017	REV: 0
	REVIEW	JBF	11/09/2017	PHOTO 30

PHOTO DESCRIPTION:
 Northern upstream slope.

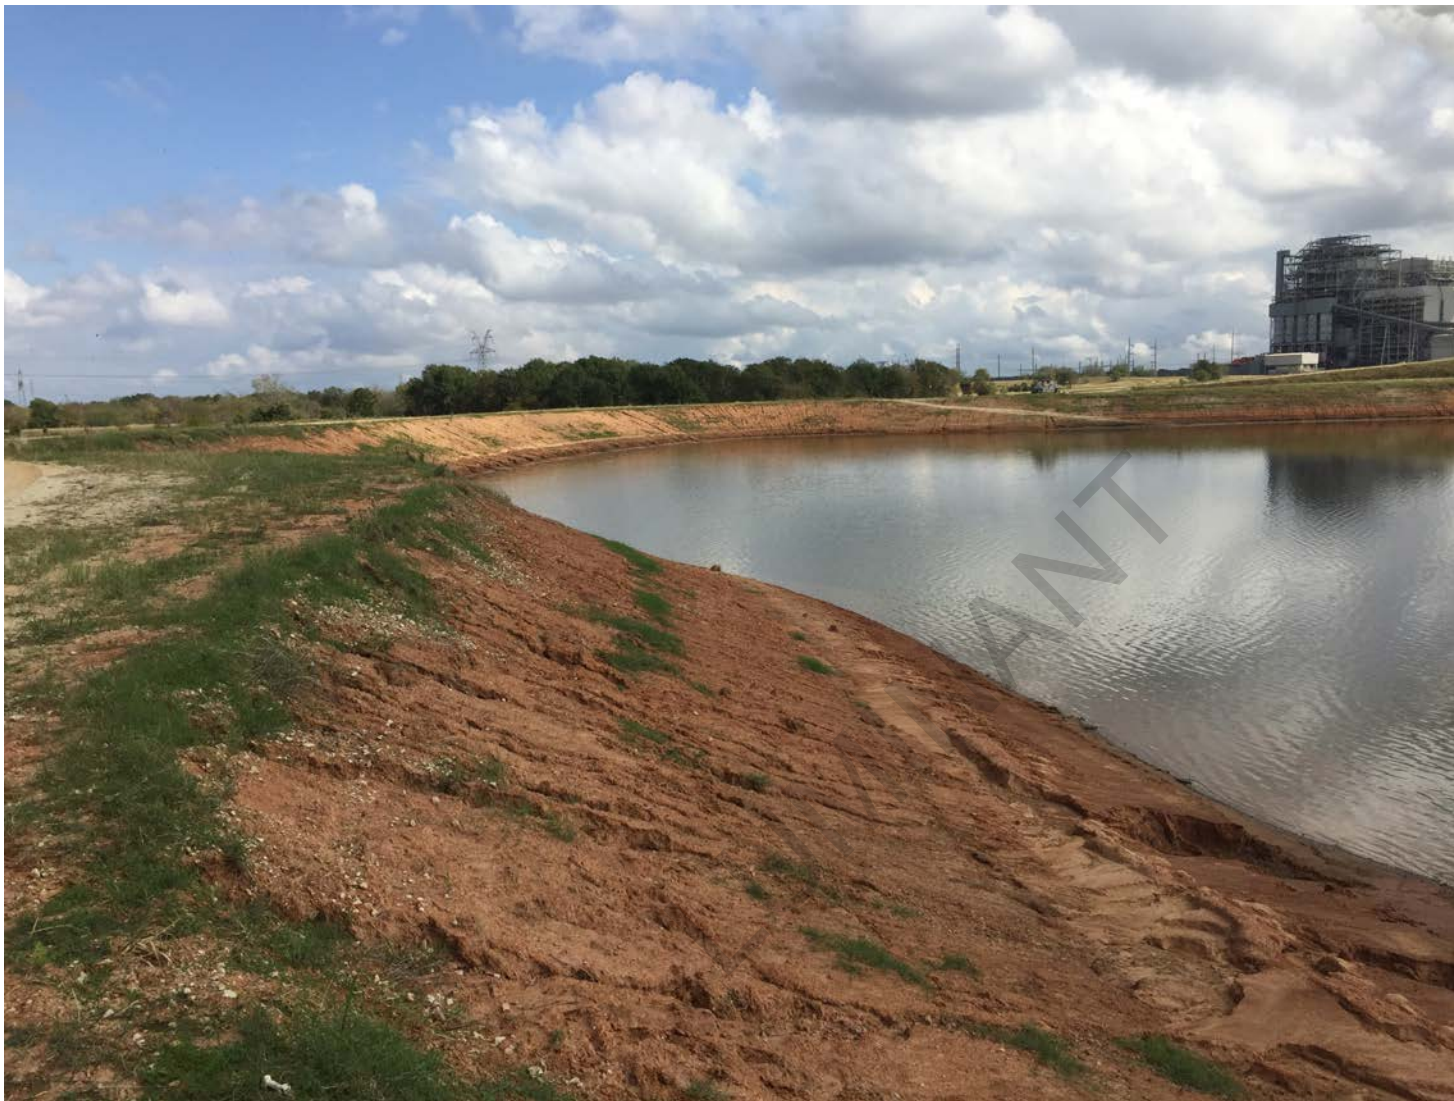
PROJECT NO. 1782004		FILE REF. Nov 2017 download 154.JPG	
	DESIGN	VK	11/09/2017	SCALE: NTS
	CHECK	VK	11/09/2017	REV: 0
	REVIEW	JBF	11/09/2017	PHOTO 31

PHOTO DESCRIPTION:
 Northwestern upstream slope.
