ANNUAL INSPECTION OF CCR UNITS

**Oak Grove Steam Electric Station
Robertson County, Texas**

January 2018

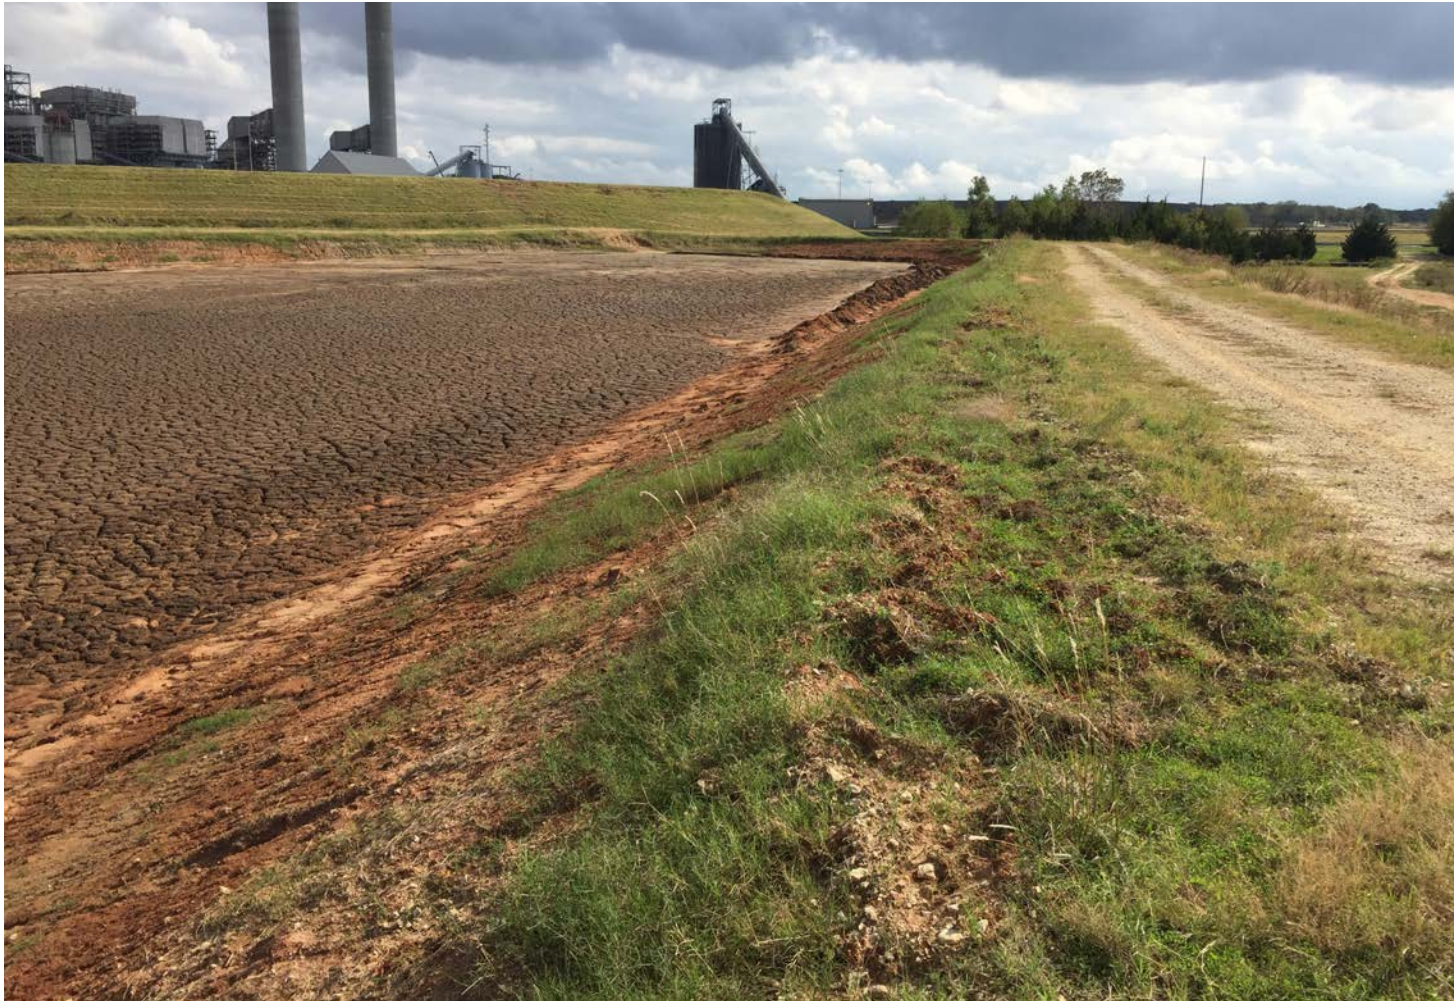
PROJECT NO. 1782004		FILE REF. Nov 2017 download 157.JPG	
	DESIGN	VK	11/09/2017	SCALE: NTS
	CHECK	VK	11/09/2017	REV: 0
	REVIEW	JBF	11/09/2017	PHOTO 32

PHOTO DESCRIPTION:
 Southern portion of FGD-B –
 looking SE.

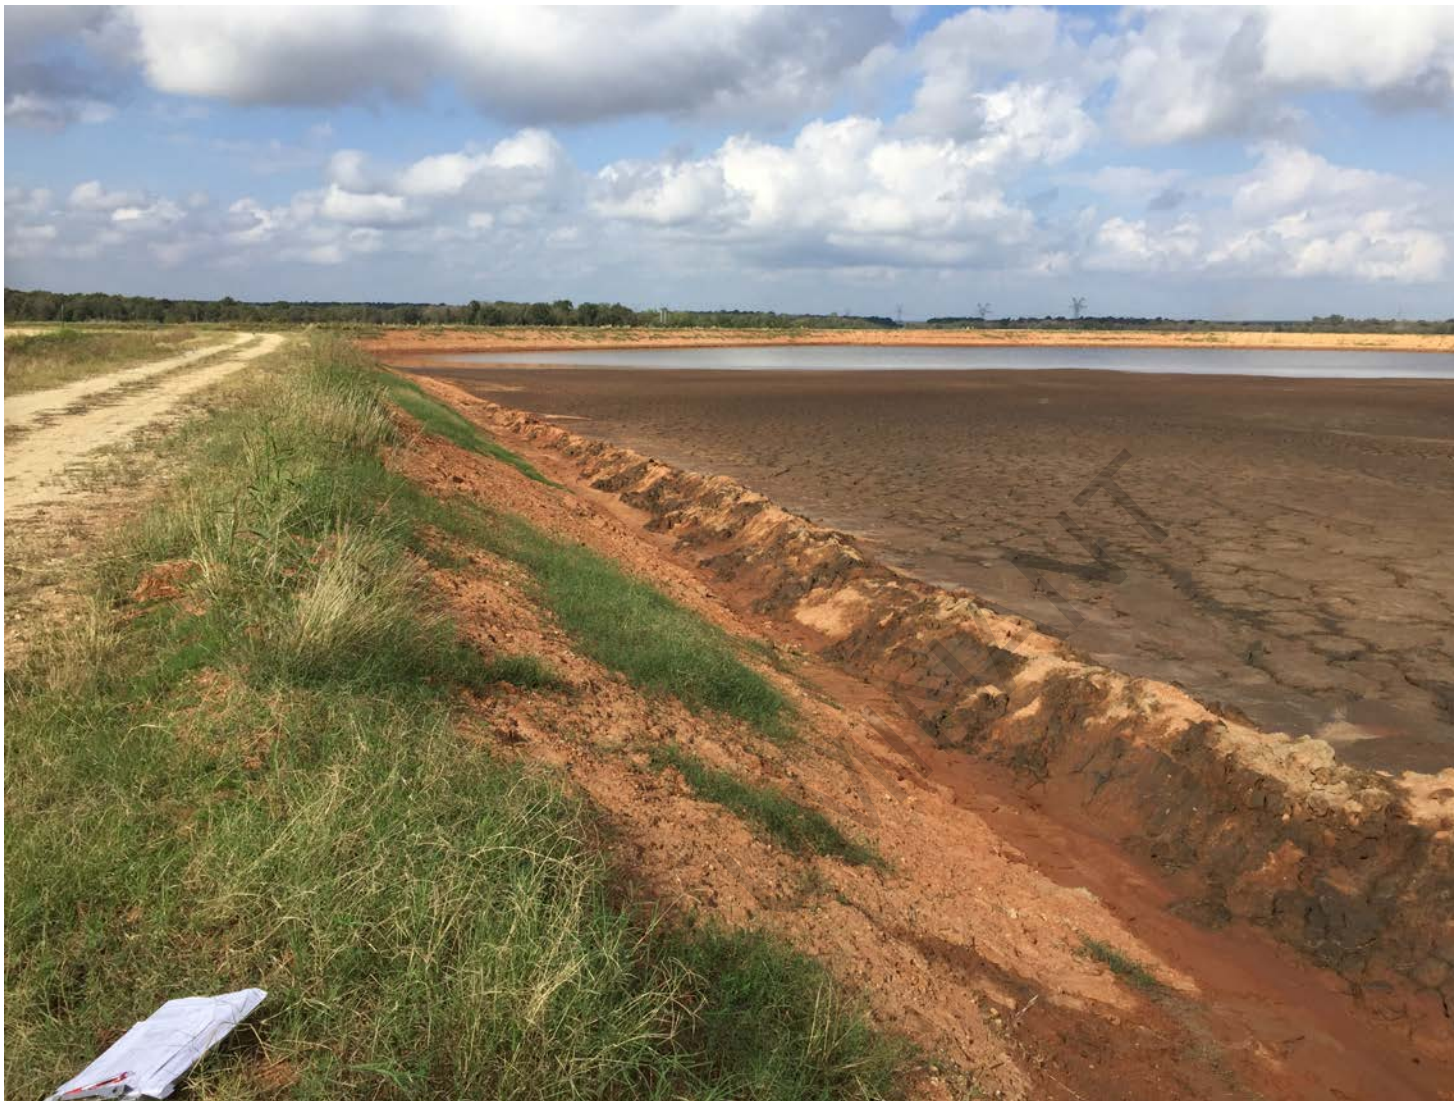
PROJECT NO. 1782004		FILE REF. Nov 2017 download 160.JPG	
	DESIGN	VK	11/09/2017	SCALE: NTS
	CHECK	VK	11/09/2017	REV: 0
	REVIEW	JBF	11/09/2017	PHOTO 33

PHOTO DESCRIPTION:
 Southern portion of FGD-B –
 looking NW.

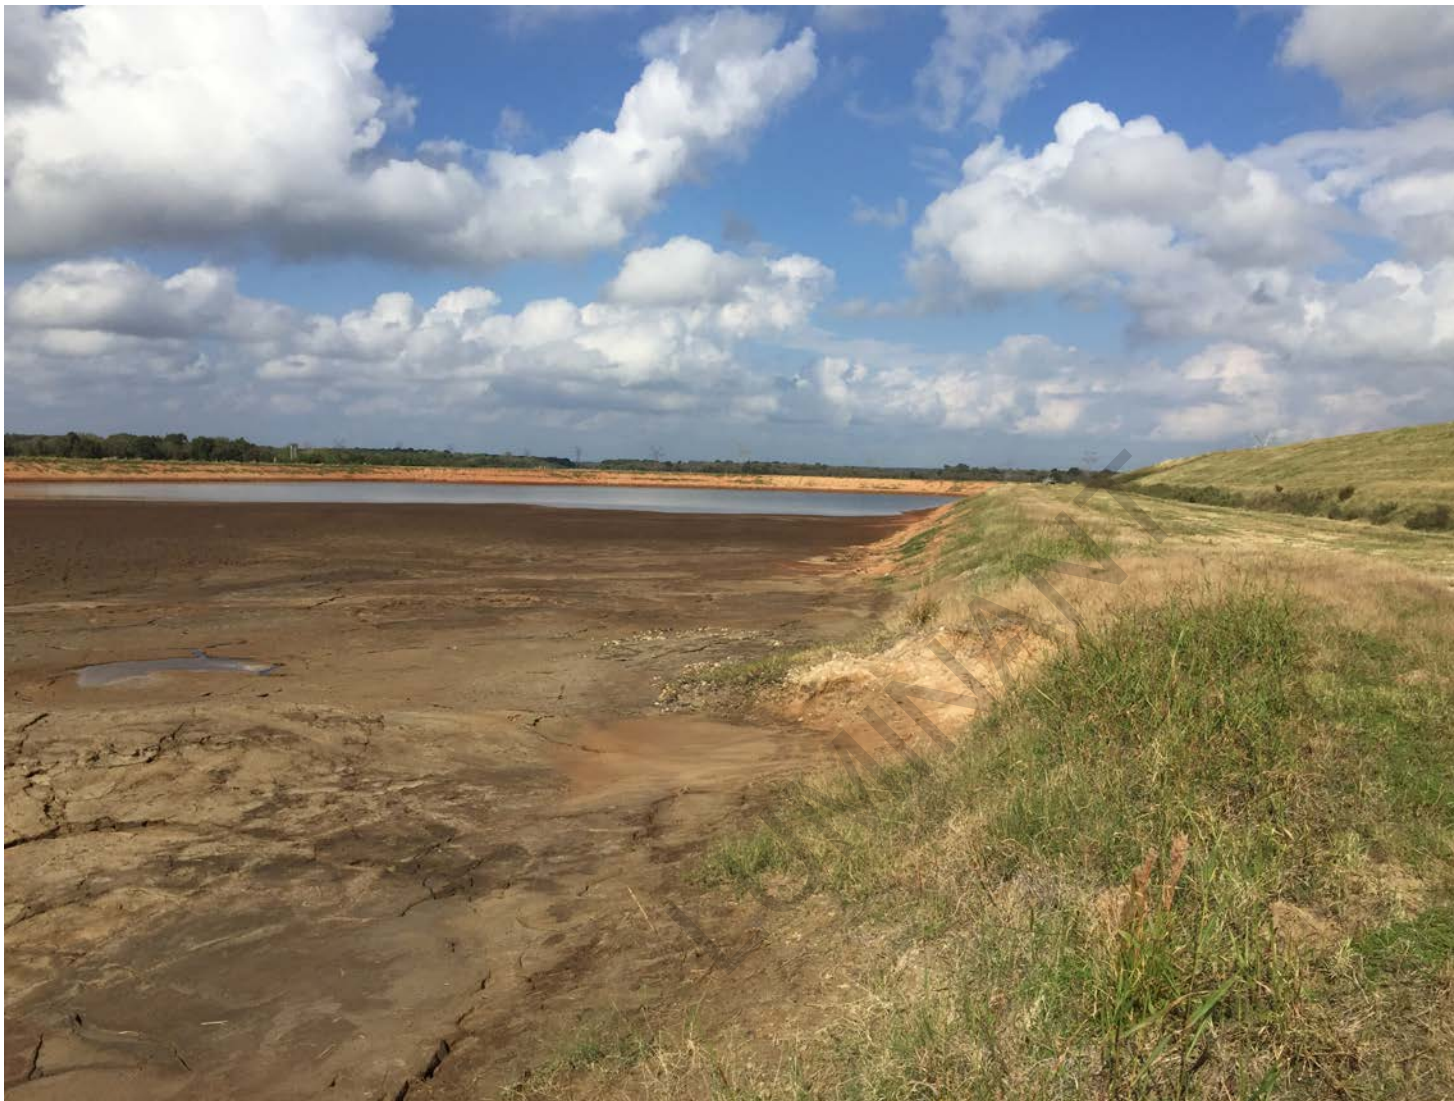
PROJECT NO. 1782004		FILE REF. Nov 2017 download 163.JPG	
	DESIGN	VK	11/09/2017	SCALE: NTS
	CHECK	VK	11/09/2017	REV: 0
	REVIEW	JBF	11/09/2017	PHOTO 34

PHOTO DESCRIPTION:
 Southeastern corner of FGD-B
 - looking N.

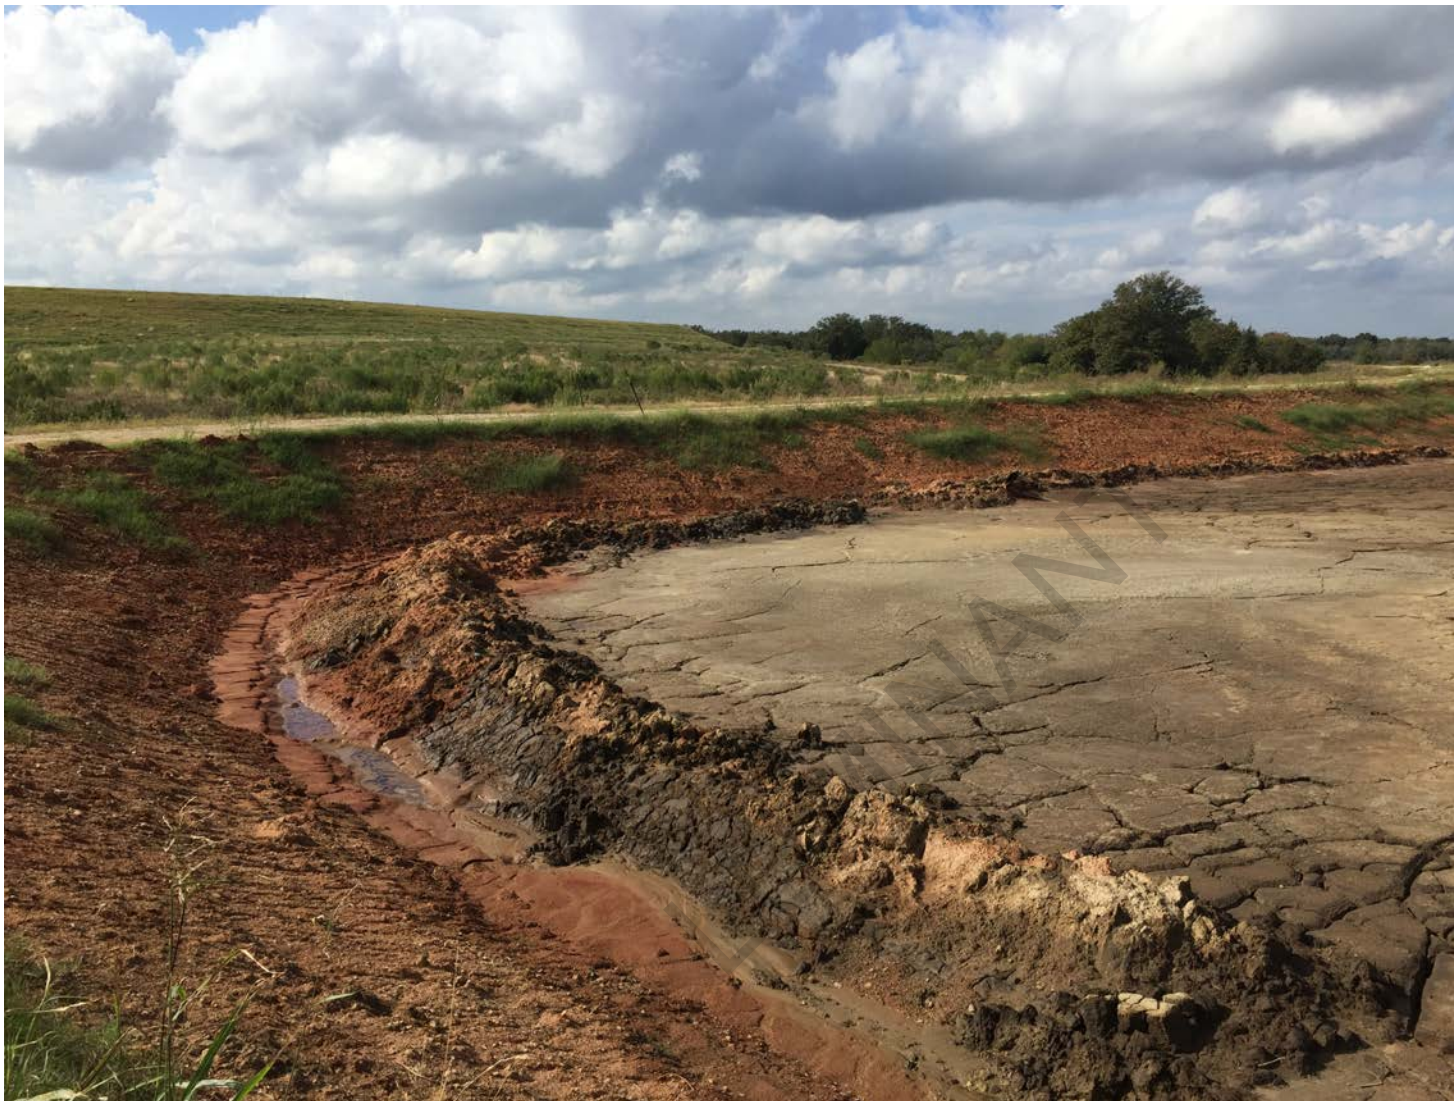
PROJECT NO. 1782004		FILE REF. Nov 2017 download 166.JPG	
	DESIGN	VK	11/09/2017	SCALE: NTS
	CHECK	VK	11/09/2017	REV: 0
	REVIEW	JBF	11/09/2017	PHOTO 35

PHOTO DESCRIPTION:
 Southeastern corner of FGD-B
 - looking SW.

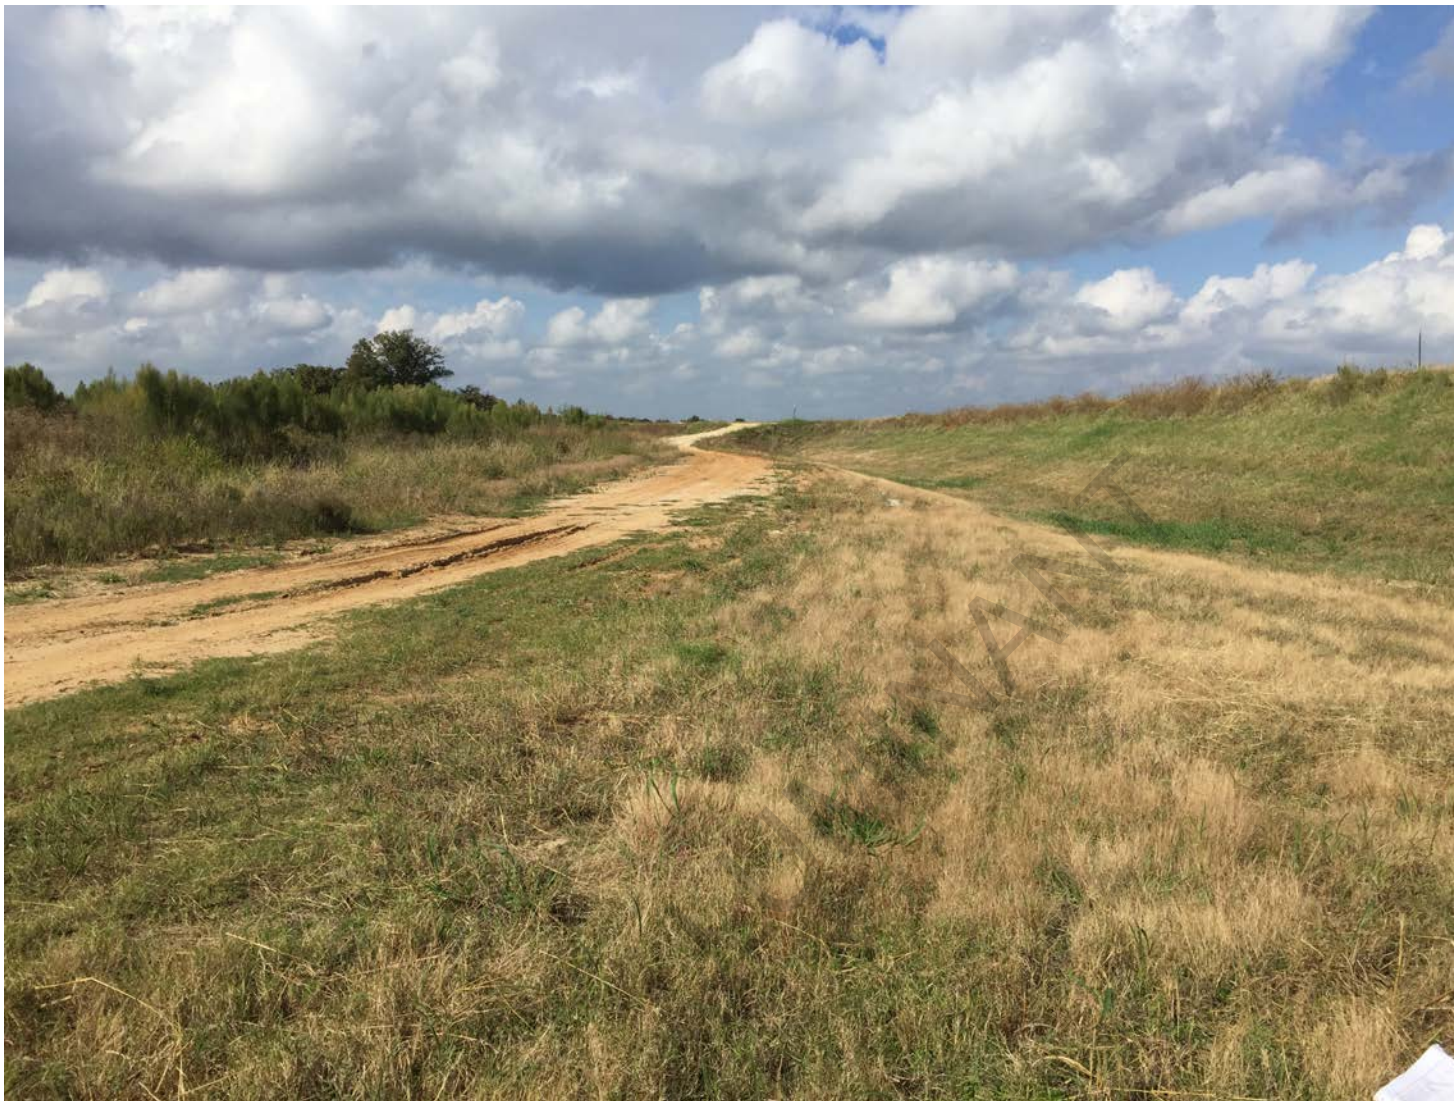
PROJECT NO. 1782004		FILE REF. Nov 2017 download 168.JPG	
	DESIGN	VK	11/09/2017	SCALE: NTS
	CHECK	VK	11/09/2017	REV: 0
	REVIEW	JBF	11/09/2017	PHOTO 37

PHOTO DESCRIPTION:
 Southern downstream slope –
 looking N.

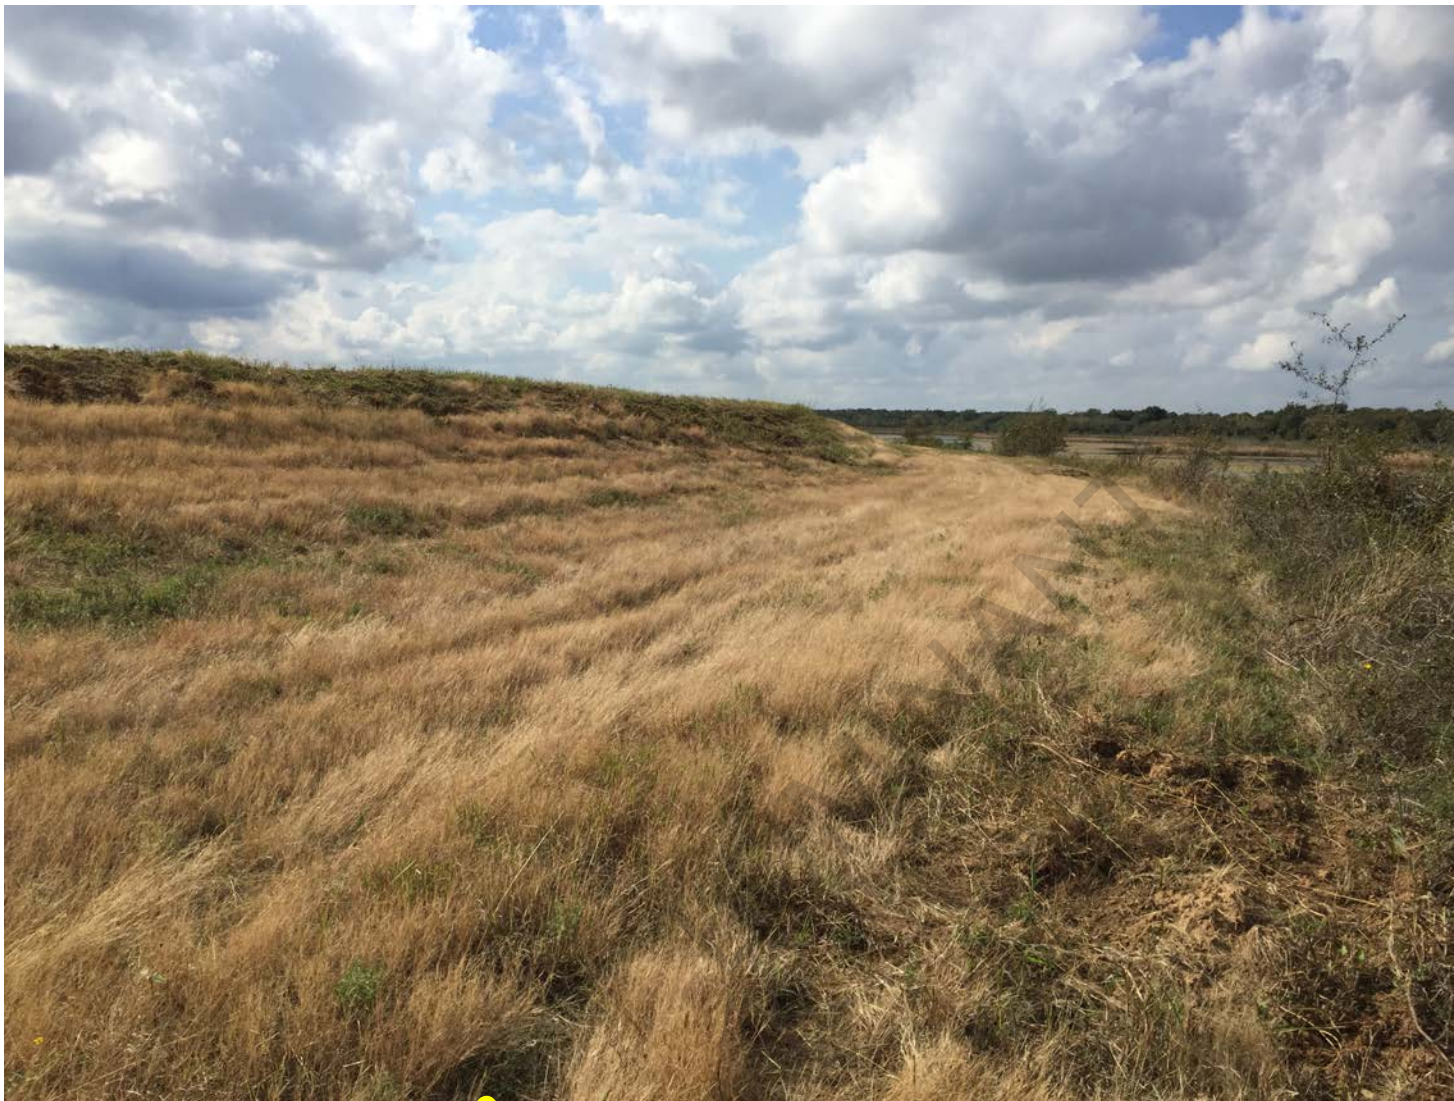
PROJECT NO. 1782004		FILE REF. Nov 2017 download 178.JPG	
	DESIGN	VK	11/09/2017	SCALE: NTS
	CHECK	VK	11/09/2017	REV: 0
	REVIEW	JBF	11/09/2017	PHOTO 41

PHOTO DESCRIPTION:
 Northeastern downstream
 slope.

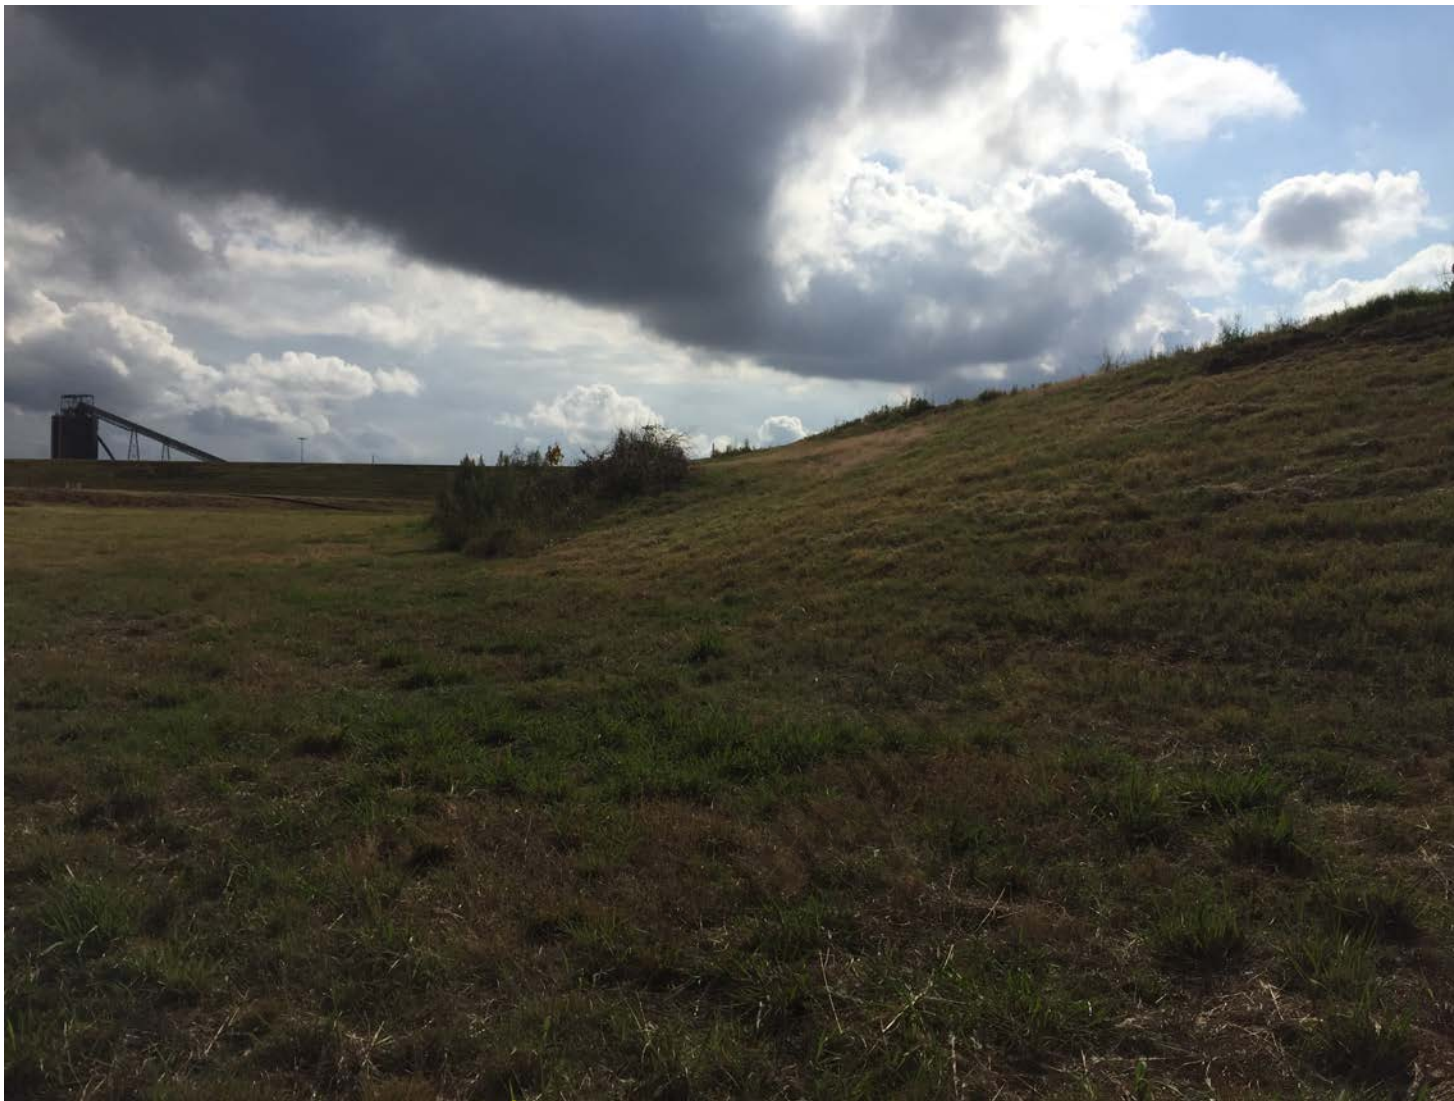
PROJECT NO. 1782004		FILE REF. Nov 2017 download 179.JPG	
	DESIGN	VK	11/09/2017	SCALE: NTS
	CHECK	VK	11/09/2017	REV: 0
	REVIEW	JBF	11/09/2017	PHOTO 42

PHOTO DESCRIPTION:
 Eastern downstream slope.

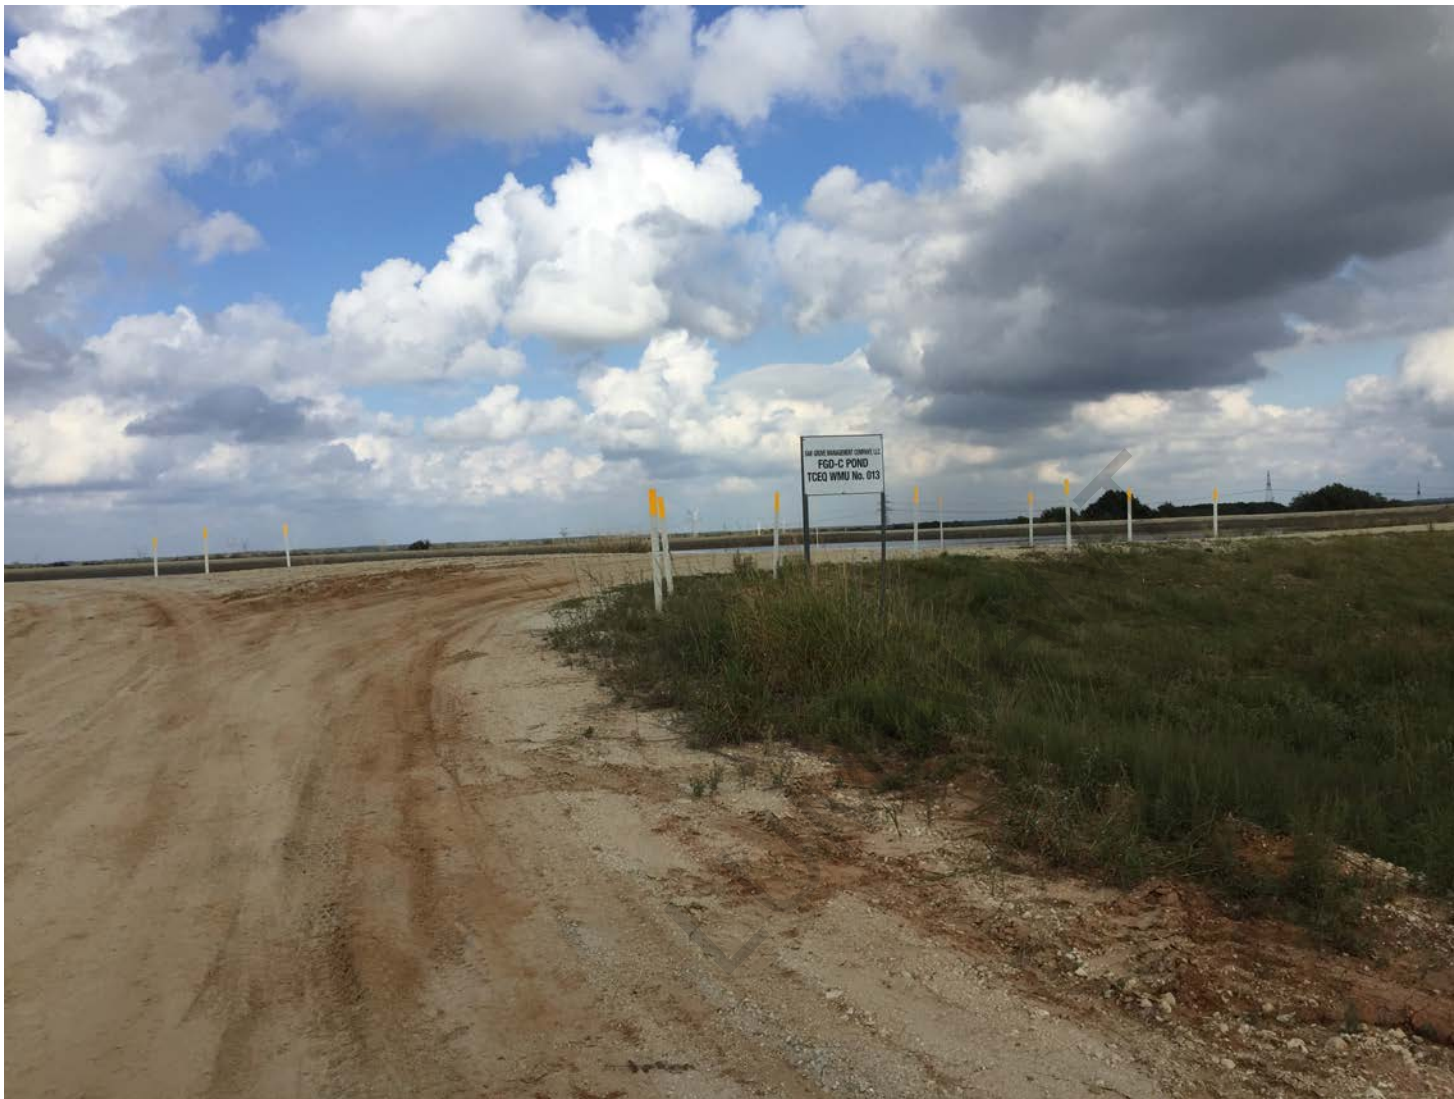
PROJECT NO. 1782004		FILE REF. Nov 2017 download 182.JPG	
	DESIGN	VK	11/09/2017	SCALE: NTS
	CHECK	VK	11/09/2017	REV: 0
	REVIEW	JBF	11/09/2017	PHOTO 43

PHOTO DESCRIPTION:
 Access ramp to FGD-C.

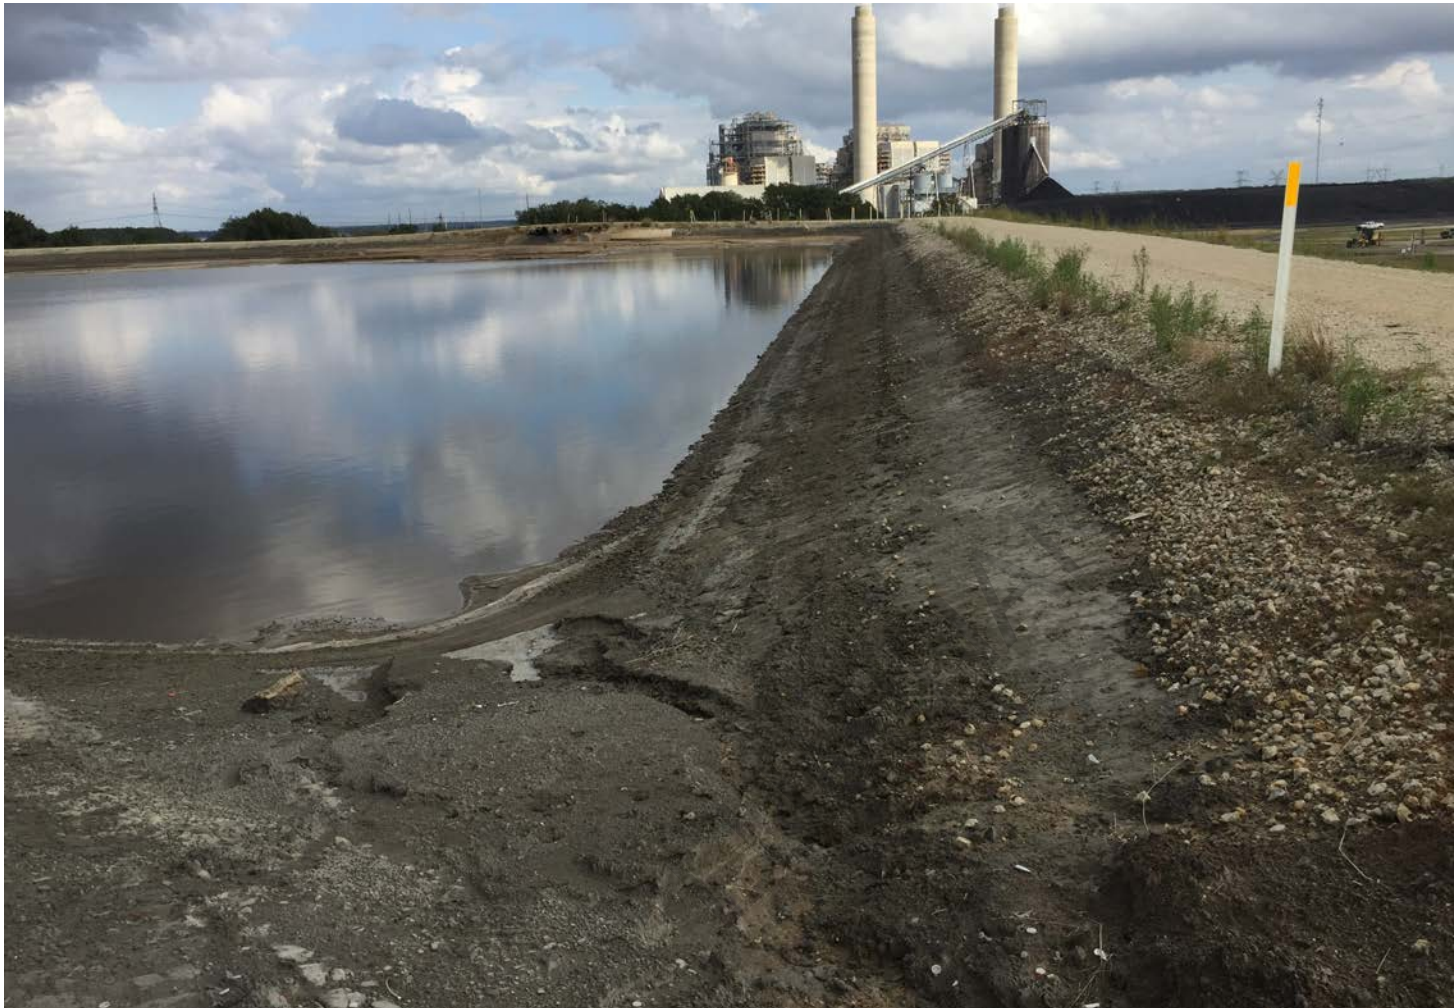
PROJECT NO. 1782004		FILE REF. Nov 2017 download 185.JPG	
	DESIGN	VK	11/09/2017	SCALE: NTS
	CHECK	VK	11/09/2017	REV: 0
	REVIEW	JBF	11/09/2017	PHOTO 44

PHOTO DESCRIPTION:
 Southwestern upstream slope.

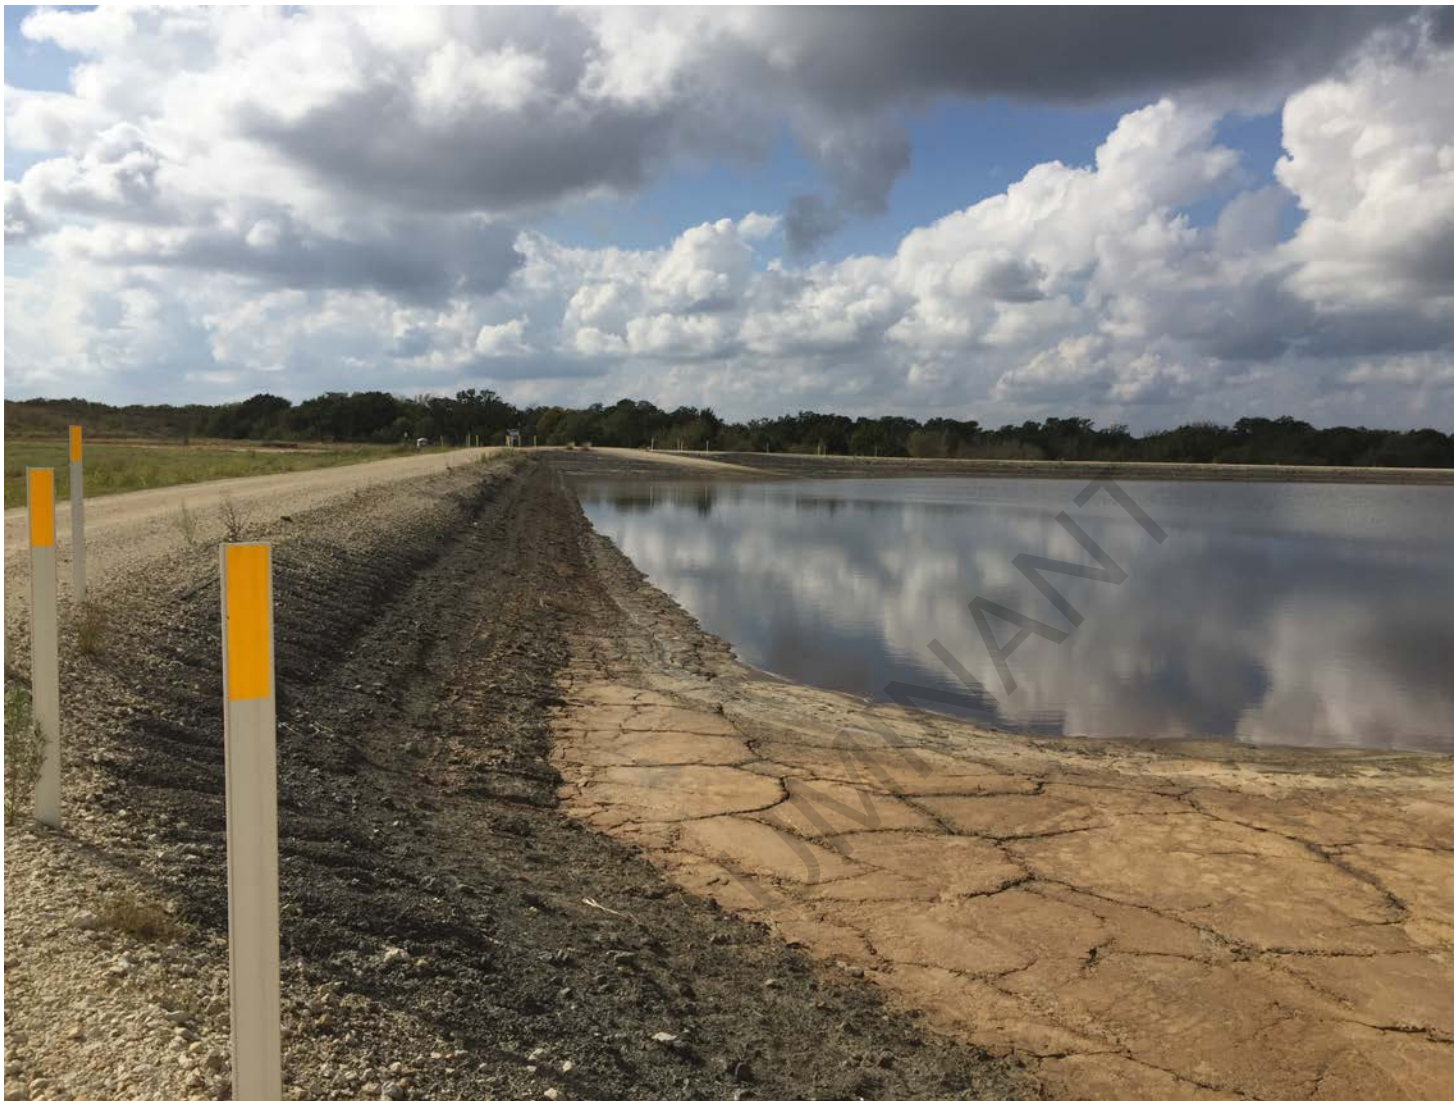
PROJECT NO. 1782004		FILE REF. Nov 2017 download 186.JPG	
	DESIGN	VK	11/09/2017	SCALE: NTS
	CHECK	VK	11/09/2017	REV: 0
	REVIEW	JBF	11/09/2017	PHOTO 45

PHOTO DESCRIPTION:
 Southeastern upstream slope –
 looking W.

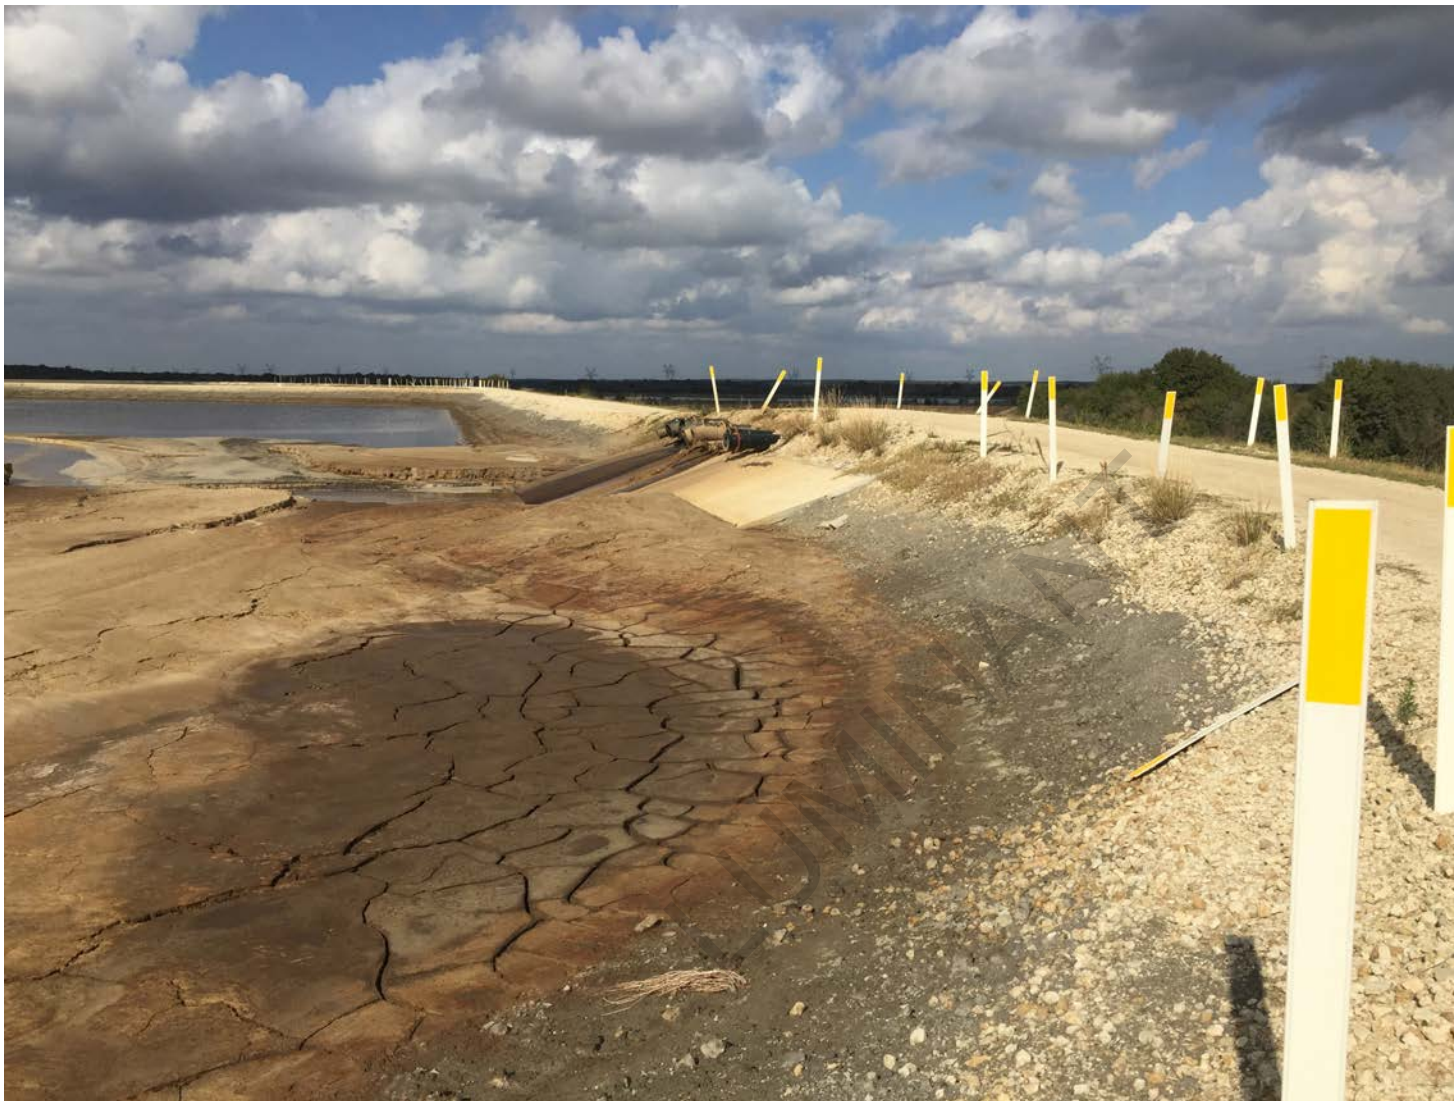
PROJECT NO. 1782004		FILE REF. Nov 2017 download 188.JPG	
	DESIGN	VK	11/09/2017	SCALE: NTS
	CHECK	VK	11/09/2017	REV: 0
	REVIEW	JBF	11/09/2017	PHOTO 46

PHOTO DESCRIPTION:
 Southeastern upstream slope –
 looking N.

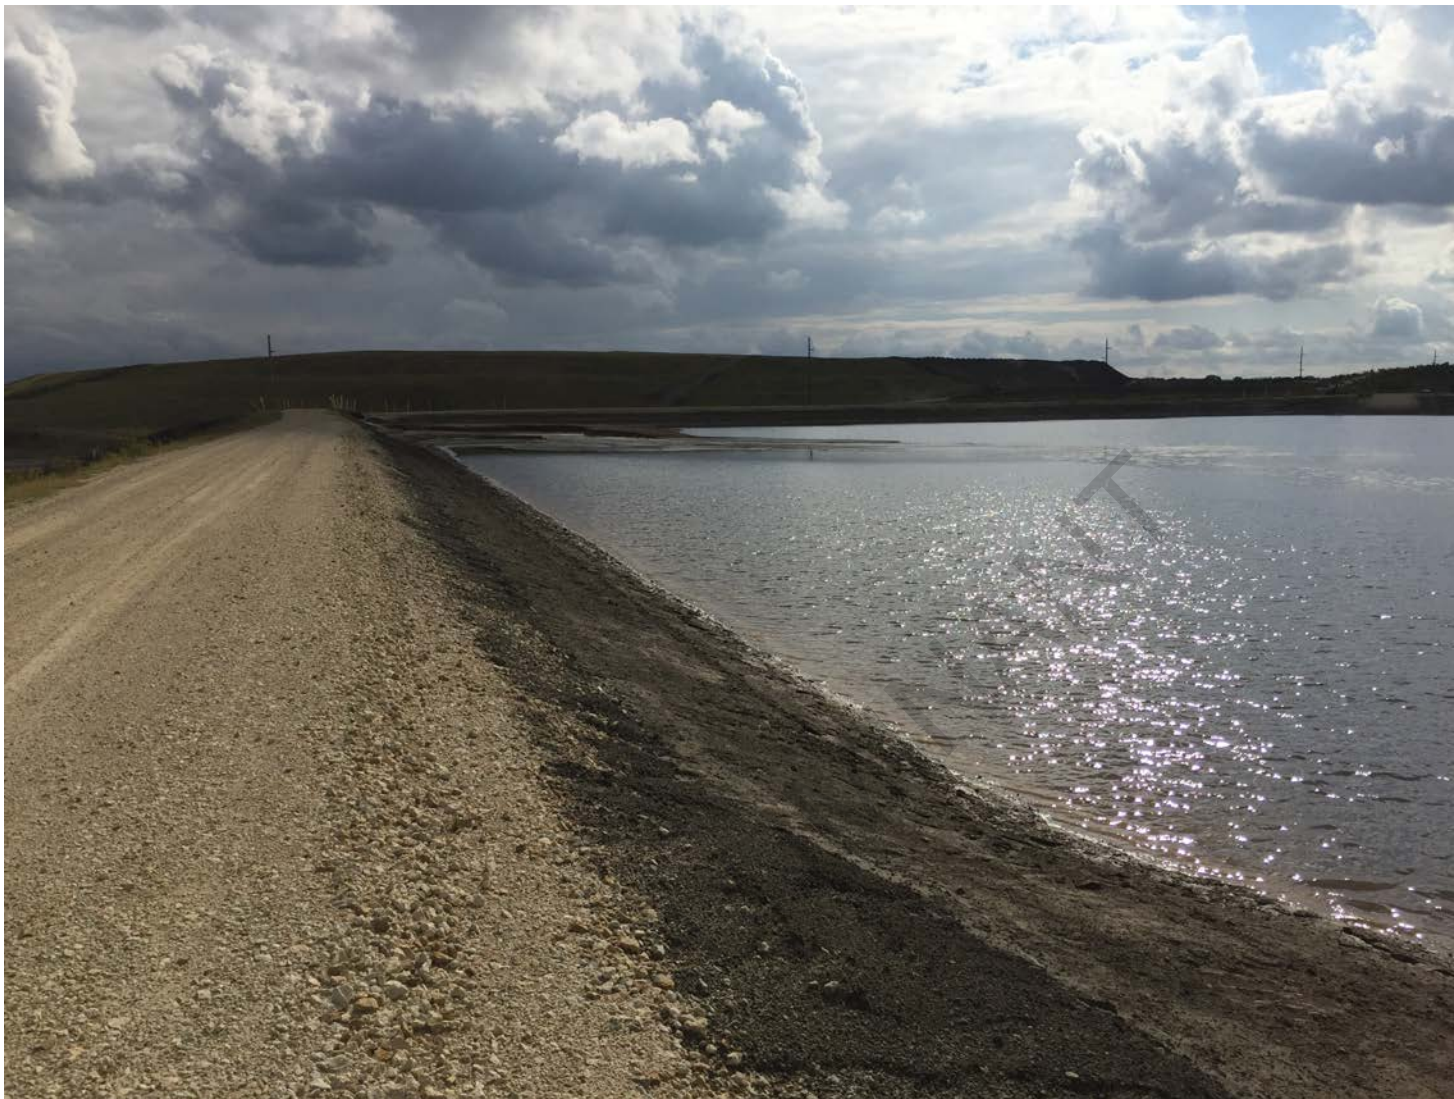
PROJECT NO. 1782004		FILE REF. Nov 2017 download 189.JPG	
	DESIGN	VK	11/09/2017	SCALE: NTS
	CHECK	VK	11/09/2017	REV: 0
	REVIEW	JBF	11/09/2017	PHOTO 47

PHOTO DESCRIPTION:
 Mid-southeastern upstream
 slope – looking S.

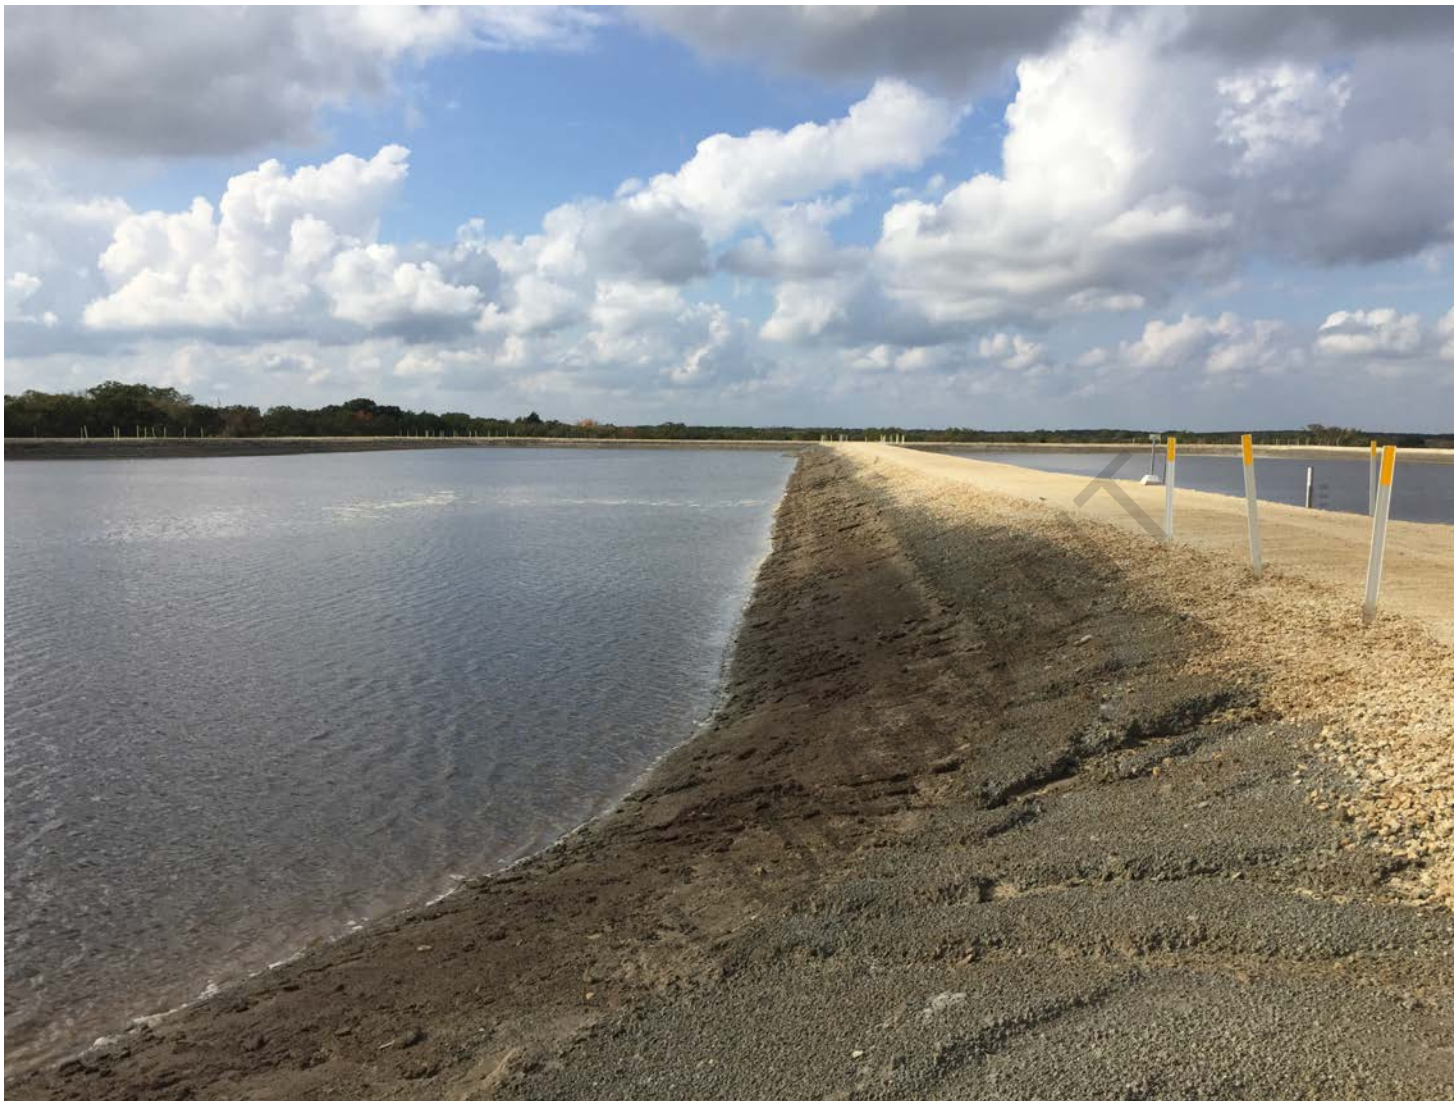
PROJECT NO. 1782004		FILE REF. Nov 2017 download 191.JPG	
	DESIGN	VK	11/09/2017	SCALE: NTS
	CHECK	VK	11/09/2017	REV: 0
	REVIEW	JBF	11/09/2017	PHOTO 48

PHOTO DESCRIPTION:
 Western slope of divider berm
 – looking NW.

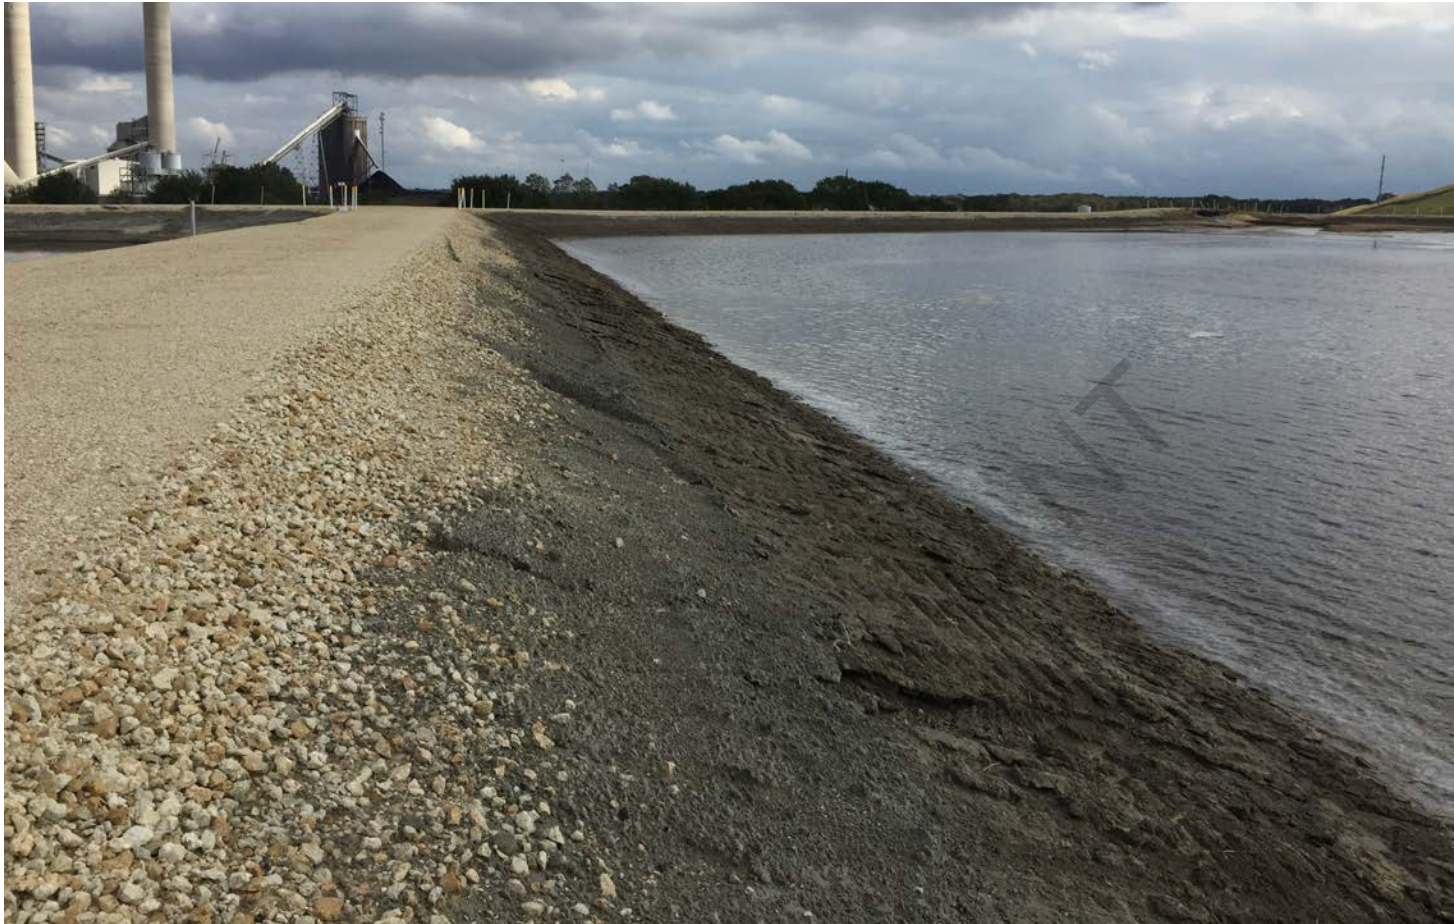
PROJECT NO. 1782004		FILE REF. Nov 2017 download 192.JPG	
	DESIGN	VK	11/09/2017	SCALE: NTS
	CHECK	VK	11/09/2017	REV: 0
	REVIEW	JBF	11/09/2017	PHOTO 49

PHOTO DESCRIPTION:
 Western slope of divider berm
 – looking SE.
