ANNUAL INSPECTION OF CCR UNITS

**Oak Grove Steam Electric Station
Robertson County, Texas**

January 2018

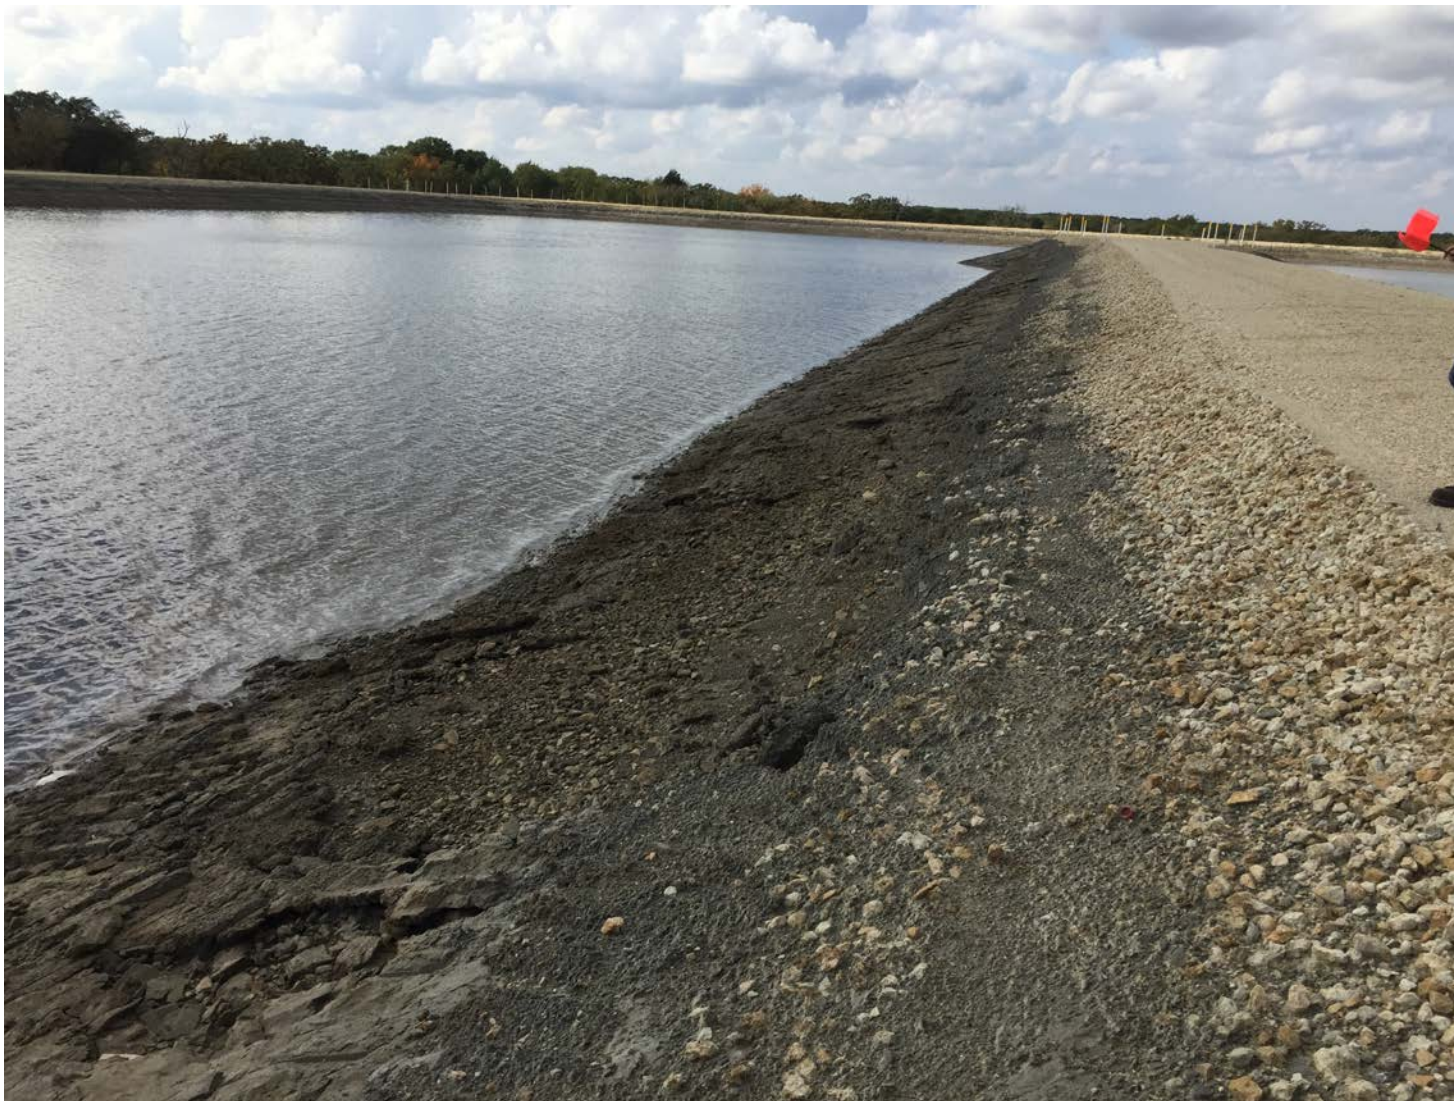
PROJECT NO. 1782004		FILE REF. Nov 2017 download 193.JPG	
	DESIGN	VK	11/09/2017	SCALE: NTS
	CHECK	VK	11/09/2017	REV: 0
	REVIEW	JBF	11/09/2017	PHOTO 50

PHOTO DESCRIPTION:
 Mid-western slope of divider
 berm – looking NW.

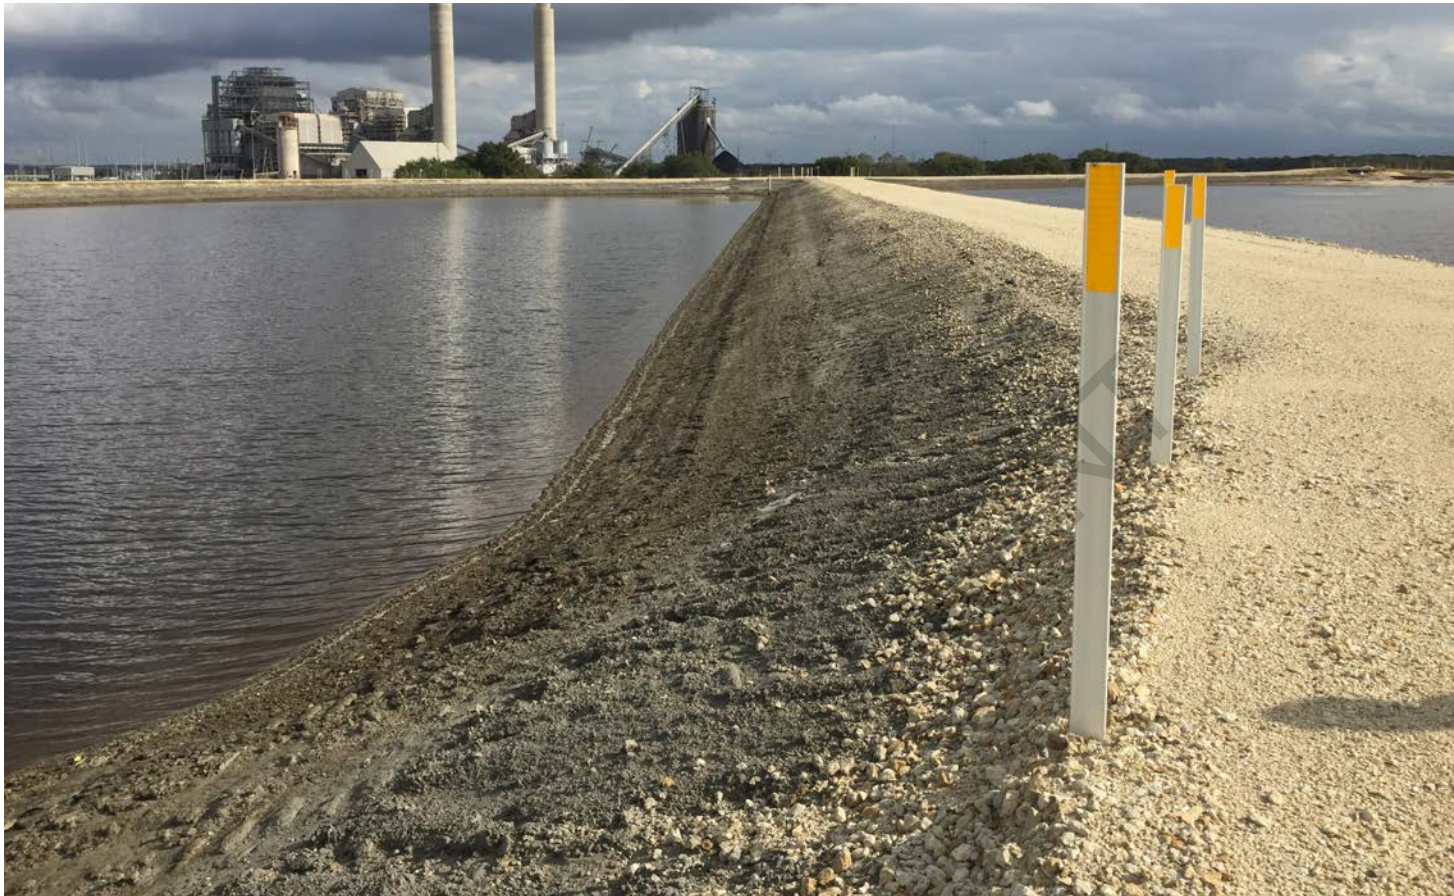
PROJECT NO. 1782004		FILE REF. Nov 2017 download 194.JPG	
	DESIGN	VK	11/09/2017	SCALE: NTS
	CHECK	VK	11/09/2017	REV: 0
	REVIEW	JBF	11/09/2017	PHOTO 51

PHOTO DESCRIPTION:
 Eastern slope of divider berm
 – looking SE.

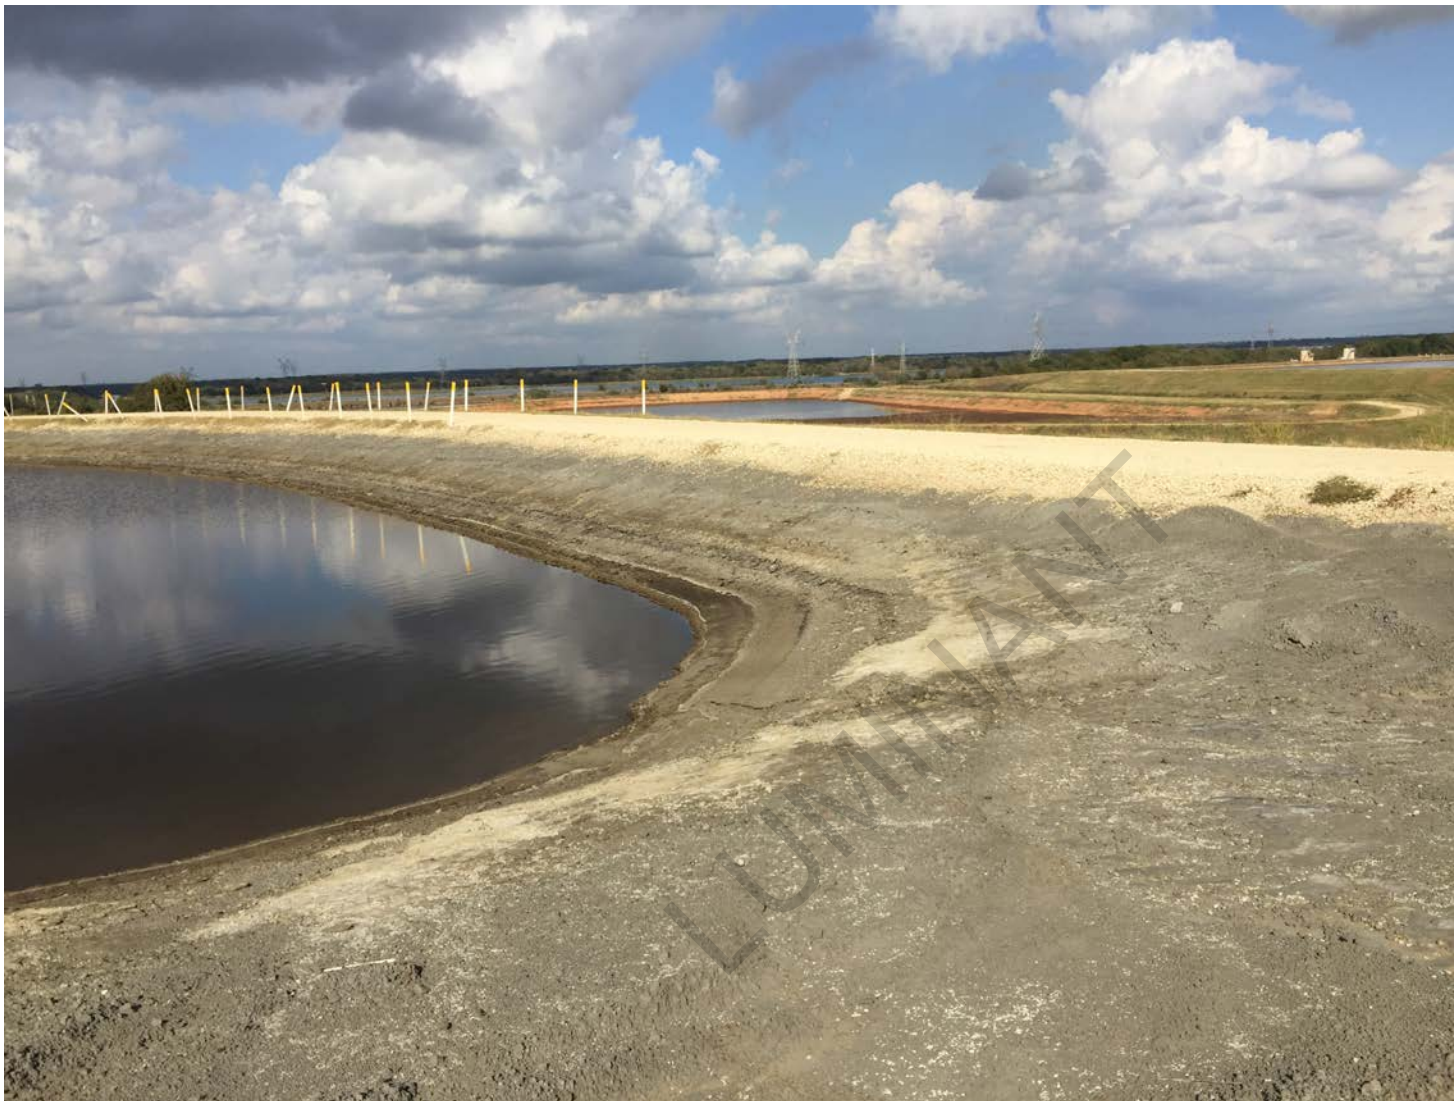
PROJECT NO. 1782004		FILE REF. Nov 2017 download 196.JPG	
	DESIGN	VK	11/09/2017	SCALE: NTS
	CHECK	VK	11/09/2017	REV: 0
	REVIEW	JBF	11/09/2017	PHOTO 52

PHOTO DESCRIPTION:
 Southern corner of divider
 berm.

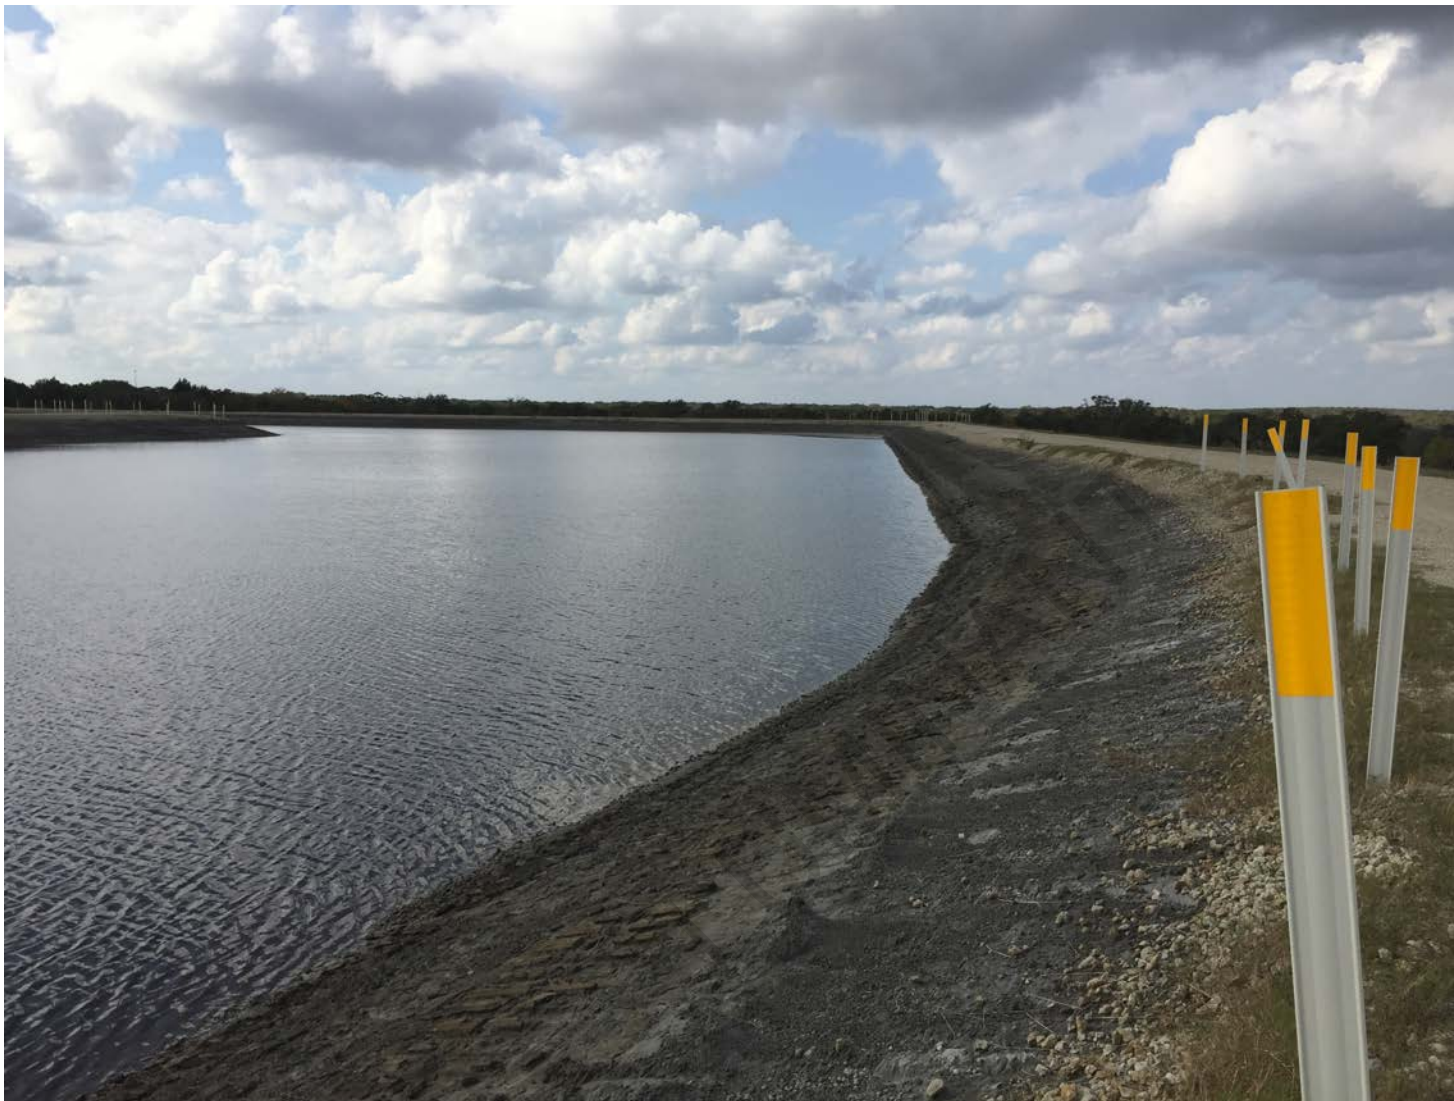
PROJECT NO. 1782004		FILE REF. Nov 2017 download 198.JPG	
	DESIGN	VK	11/09/2017	SCALE: NTS
	CHECK	VK	11/09/2017	REV: 0
	REVIEW	JBF	11/09/2017	PHOTO 53

PHOTO DESCRIPTION:
 Northeastern upstream slope

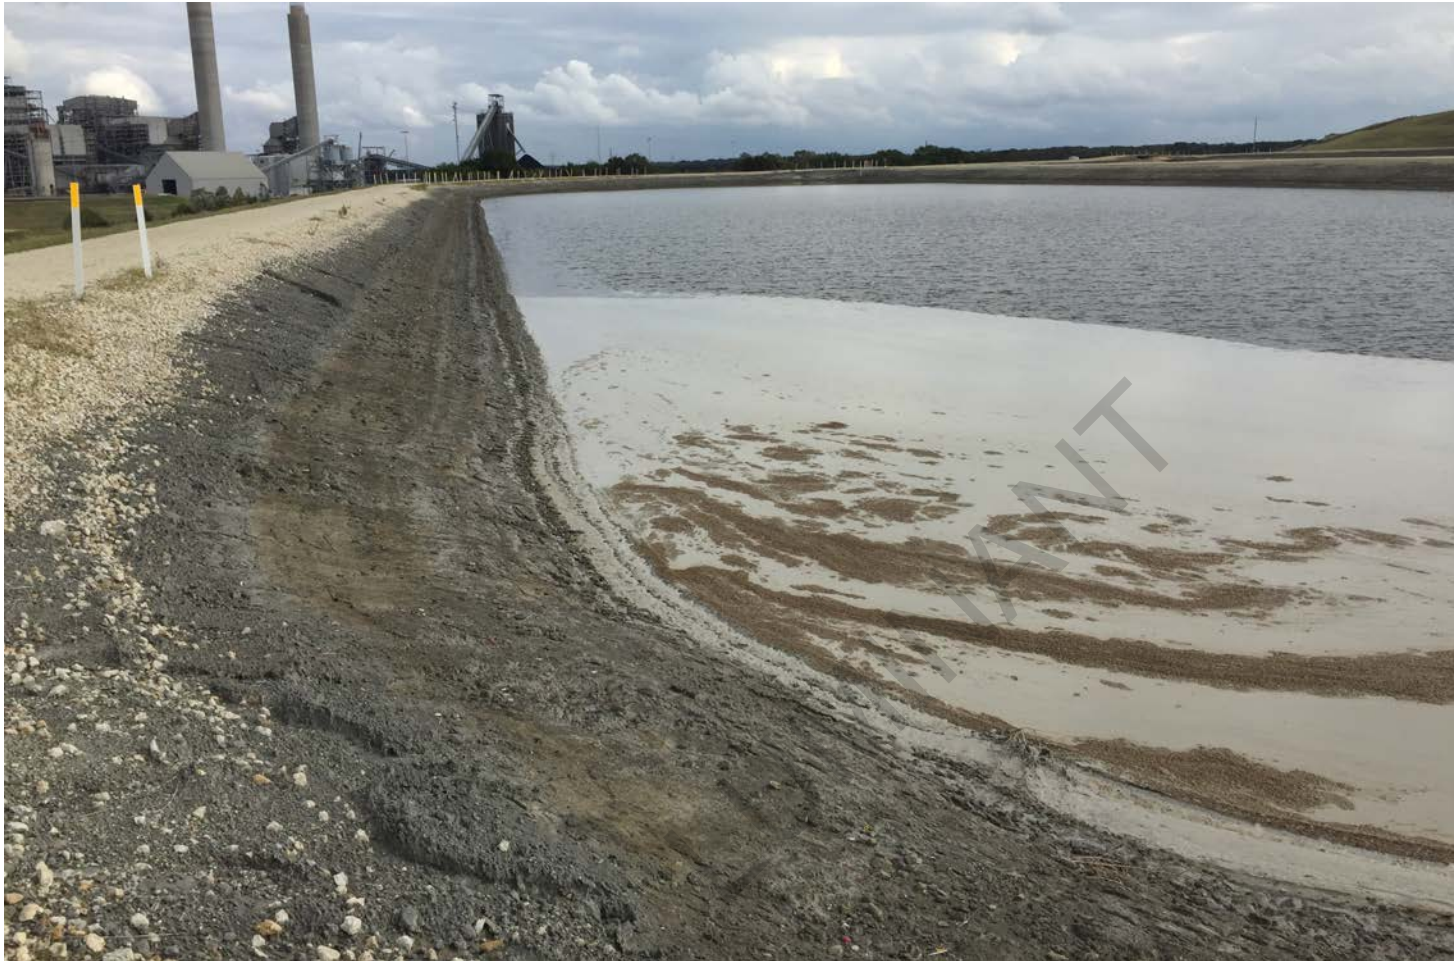
PROJECT NO. 1782004		FILE REF. Nov 2017 download 200.JPG	
	DESIGN	VK	11/09/2017	SCALE: NTS
	CHECK	VK	11/09/2017	REV: 0
	REVIEW	JBF	11/09/2017	PHOTO 54

PHOTO DESCRIPTION:
 Northeastern upstream slope –
 looking SE.

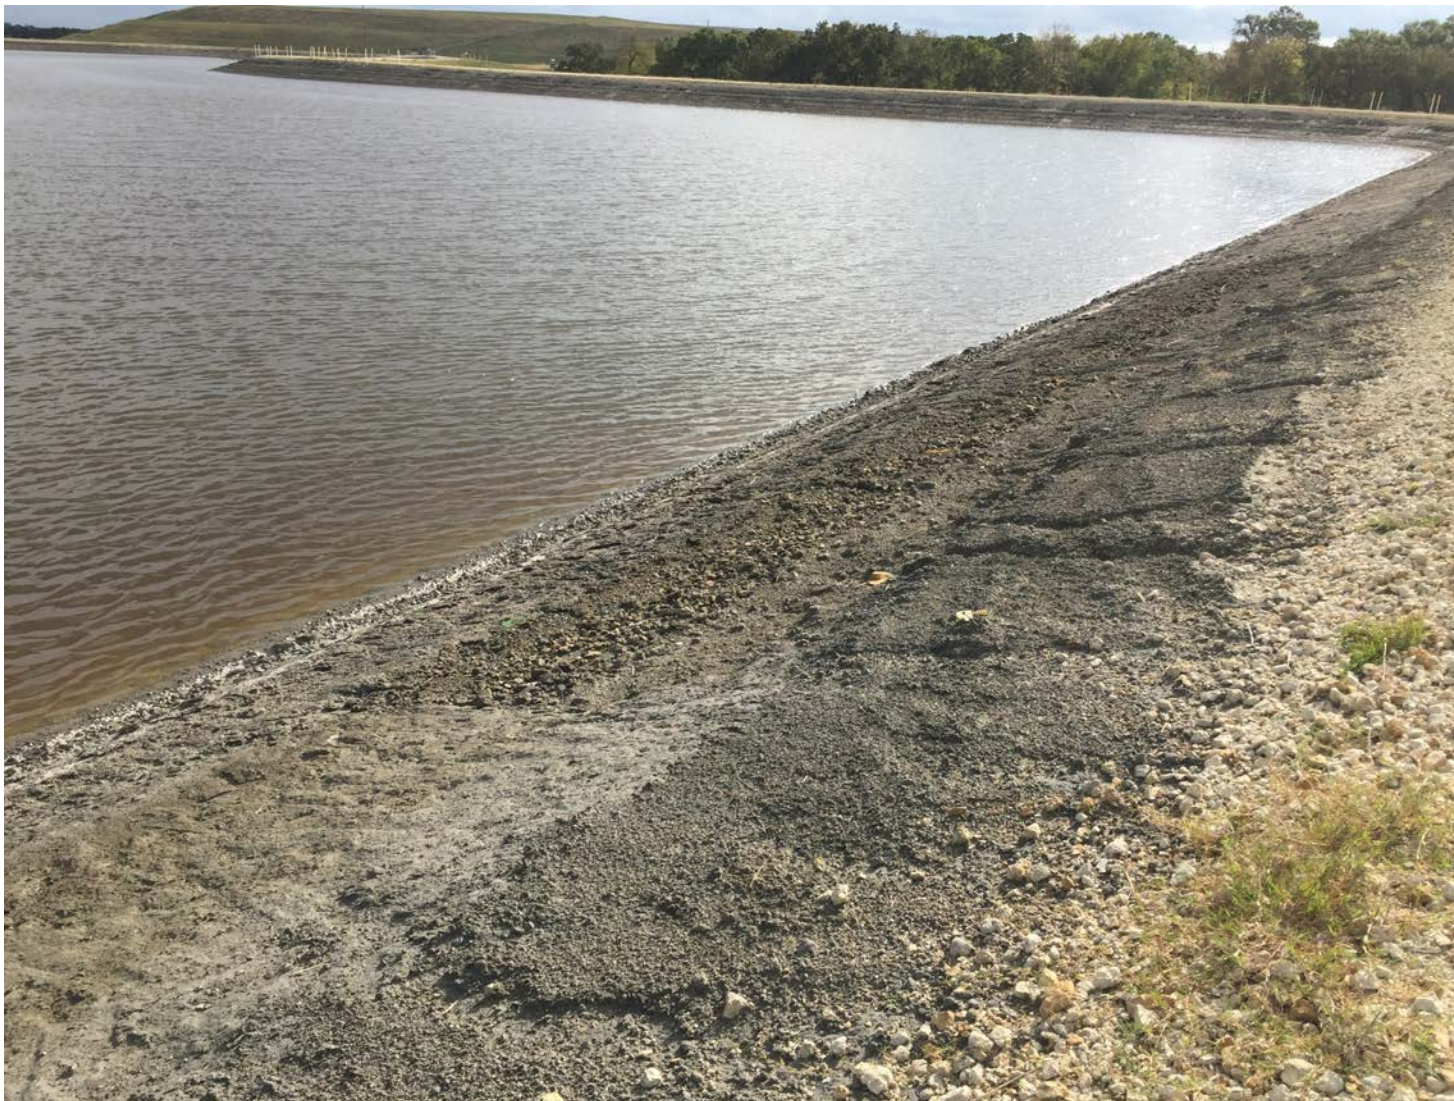
PROJECT NO. 1782004		FILE REF. Nov 2017 download 201.JPG	
	DESIGN	VK	11/09/2017	SCALE: NTS
	CHECK	VK	11/09/2017	REV: 0
	REVIEW	JBF	11/09/2017	PHOTO 55

PHOTO DESCRIPTION:
 Northwestern upstream slope –
 looking SW.

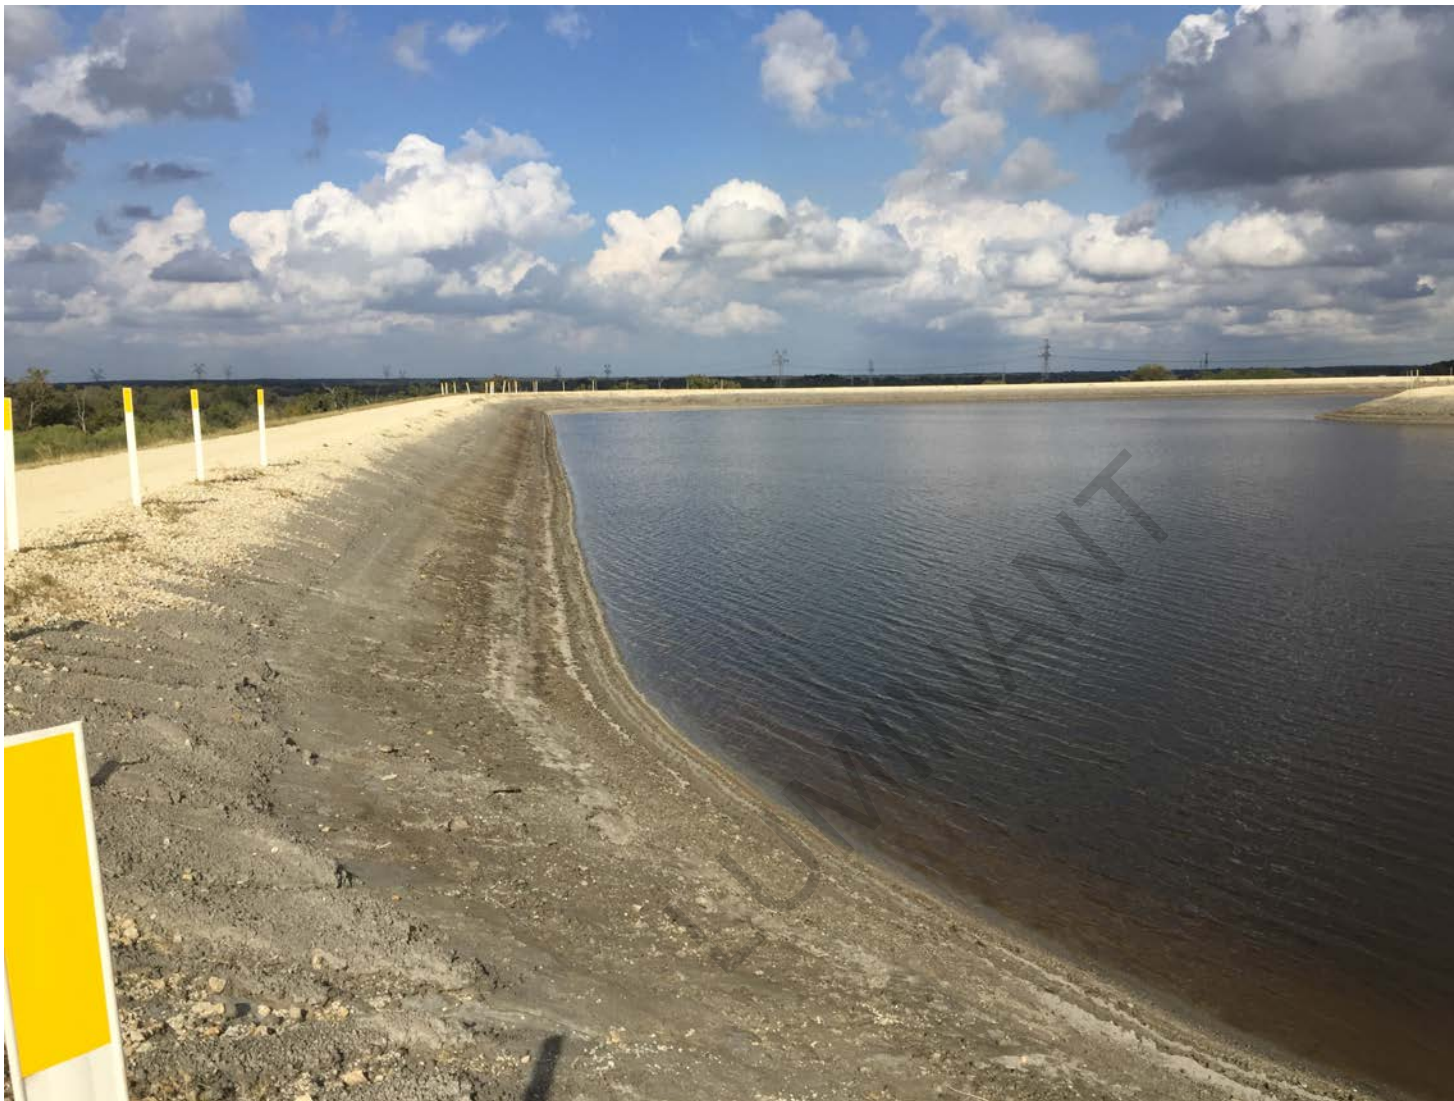
PROJECT NO. 1782004		FILE REF. Nov 2017 download 203.JPG	
	DESIGN	VK	11/09/2017	SCALE: NTS
	CHECK	VK	11/09/2017	REV: 0
	REVIEW	JBF	11/09/2017	PHOTO 56

PHOTO DESCRIPTION:
 Northwestern upstream slope –
 looking NE.

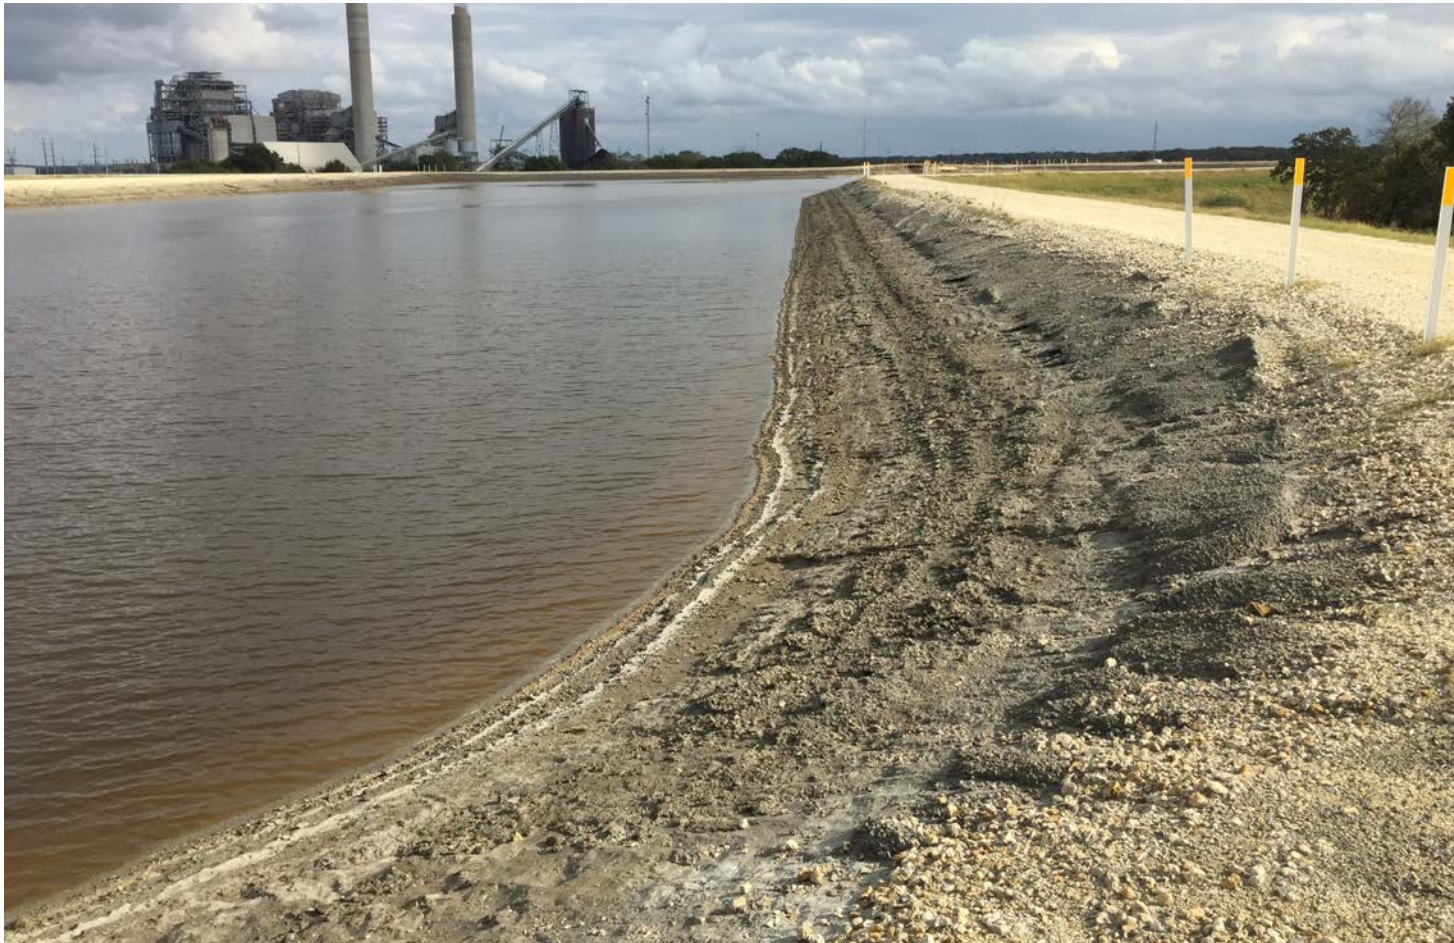
PROJECT NO. 1782004		FILE REF. Nov 2017 download 204.JPG	
	DESIGN	VK	11/09/2017	SCALE: NTS
	CHECK	VK	11/09/2017	REV: 0
	REVIEW	JBF	11/09/2017	PHOTO 57

PHOTO DESCRIPTION:
 Northern portion of western
 upstream slope.

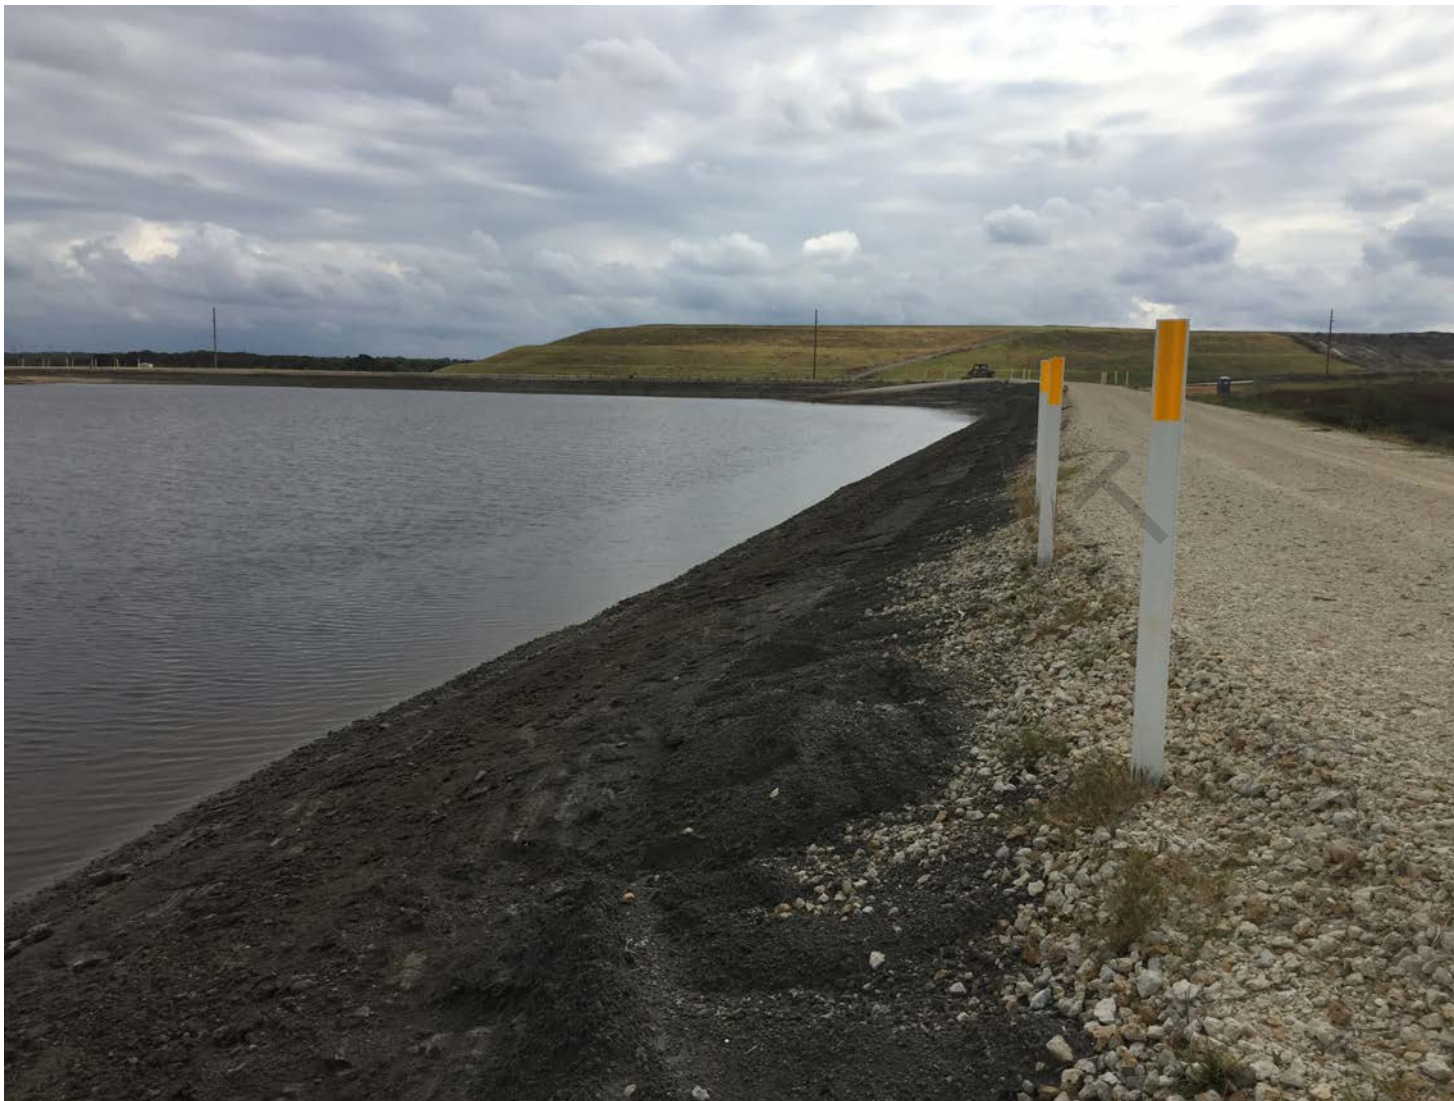
PROJECT NO. 1782004		FILE REF. Nov 2017 download 205.JPG	
	DESIGN	VK	11/09/2017	SCALE: NTS
	CHECK	VK	11/09/2017	REV: 0
	REVIEW	JBF	11/09/2017	PHOTO 58

PHOTO DESCRIPTION:
 Southern portion of western
 upstream slope – looking S.

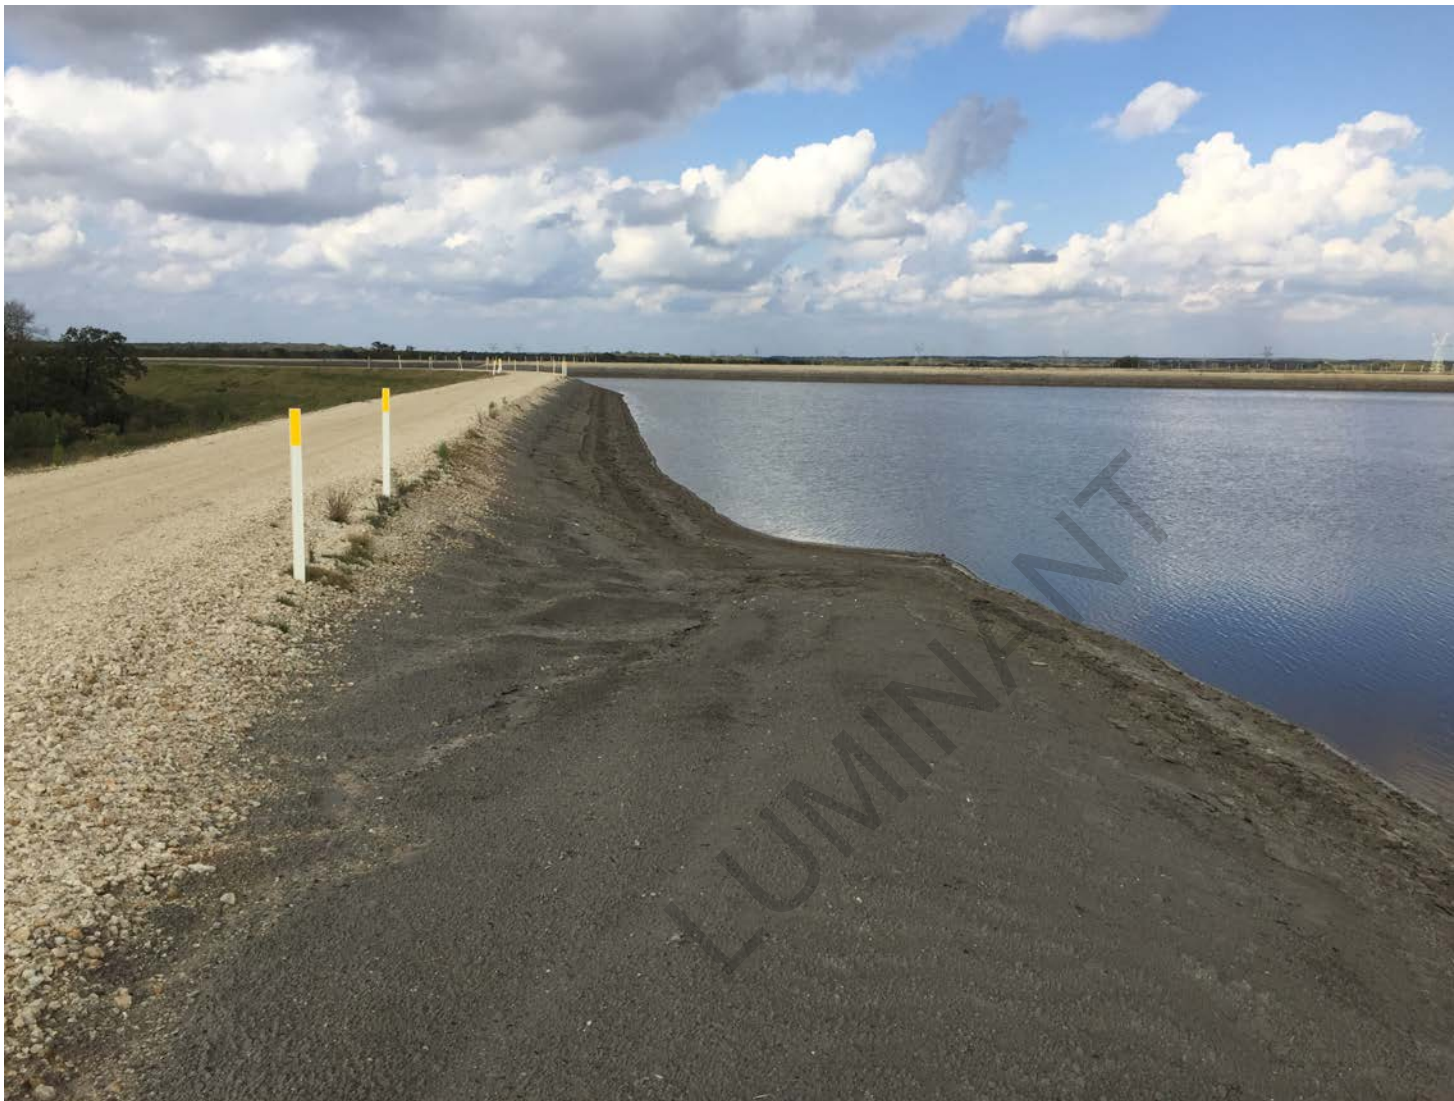
PROJECT NO. 1782004		FILE REF. Nov 2017 download 206.JPG	
	DESIGN	VK	11/09/2017	SCALE: NTS
	CHECK	VK	11/09/2017	REV: 0
	REVIEW	JBF	11/09/2017	PHOTO 59

PHOTO DESCRIPTION:
 Southern portion of western
 upstream slope – looking N.

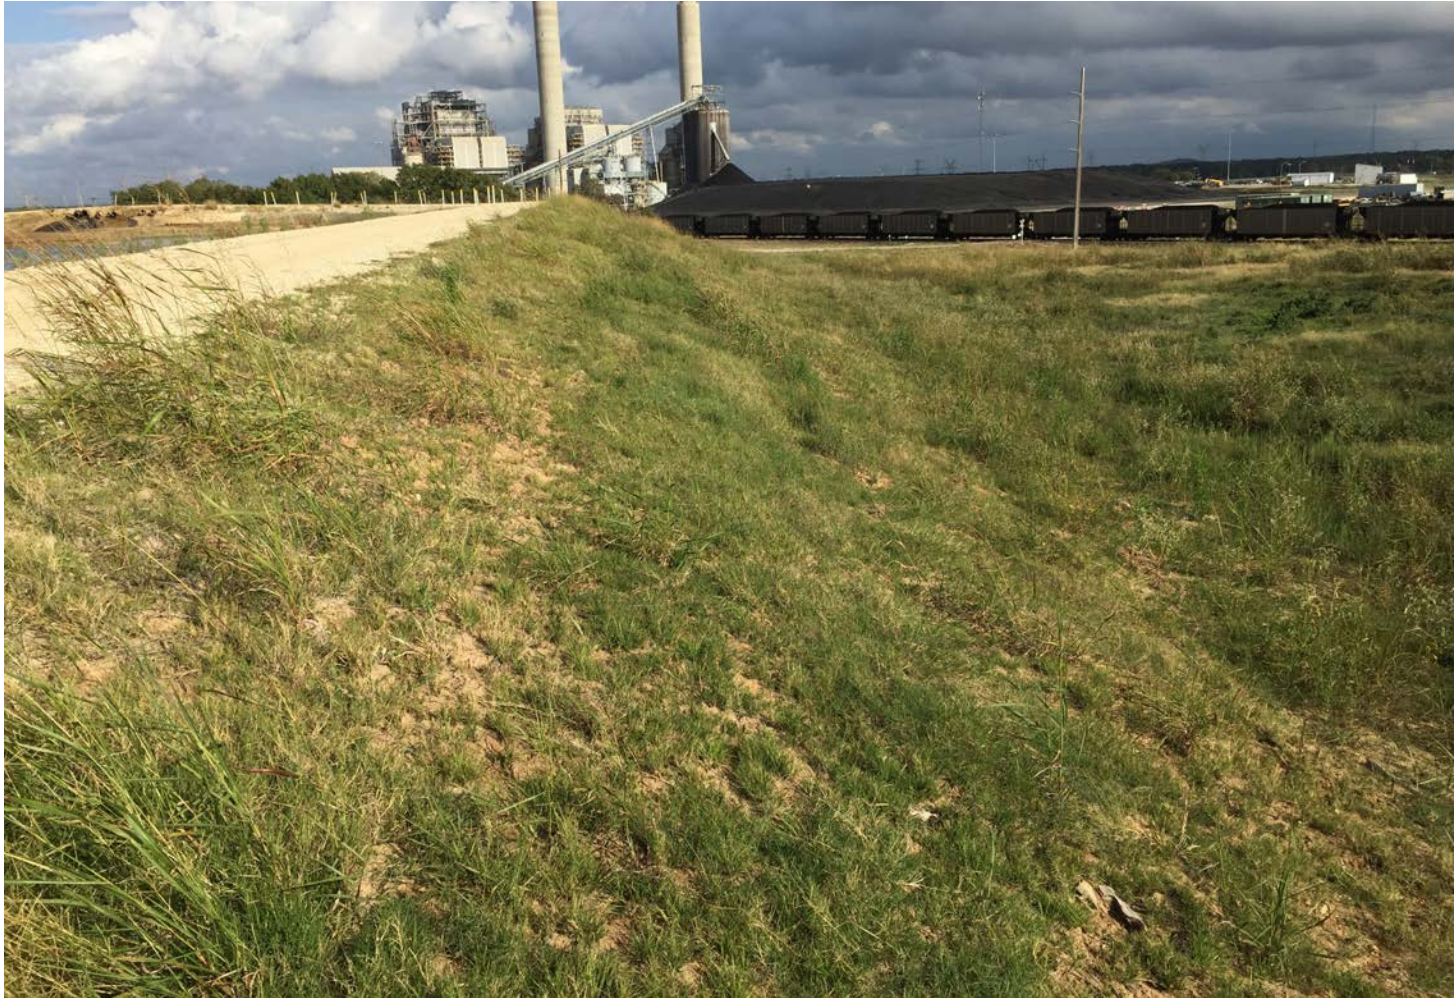
PROJECT NO. 1782004		FILE REF. Nov 2017 download 207.JPG	
	DESIGN	VK	11/09/2017	SCALE: NTS
	CHECK	VK	11/09/2017	REV: 0
	REVIEW	JBF	11/09/2017	PHOTO 60

PHOTO DESCRIPTION:
 Western portion of southern
 downstream slope. Poor grass
 cover.

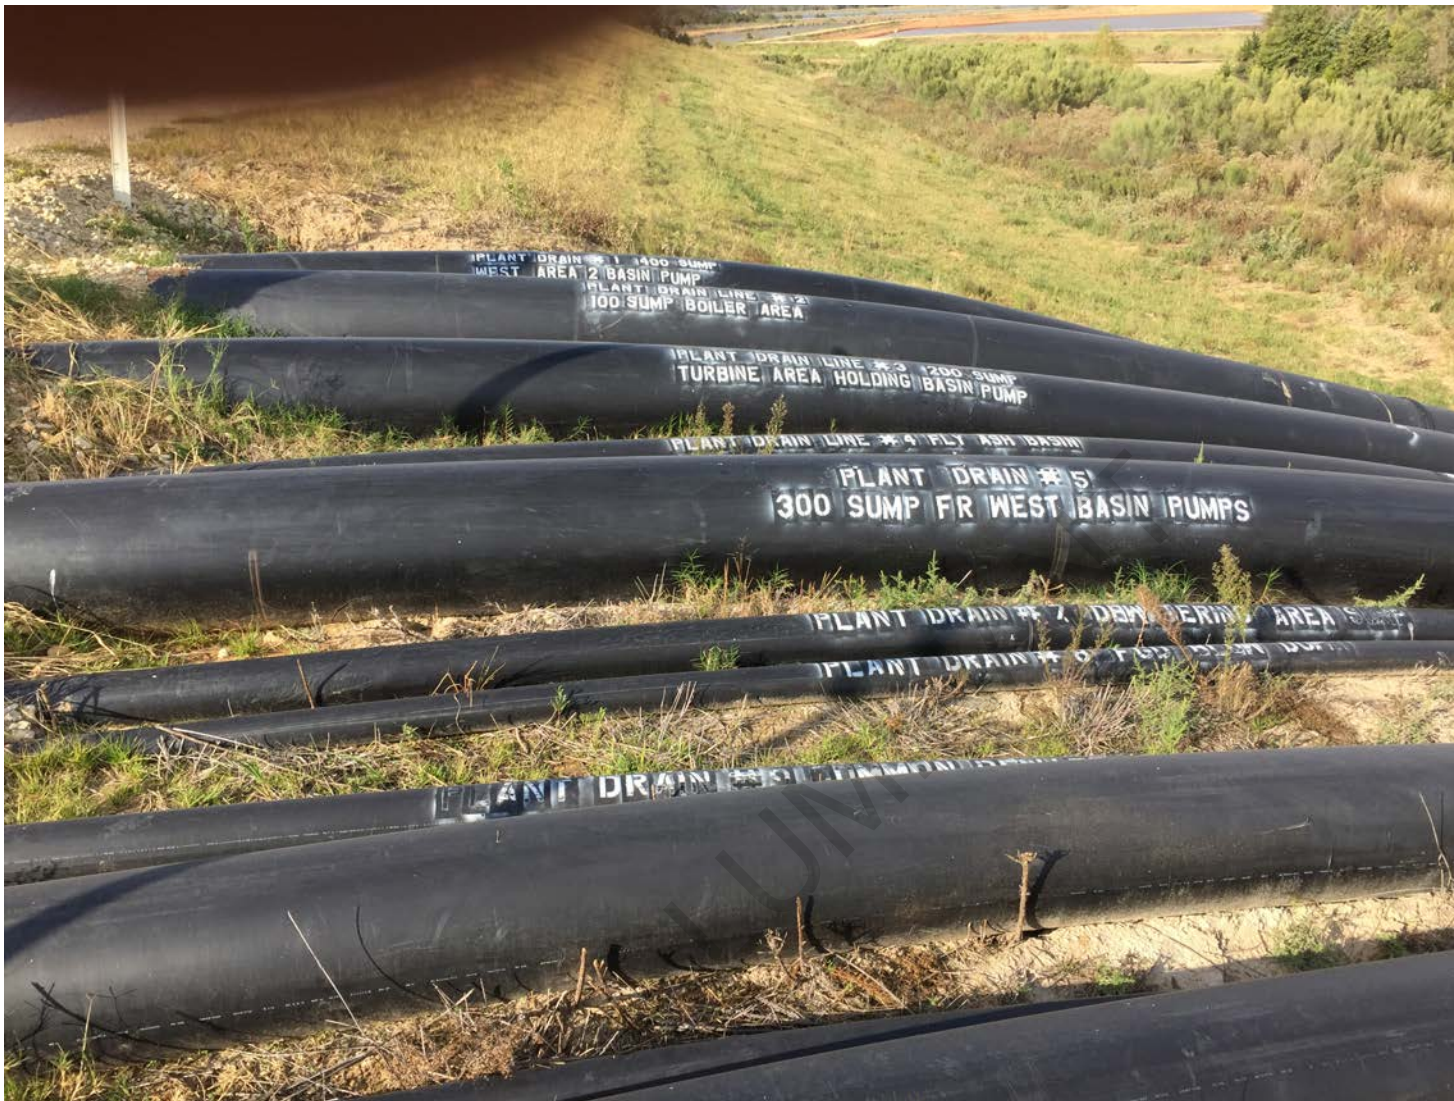
PROJECT NO. 1782004		FILE REF. Nov 2017 download 209.JPG	
	DESIGN	VK	11/09/2017	SCALE: NTS
	CHECK	VK	11/09/2017	REV: 0
	REVIEW	JBF	11/09/2017	PHOTO 61

PHOTO DESCRIPTION:
 Southern portion of eastern downstream slope. Inlet pipes.

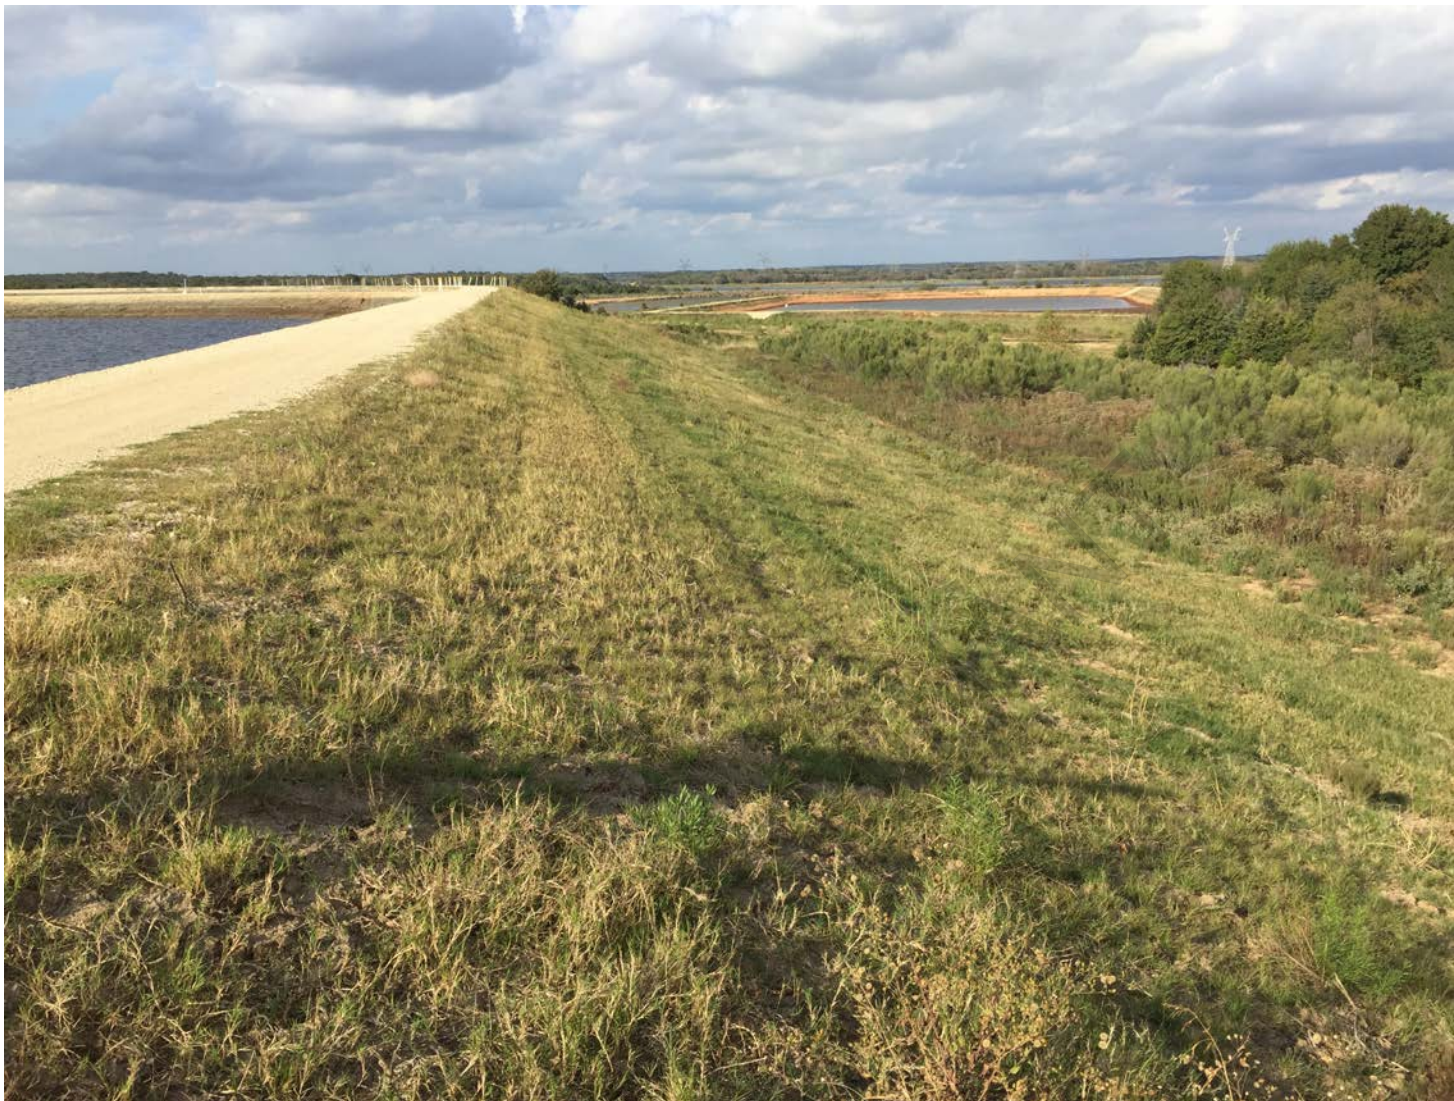
PROJECT NO. 1782004		FILE REF. Nov 2017 download 212.JPG	
	DESIGN	VK	11/09/2017	SCALE: NTS
	CHECK	VK	11/09/2017	REV: 0
	REVIEW	JBF	11/09/2017	PHOTO 62

PHOTO DESCRIPTION:
 Eastern downstream slope.

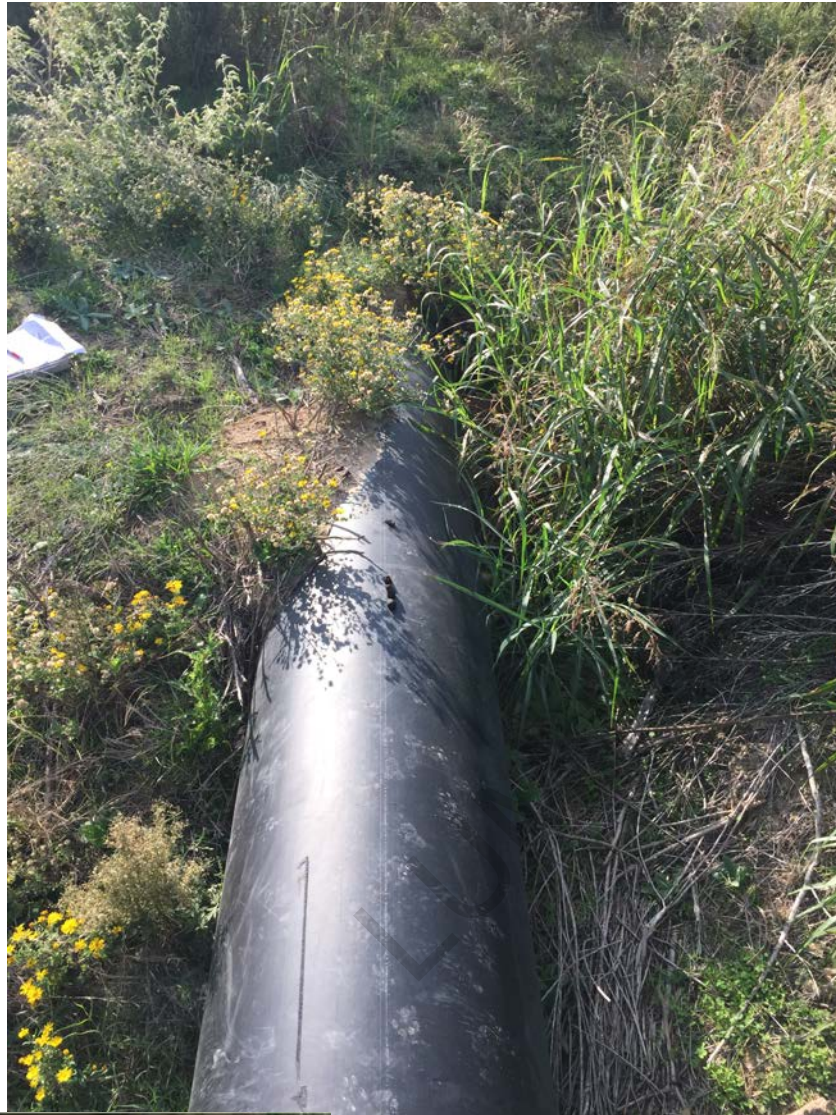
PROJECT NO. 1782004		FILE REF. Nov 2017 download 213.JPG	
	DESIGN	VK	11/09/2017	SCALE: NTS
	CHECK	VK	11/09/2017	REV: 0
	REVIEW	JBF	11/09/2017	PHOTO 63

PHOTO DESCRIPTION:
 Outlet pipe.

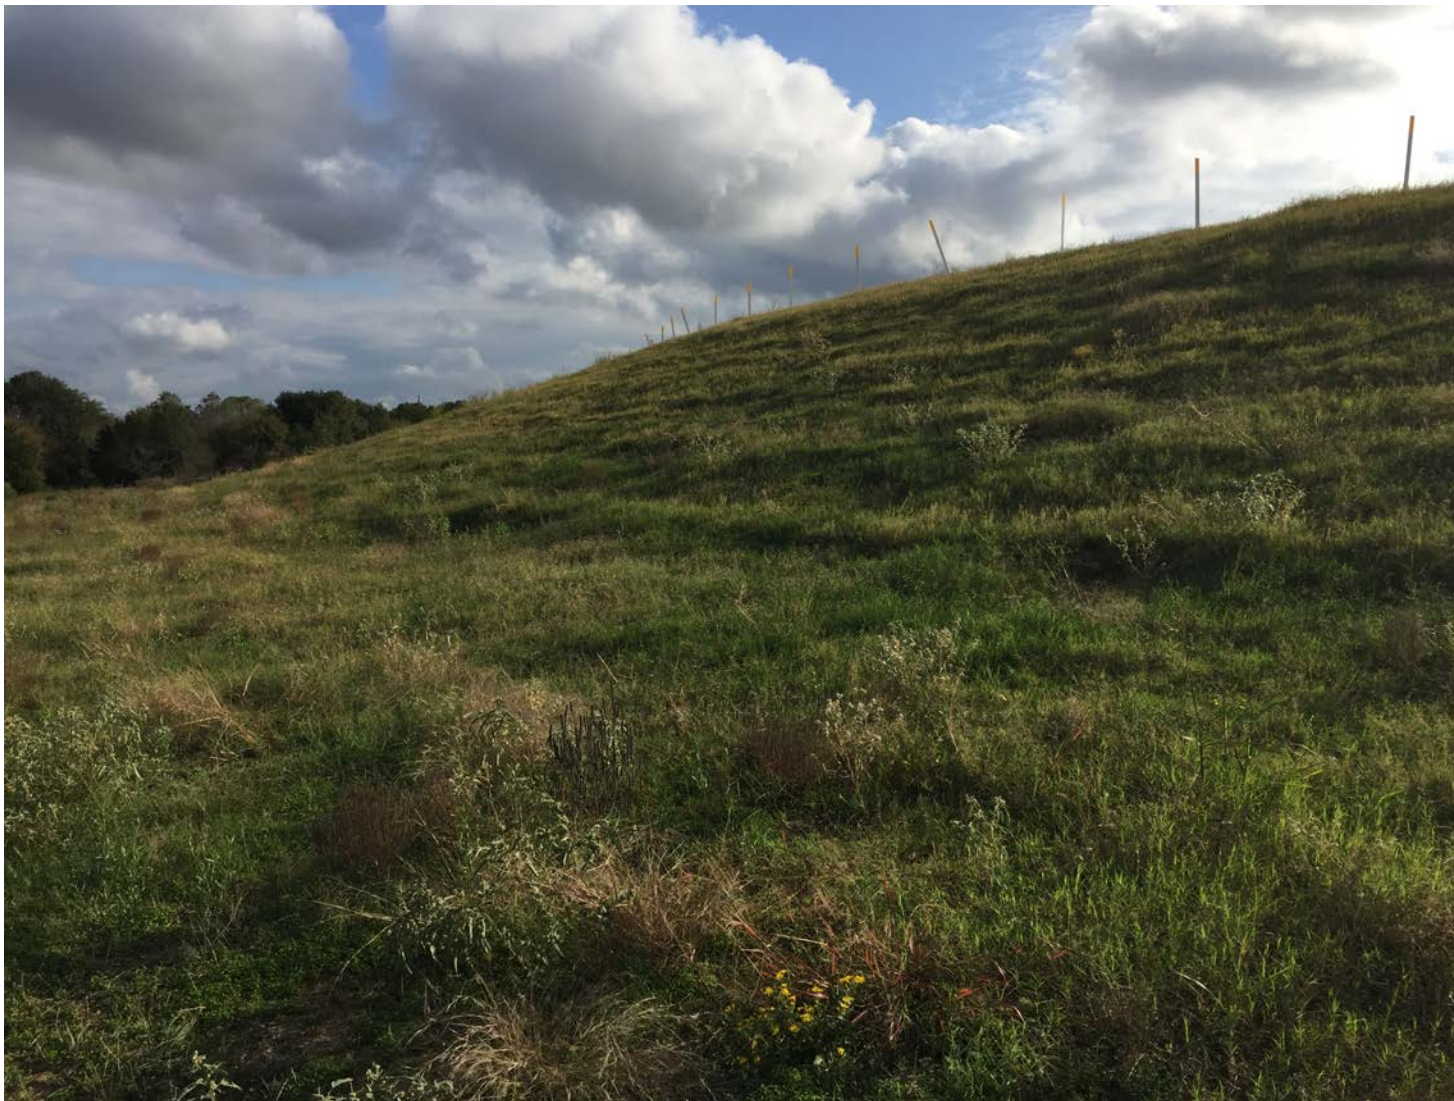
PROJECT NO. 1782004		FILE REF. Nov 2017 download 214.JPG	
	DESIGN	VK	11/09/2017	SCALE: NTS
	CHECK	VK	11/09/2017	REV: 0
	REVIEW	JB	11/09/2017	PHOTO 64

PHOTO DESCRIPTION:
 Northeastern downstream slope
 – looking S.
