ANNUAL INSPECTION OF CCR UNITS

**Oak Grove Steam Electric Station
Robertson County, Texas**

January 2018

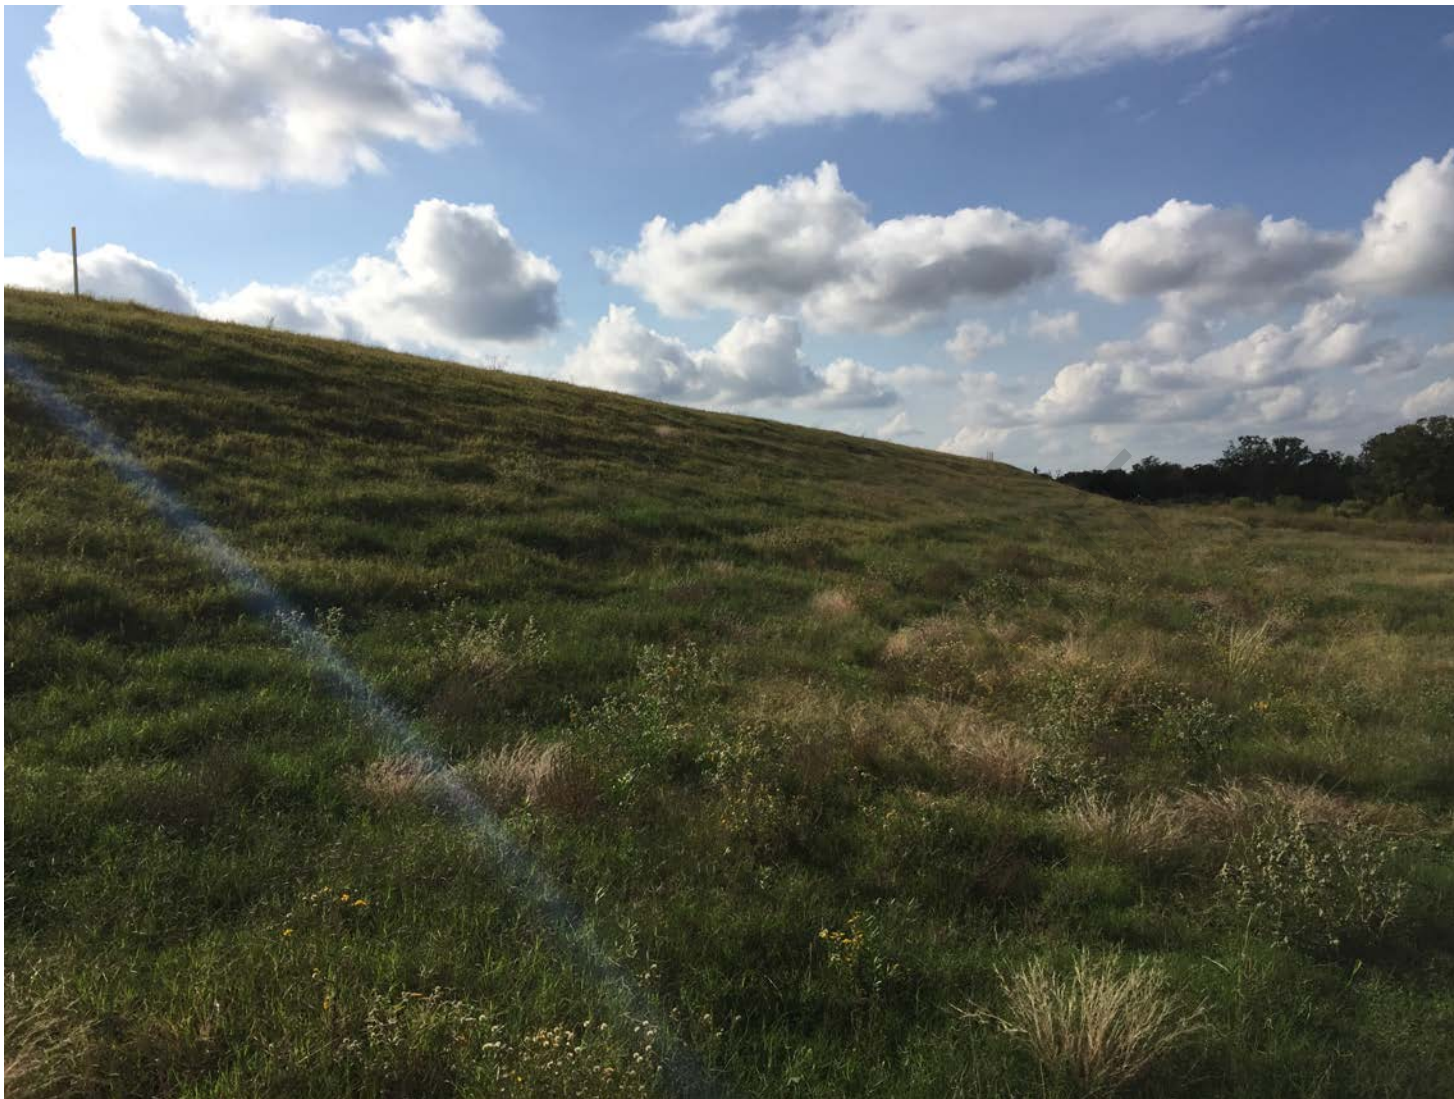
PROJECT NO. 1782004		FILE REF. Nov 2017 download 217.JPG	
	DESIGN	VK	11/09/2017	SCALE: NTS
	CHECK	VK	11/09/2017	REV: 0
	REVIEW	JBF	11/09/2017	PHOTO 65

PHOTO DESCRIPTION:
 Northeastern downstream slope
 – looking N.

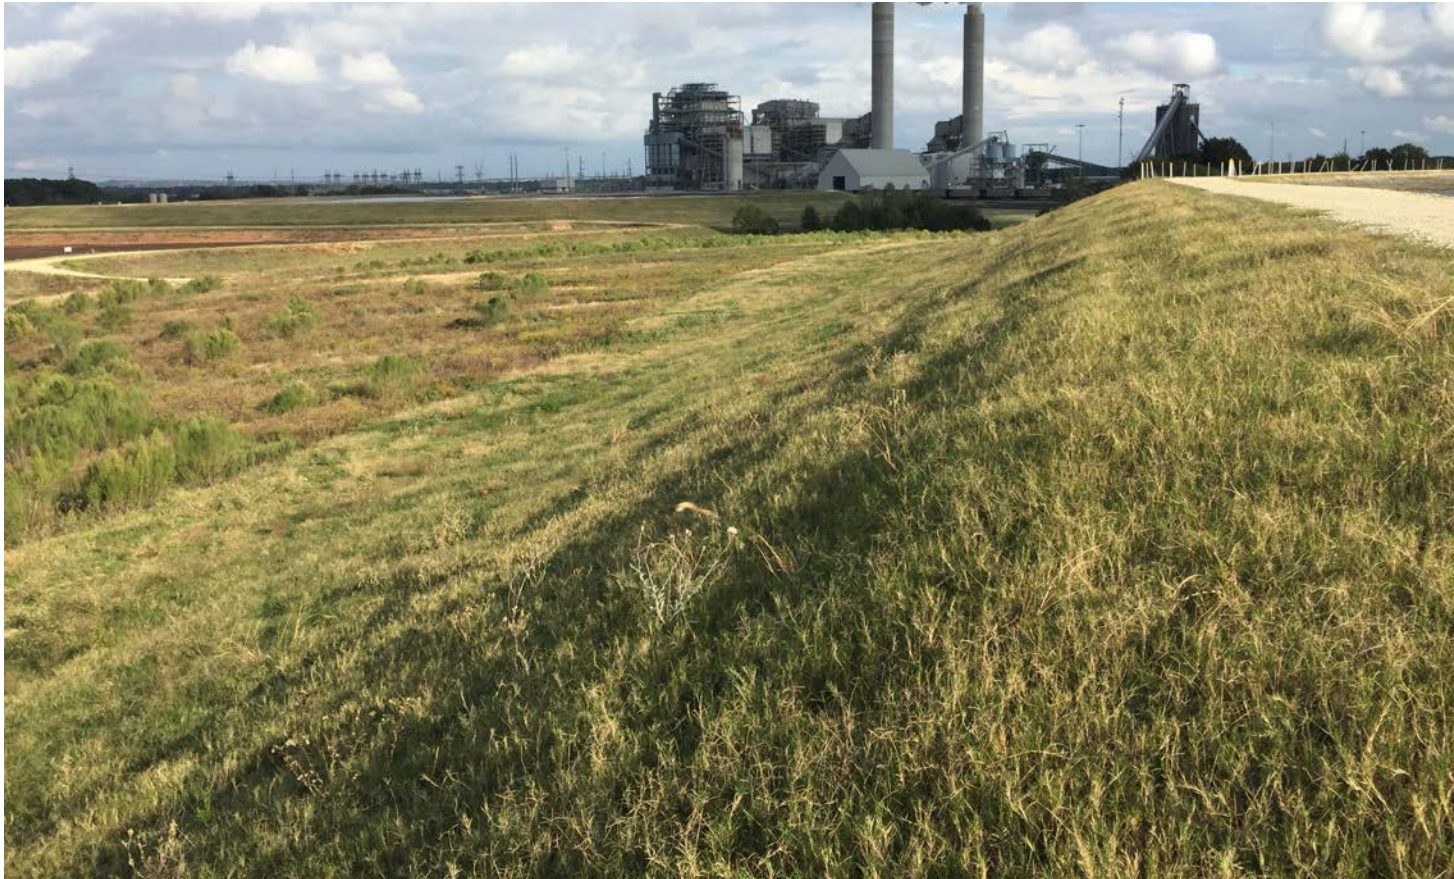
PROJECT NO. 1782004		FILE REF. Nov 2017 download 218.JPG	
	DESIGN	VK	11/09/2017	SCALE: NTS
	CHECK	VK	11/09/2017	REV: 0
	REVIEW	JBF	11/09/2017	PHOTO 66

PHOTO DESCRIPTION:
 Northeastern downstream slope
 – looking SE.

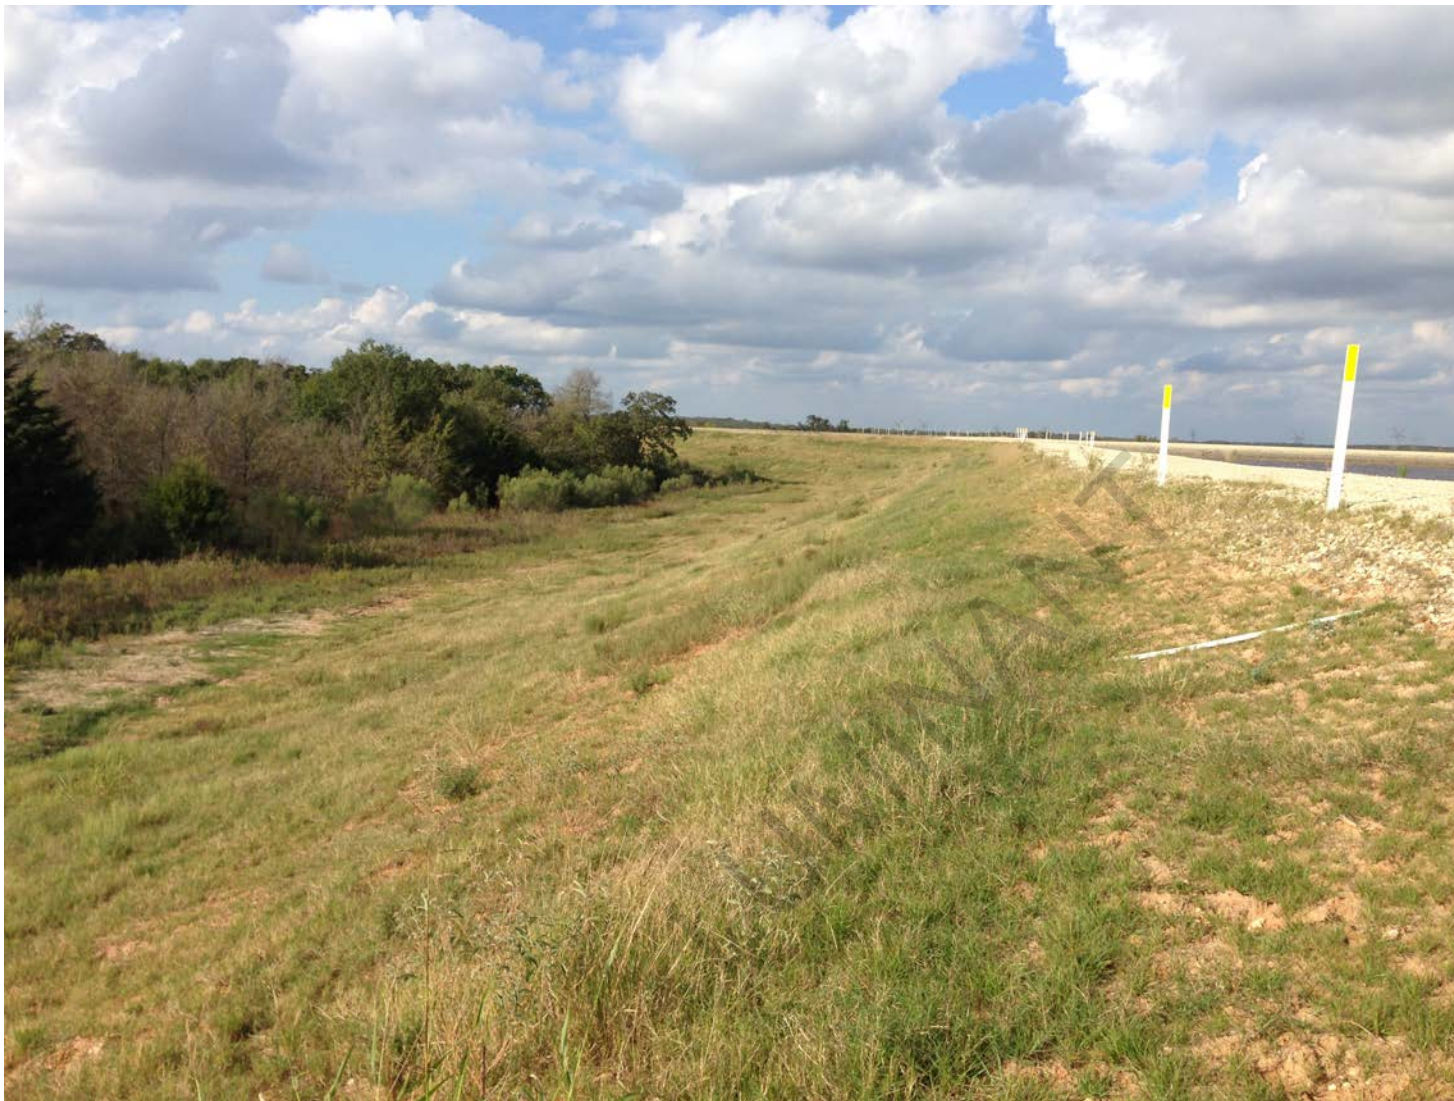
PROJECT NO. 1782004		FILE REF. Nov 2017 download 219.JPG	
	DESIGN	VK	11/09/2017	SCALE: NTS
	CHECK	VK	11/09/2017	REV: 0
	REVIEW	JBF	11/09/2017	PHOTO 67

PHOTO DESCRIPTION:
 Southern portion of western
 downstream slope – looking N.

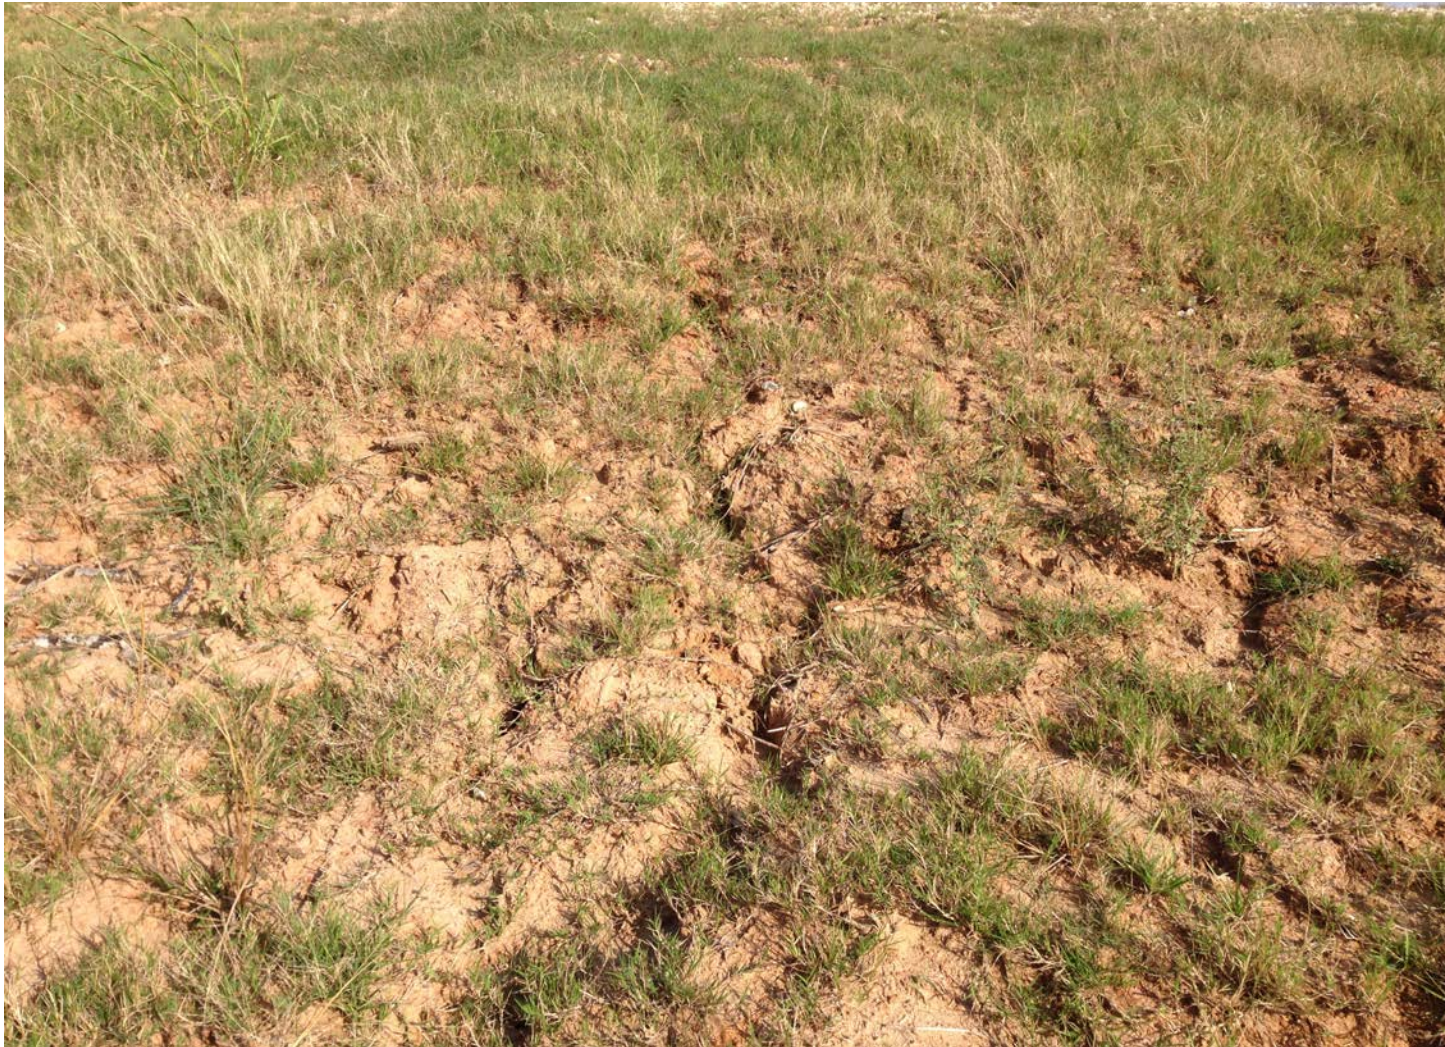
PROJECT NO. 1782004		FILE REF. Nov 2017 download 300.JPG	
	DESIGN	VK	11/09/2017	SCALE: NTS
	CHECK	VK	11/09/2017	REV: 0
	REVIEW	JBF	11/09/2017	PHOTO 68

PHOTO DESCRIPTION:
 Western downstream slope.
 Erosion rills.

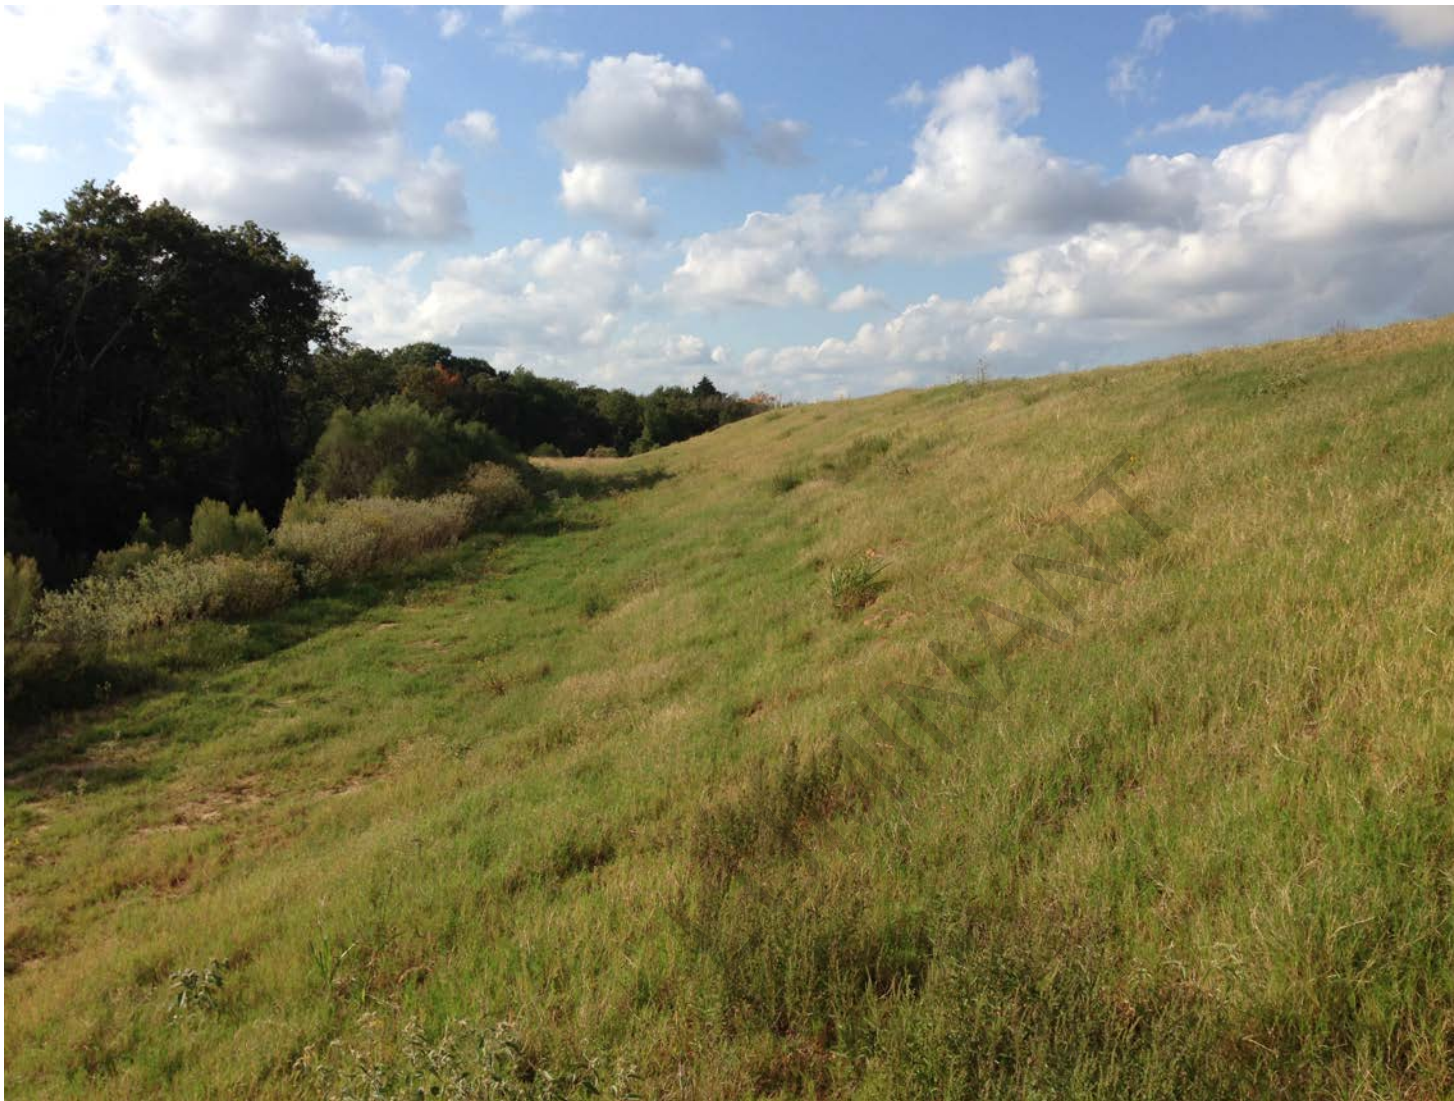
PROJECT NO. 1782004		FILE REF. Nov 2017 download 301.JPG	
	DESIGN	VK	11/09/2017	SCALE: NTS
	CHECK	VK	11/09/2017	REV: 0
	REVIEW	JBF	11/09/2017	PHOTO 69

PHOTO DESCRIPTION:
 Northern portion of western
 downstream slope.

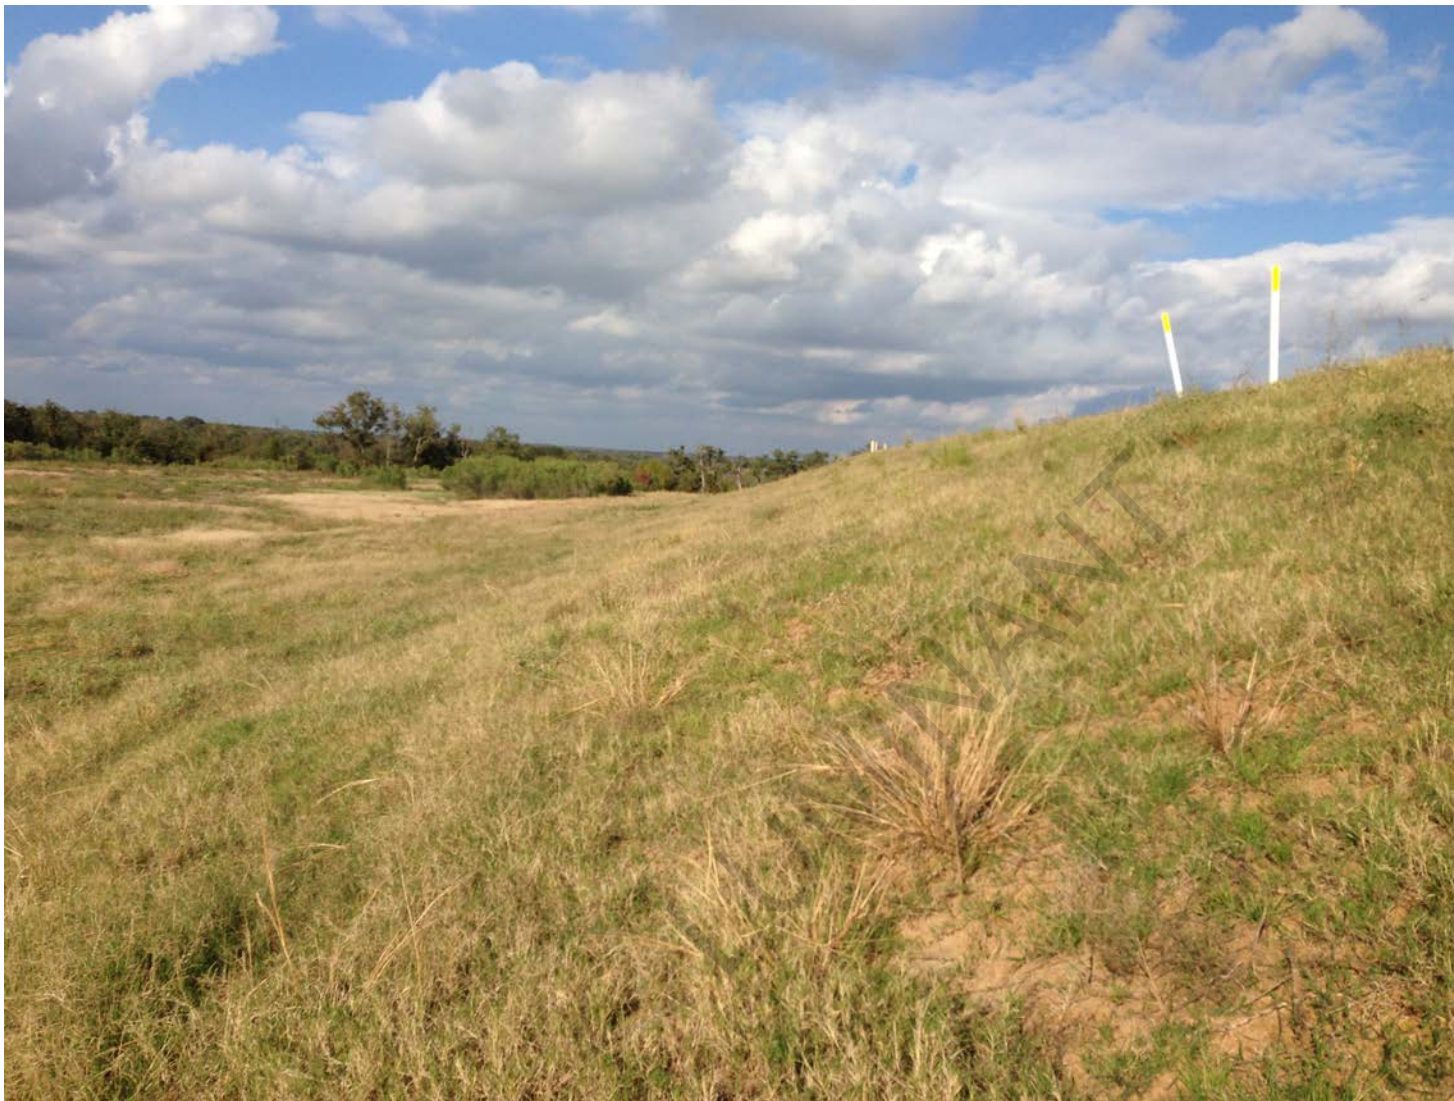
PROJECT NO. 1782004		FILE REF. Nov 2017 download 302.JPG	
	DESIGN	VK	11/09/2017	SCALE: NTS
	CHECK	VK	11/09/2017	REV: 0
	REVIEW	JBF	11/09/2017	PHOTO 70

PHOTO DESCRIPTION:
 Northwestern downstream
 slope.

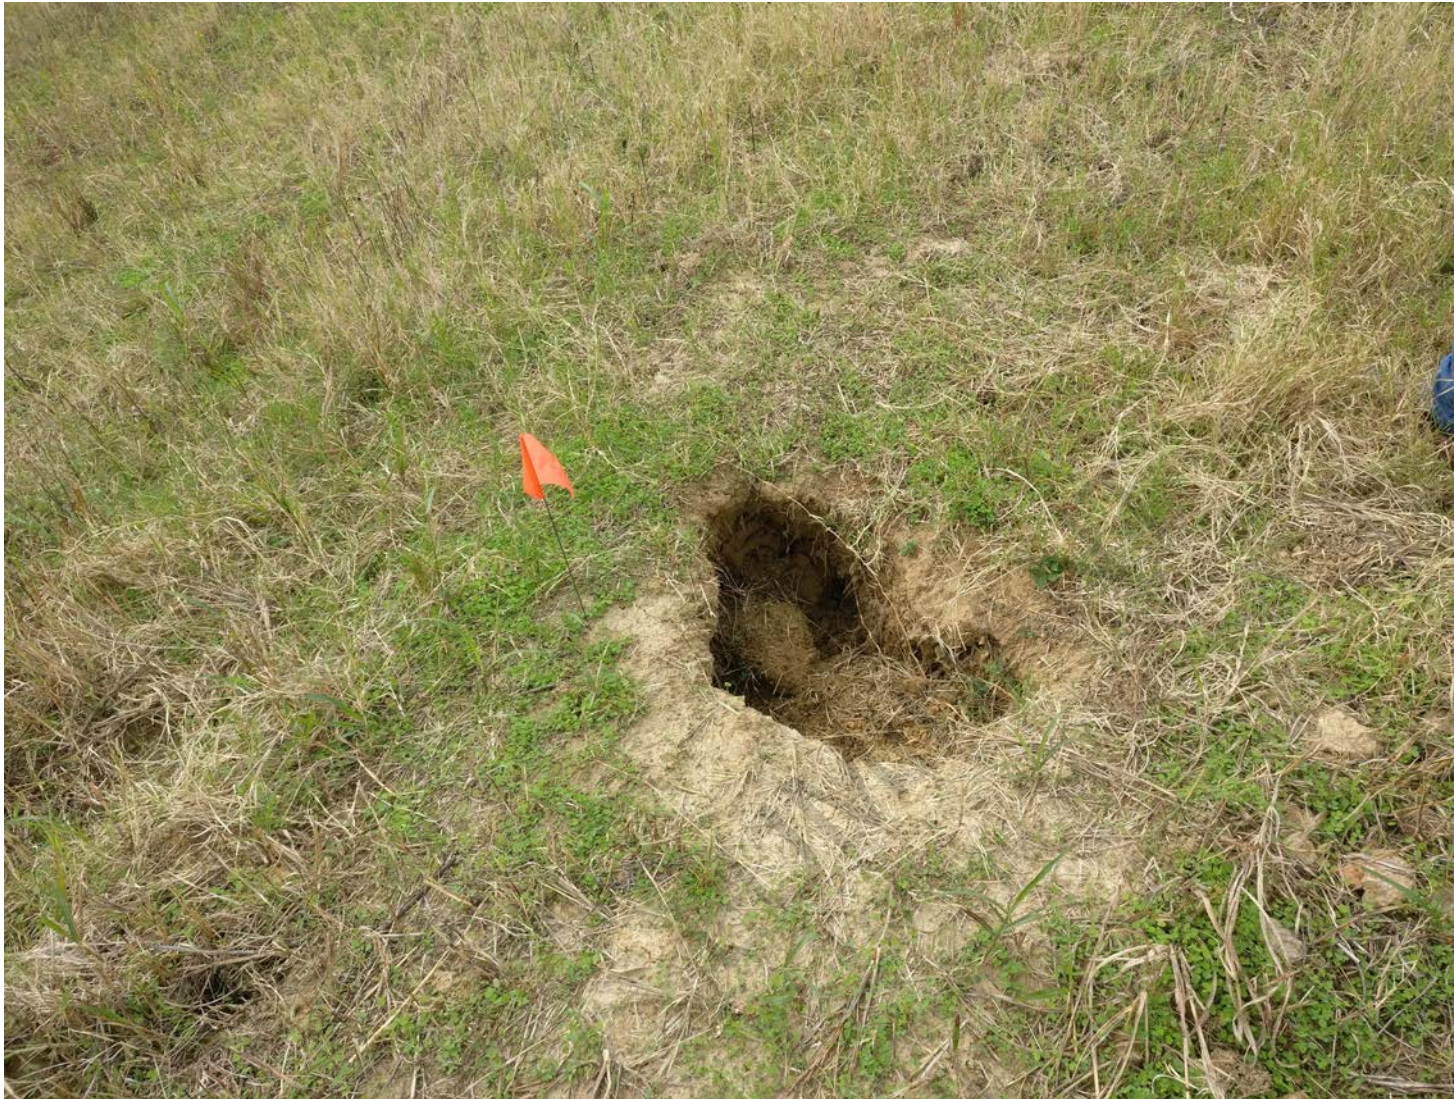
PROJECT NO. 1782004		FILE REF. IMG_20171116_104836.jpg	
	DESIGN	VK	11/09/2017	SCALE: NTS
	CHECK	VK	11/09/2017	REV: 0
	REVIEW	JBF	11/09/2017	PHOTO 1

PHOTO DESCRIPTION:
 Animal burrow on southern
 slope of Cell 2.

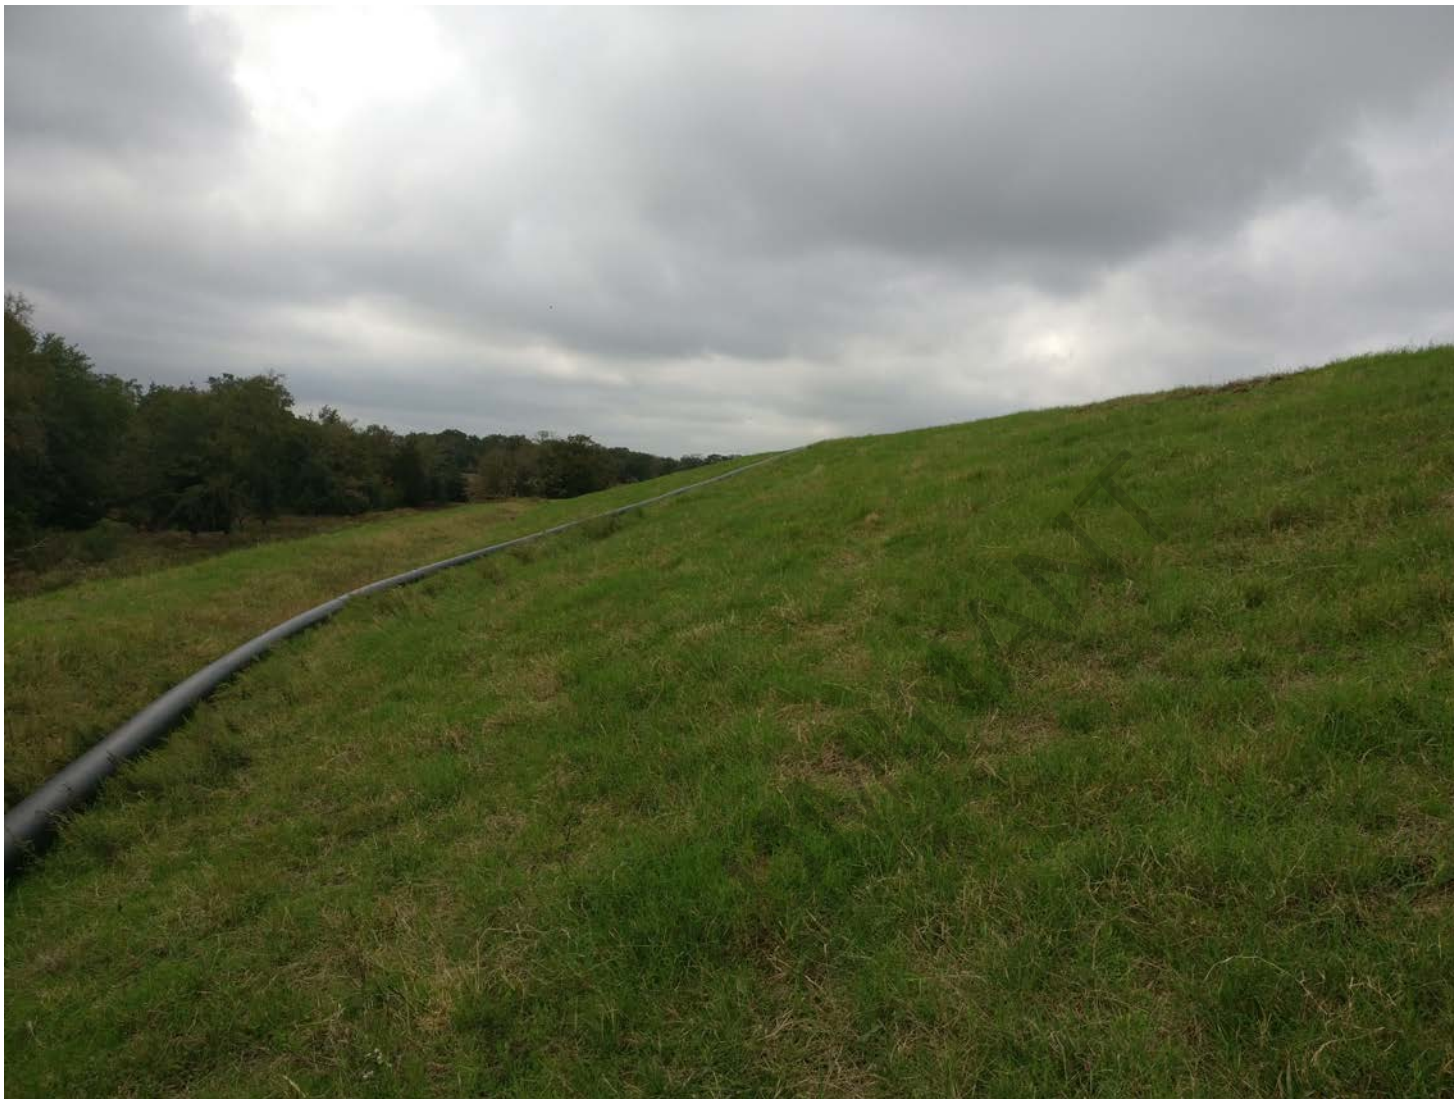
PROJECT NO. 1782004		FILE REF. IMG_20171116_105224.jpg	
	DESIGN	VK	11/09/2017	SCALE: NTS
	CHECK	VK	11/09/2017	REV: 0
	REVIEW	JBF	11/09/2017	PHOTO 2

PHOTO DESCRIPTION:
 Cell 3 south slope (eastern
 half).

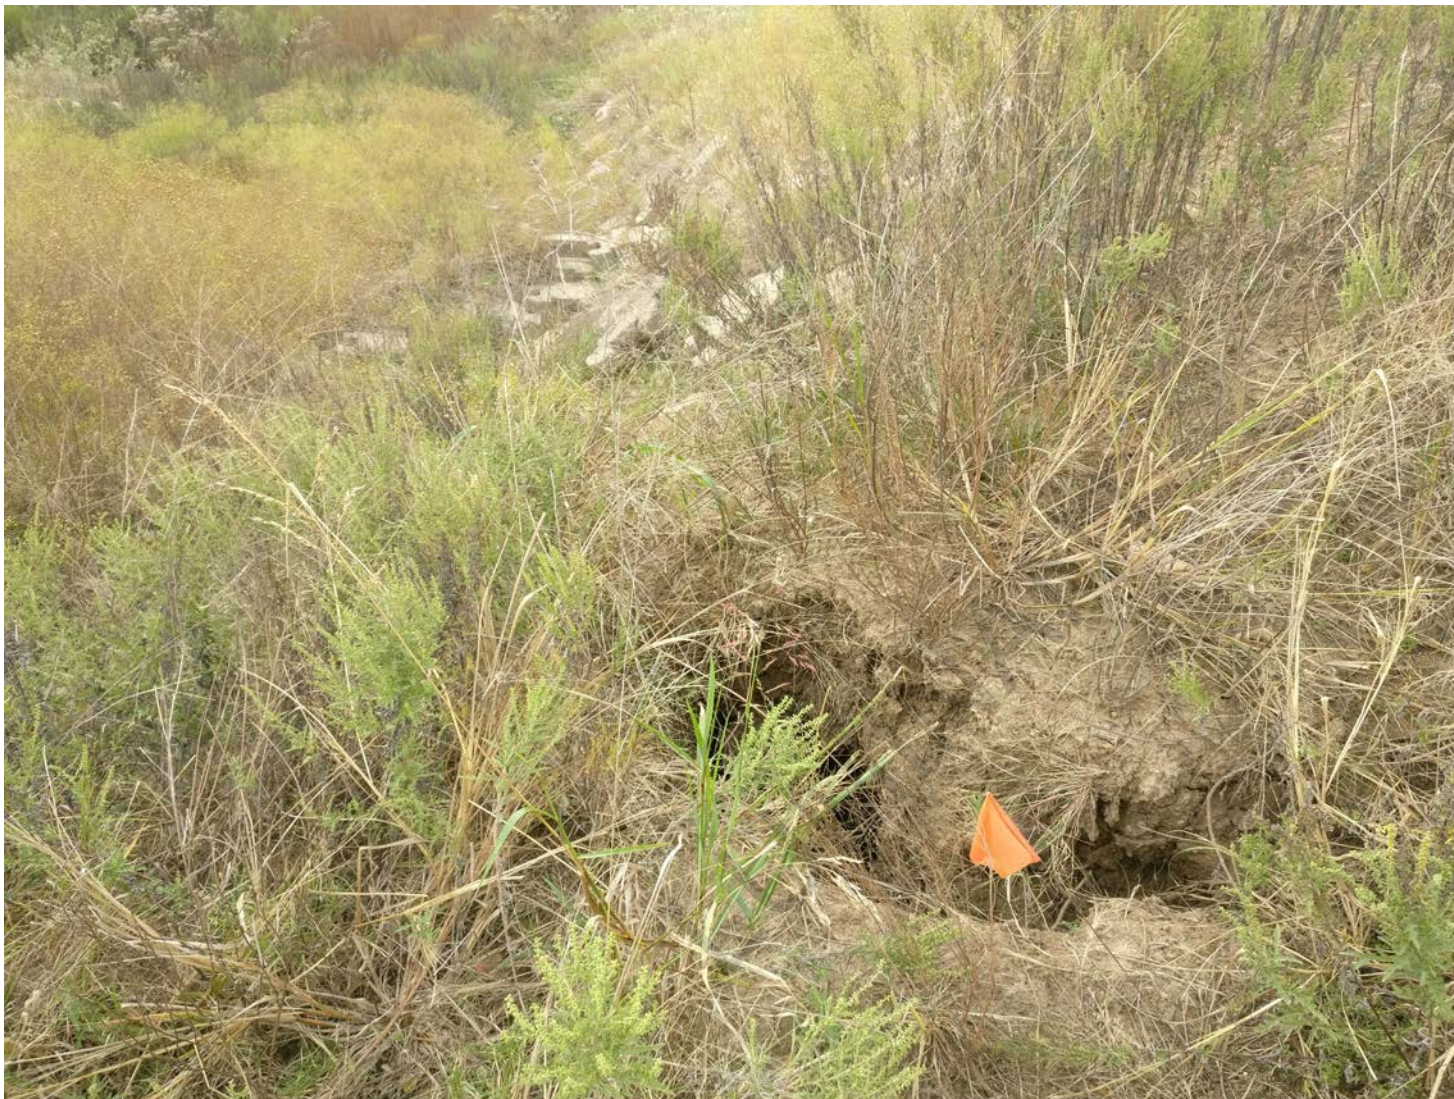
PROJECT NO. 1782004		FILE REF. IMG_20171116_105809.jpg	
	DESIGN	VK	11/09/2017	SCALE: NTS
	CHECK	VK	11/09/2017	REV: 0
	REVIEW	JBF	11/09/2017	PHOTO 3

PHOTO DESCRIPTION:
 Seepage below concrete block
 downchute of southern Cell 3
 slope perimeter.

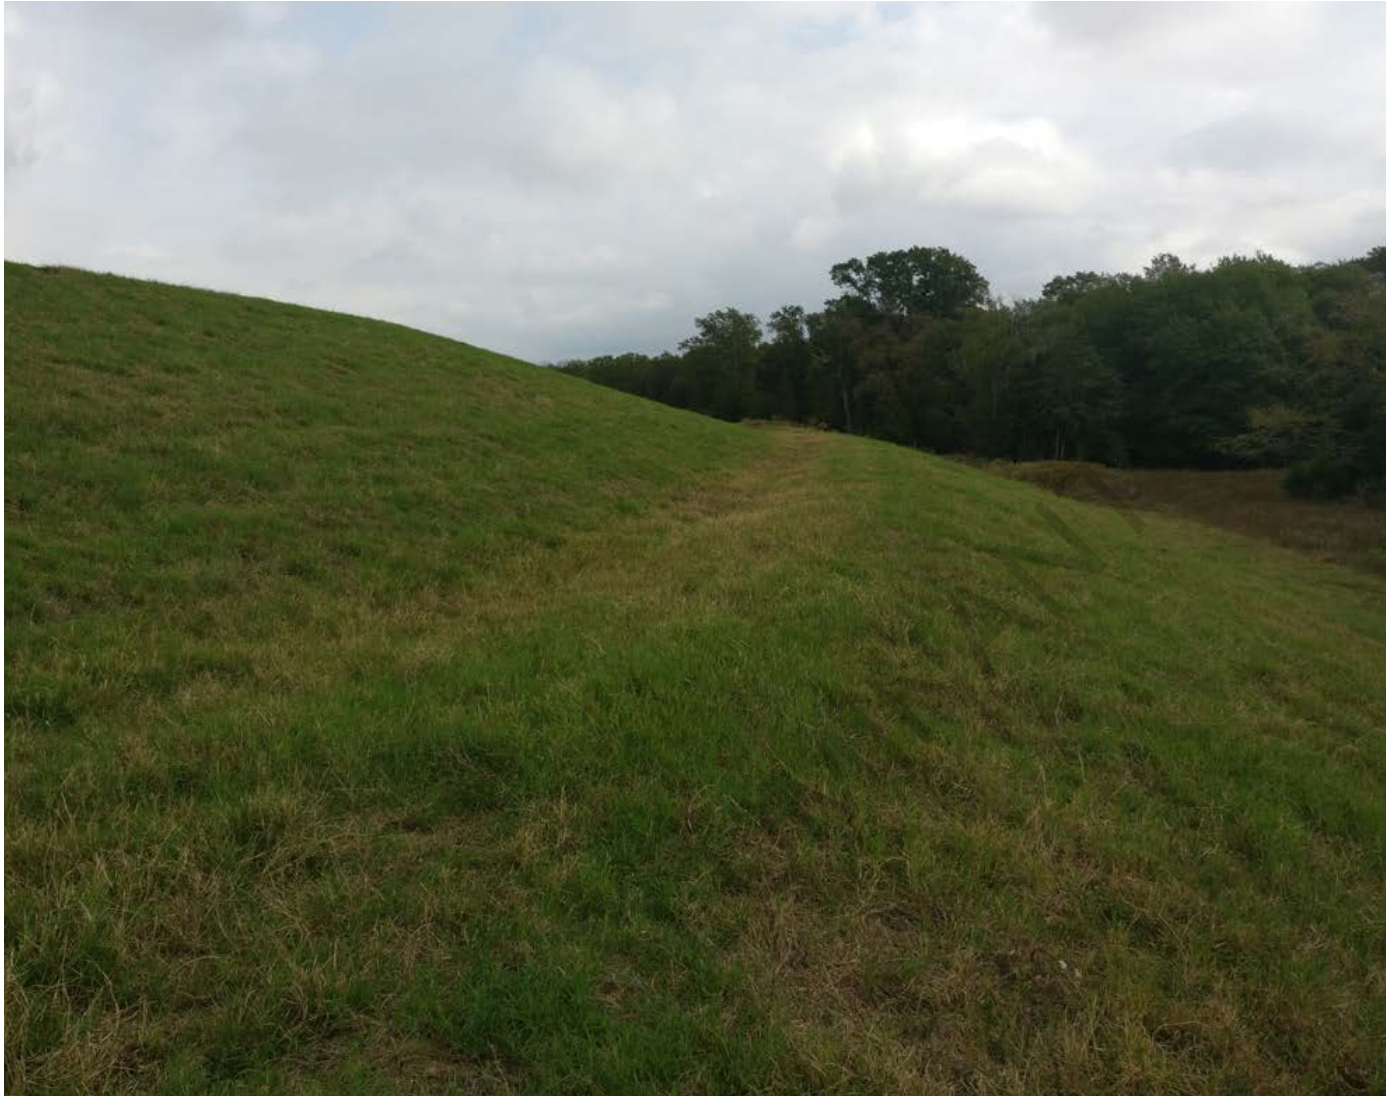
PHOTO DESCRIPTION:
Cell 3 south slope (western
half).

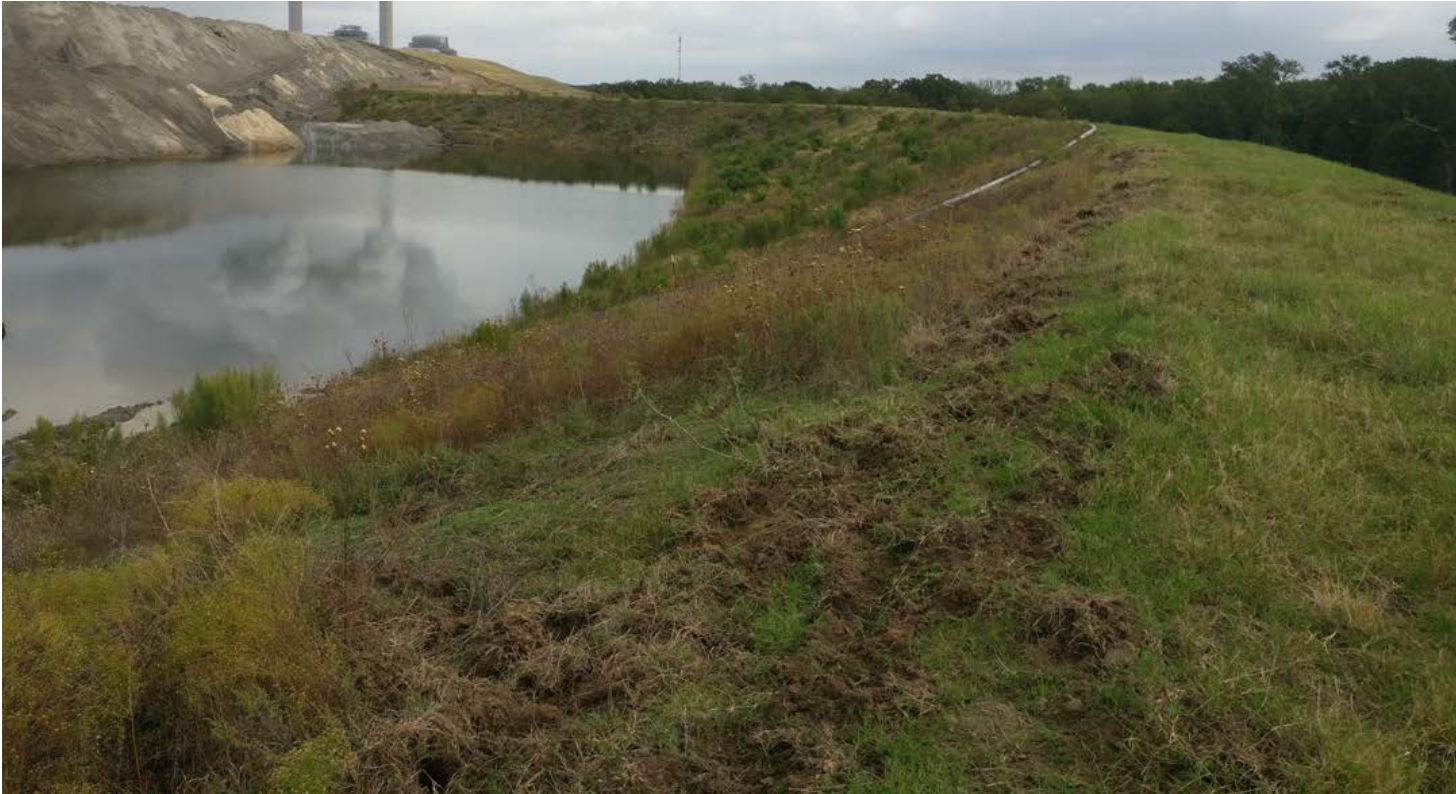
PROJECT NO. 1782004		FILE REF. IMG_20171116_110615.jpg	
	DESIGN	VK	11/09/2017	SCALE: NTS
	CHECK	VK	11/09/2017	REV: 0
	REVIEW	JBF	11/09/2017	PHOTO 5

PHOTO DESCRIPTION:
 Internal slope of Cell 3 with
 vegetation.

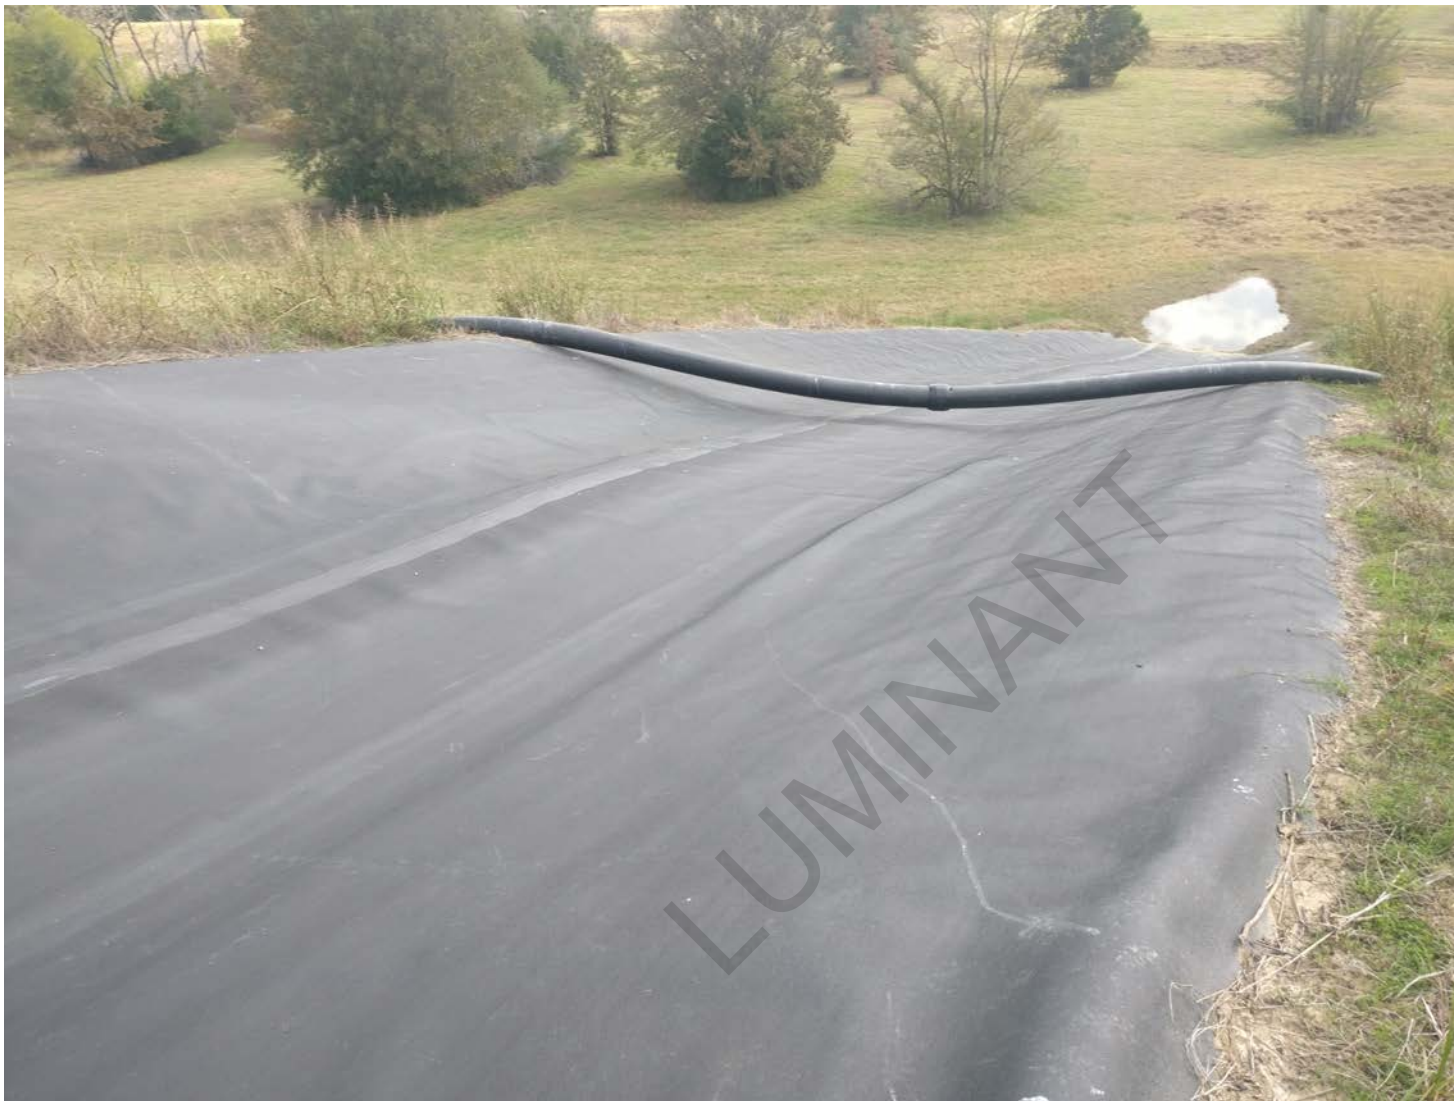
PROJECT NO. 1782004		FILE REF. IMG_20171116_110754.jpg	
	DESIGN	VK	11/09/2017	SCALE: NTS
	CHECK	VK	11/09/2017	REV: 0
	REVIEW	JBF	11/09/2017	PHOTO 6

PHOTO DESCRIPTION:
 HDPE geomembrane-lined
 downchute at west end of Cell
 1 southern slope.

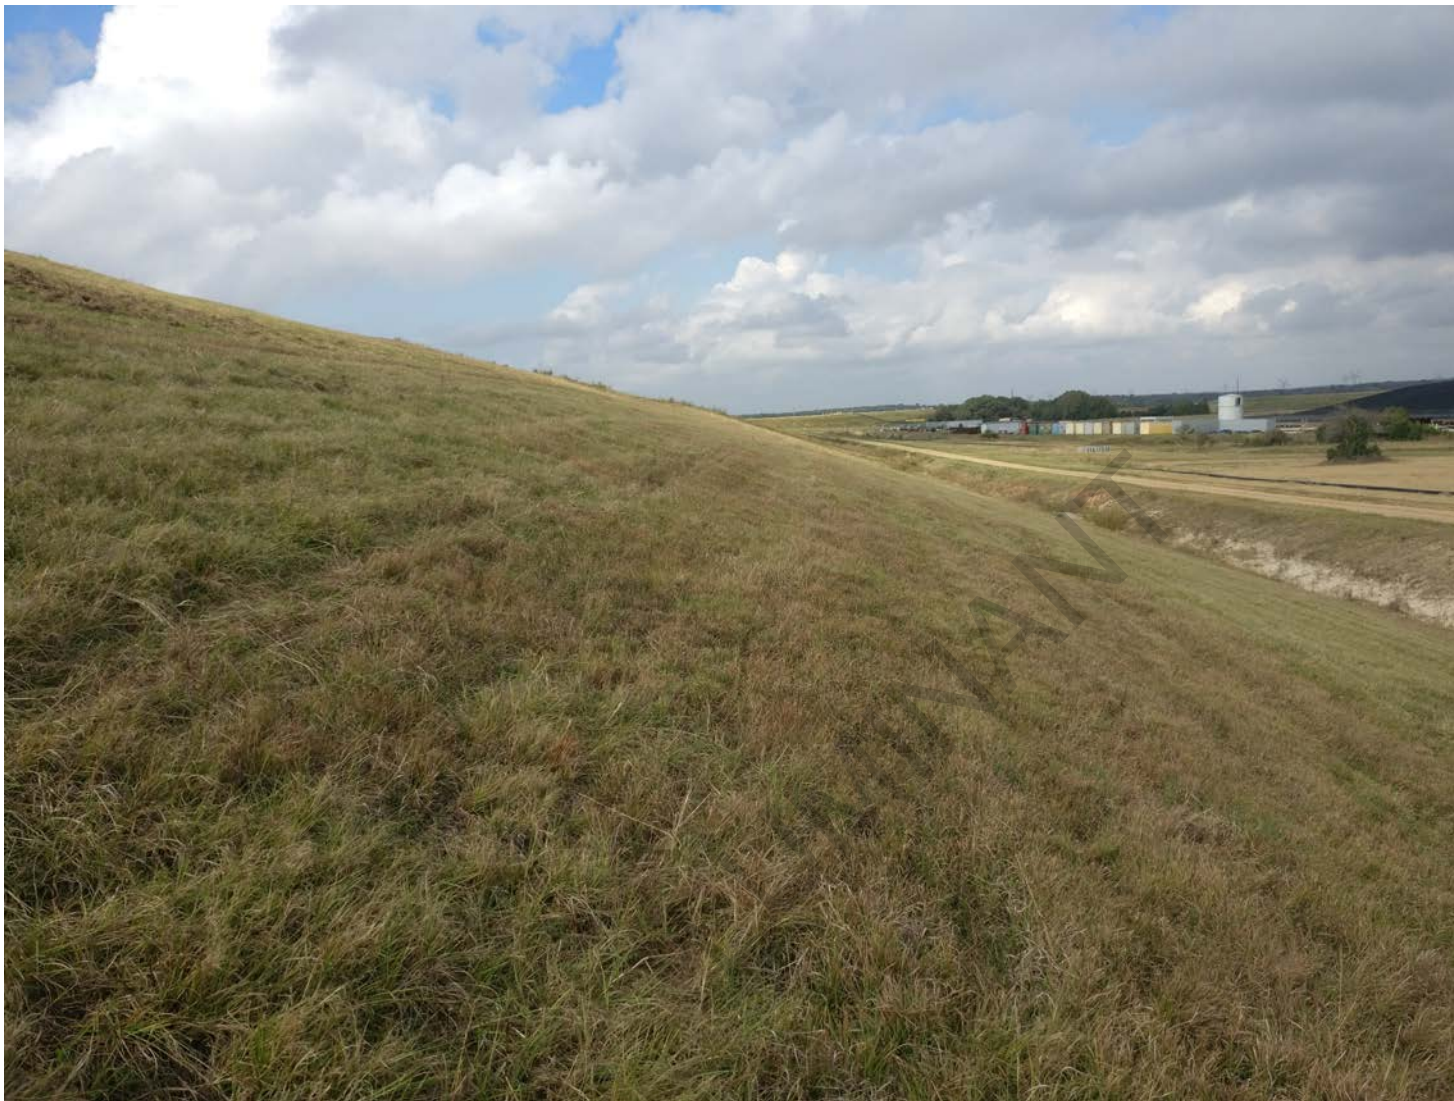
PROJECT NO. 1782004		FILE REF. IMG_20171116_123508.jpg	
	DESIGN	VK	11/09/2017	SCALE: NTS
	CHECK	VK	11/09/2017	REV: 0
	REVIEW	JBF	11/09/2017	PHOTO 8

PHOTO DESCRIPTION:
 Eastern slope of Cell 1 –
 south half.

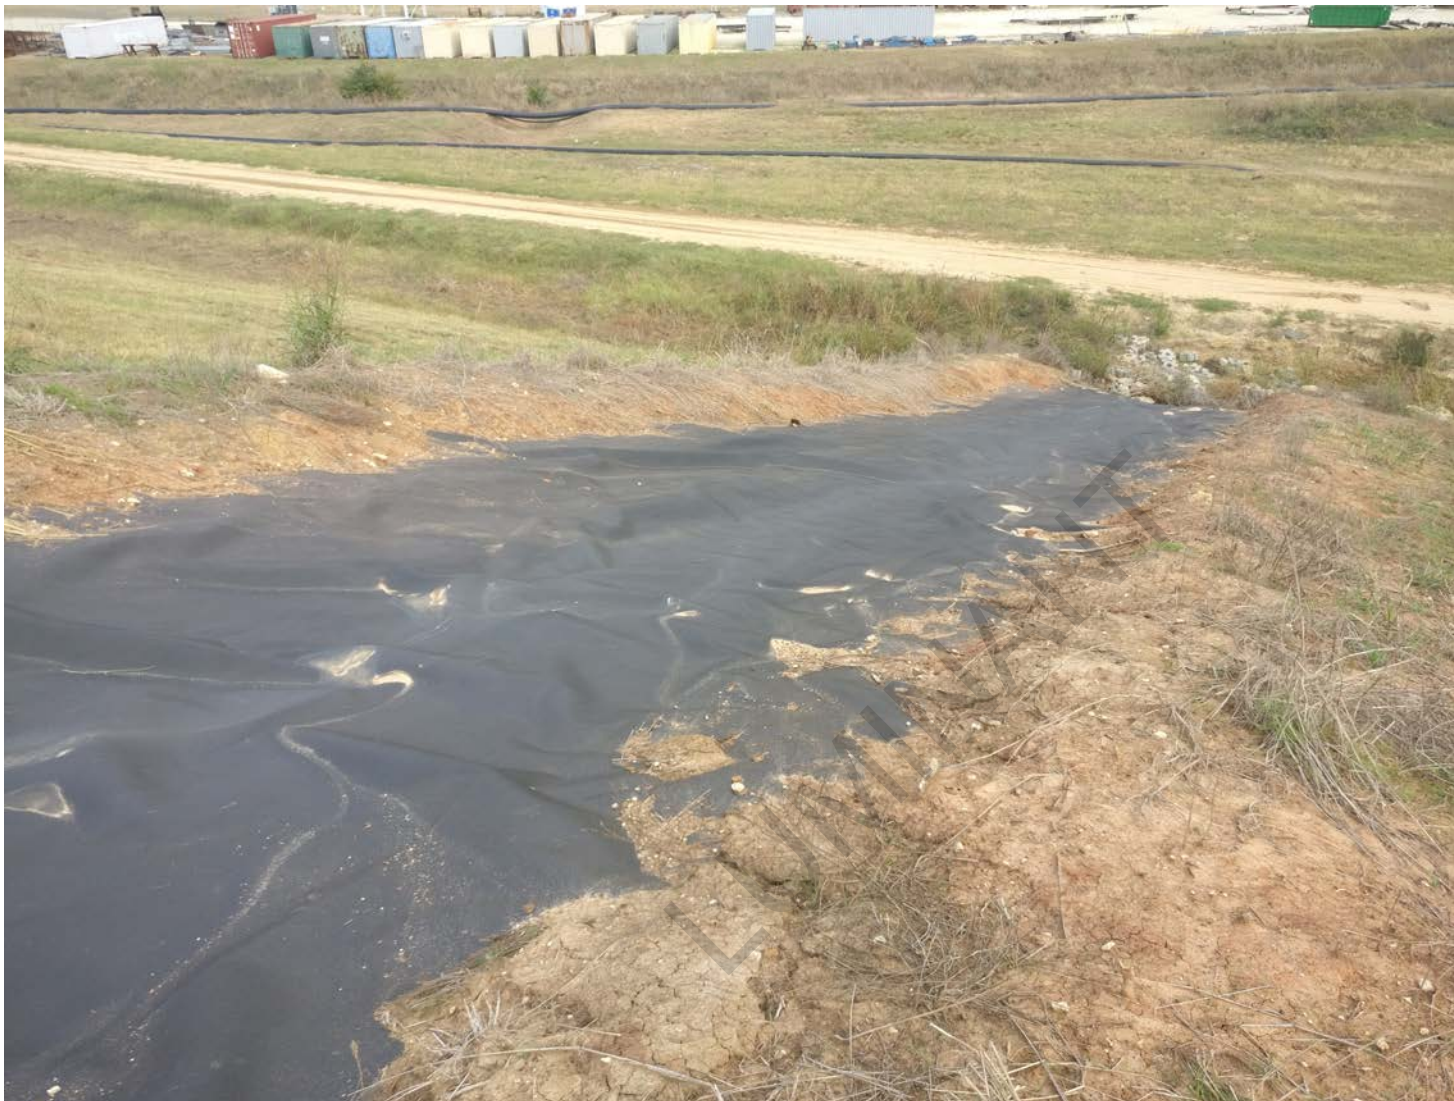
PROJECT NO. 1782004		FILE REF. IMG_20171116_124127.jpg	
	DESIGN	VK	11/09/2017	SCALE: NTS
	CHECK	VK	11/09/2017	REV: 0
	REVIEW	JBF	11/09/2017	PHOTO 9

PHOTO DESCRIPTION:
 HDPE geomembrane-lined
 downchute at Cell 1 eastern
 slope.
