ANNUAL INSPECTION OF CCR UNITS

**Oak Grove Steam Electric Station
Robertson County, Texas**

January 2018

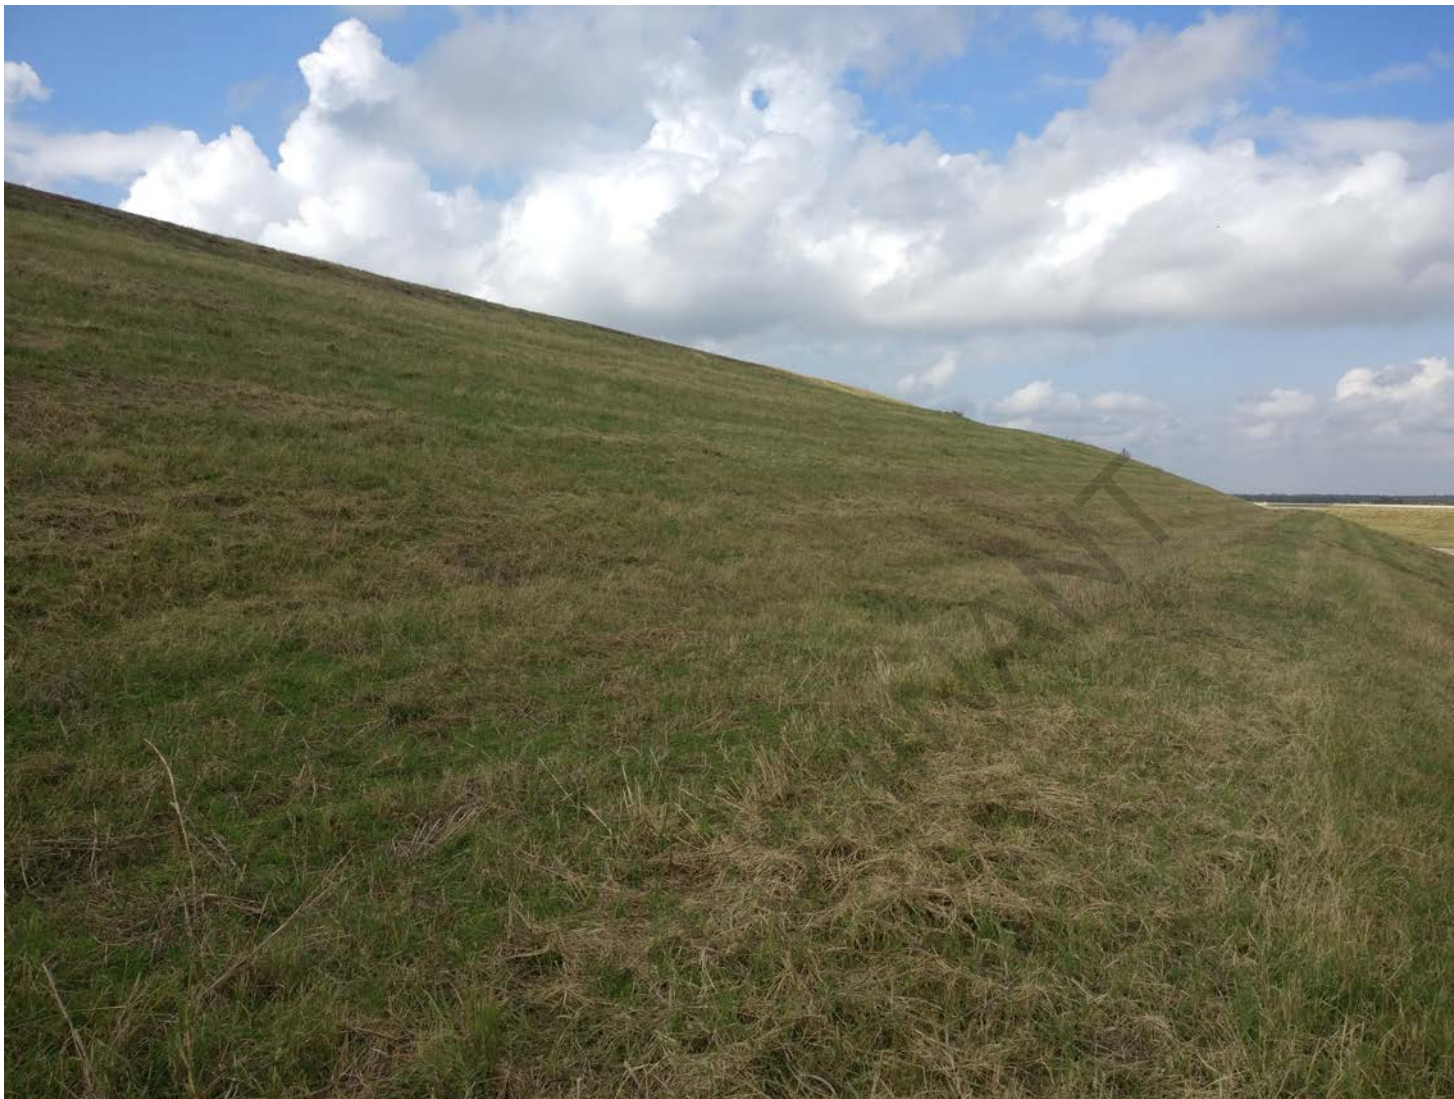
PROJECT NO. 1782004		FILE REF. IMG_20171116_124617.jpg	
	DESIGN	VK	11/09/2017	SCALE: NTS
	CHECK	VK	11/09/2017	REV: 0
	REVIEW	JBF	11/09/2017	PHOTO 10

PHOTO DESCRIPTION:
 Eastern slope of Cell 1 –
 north half.

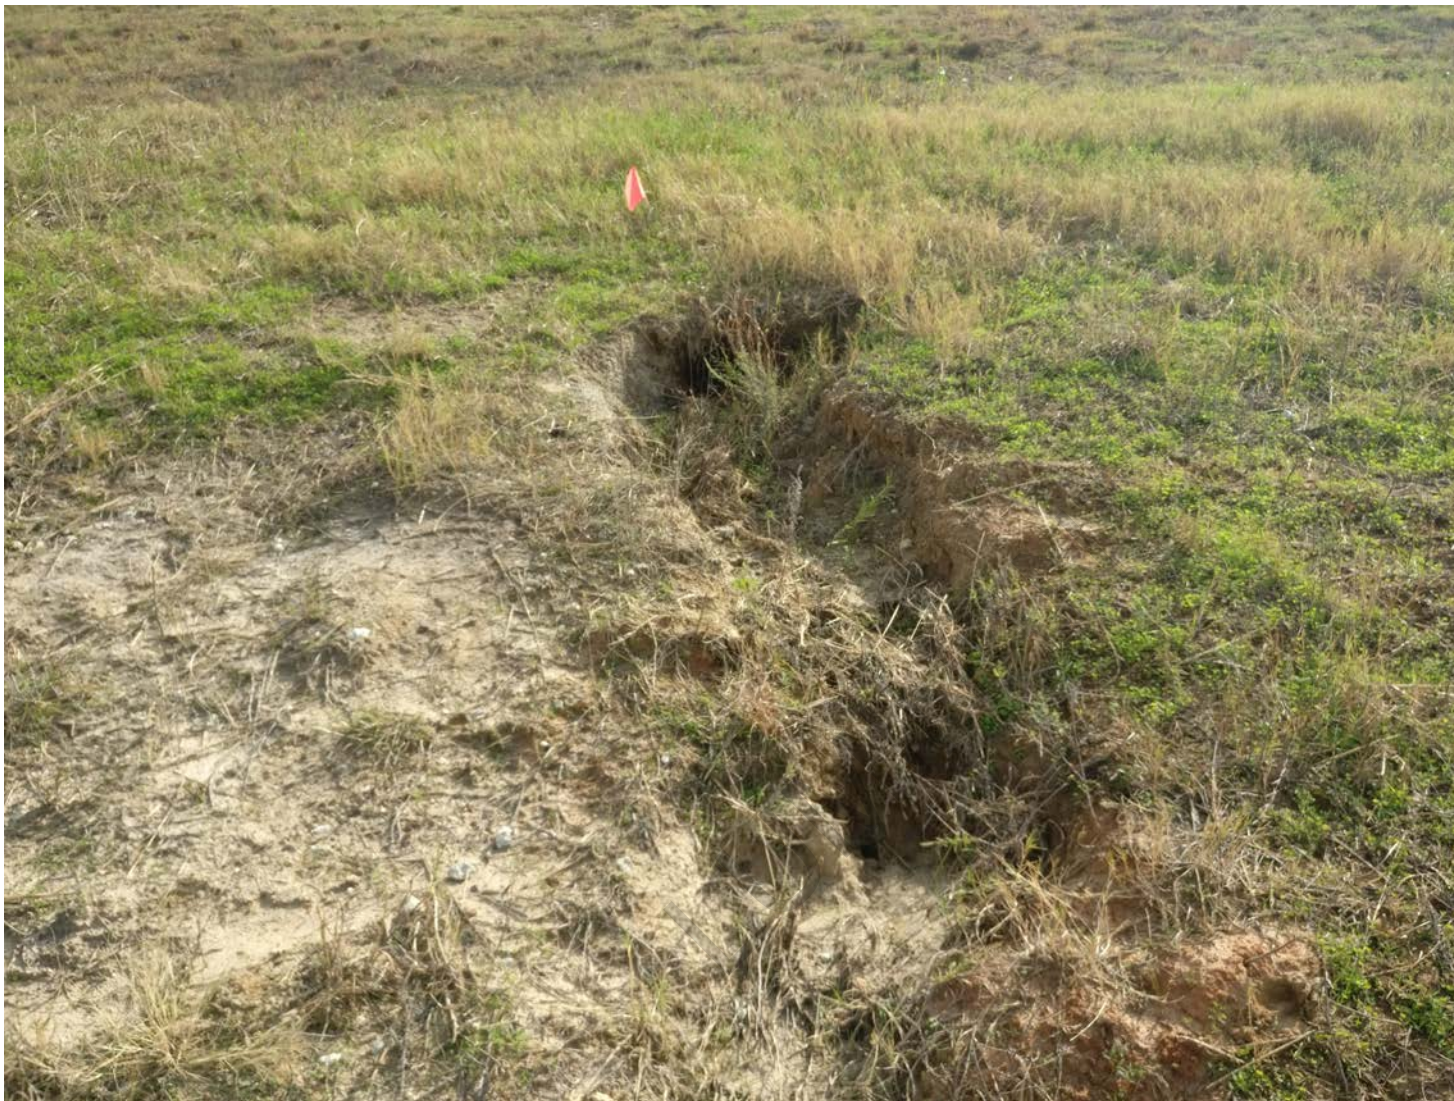
PHOTO DESCRIPTION:
 Rilling on final cover on top
 of Cell 1 – north corner
 (central).

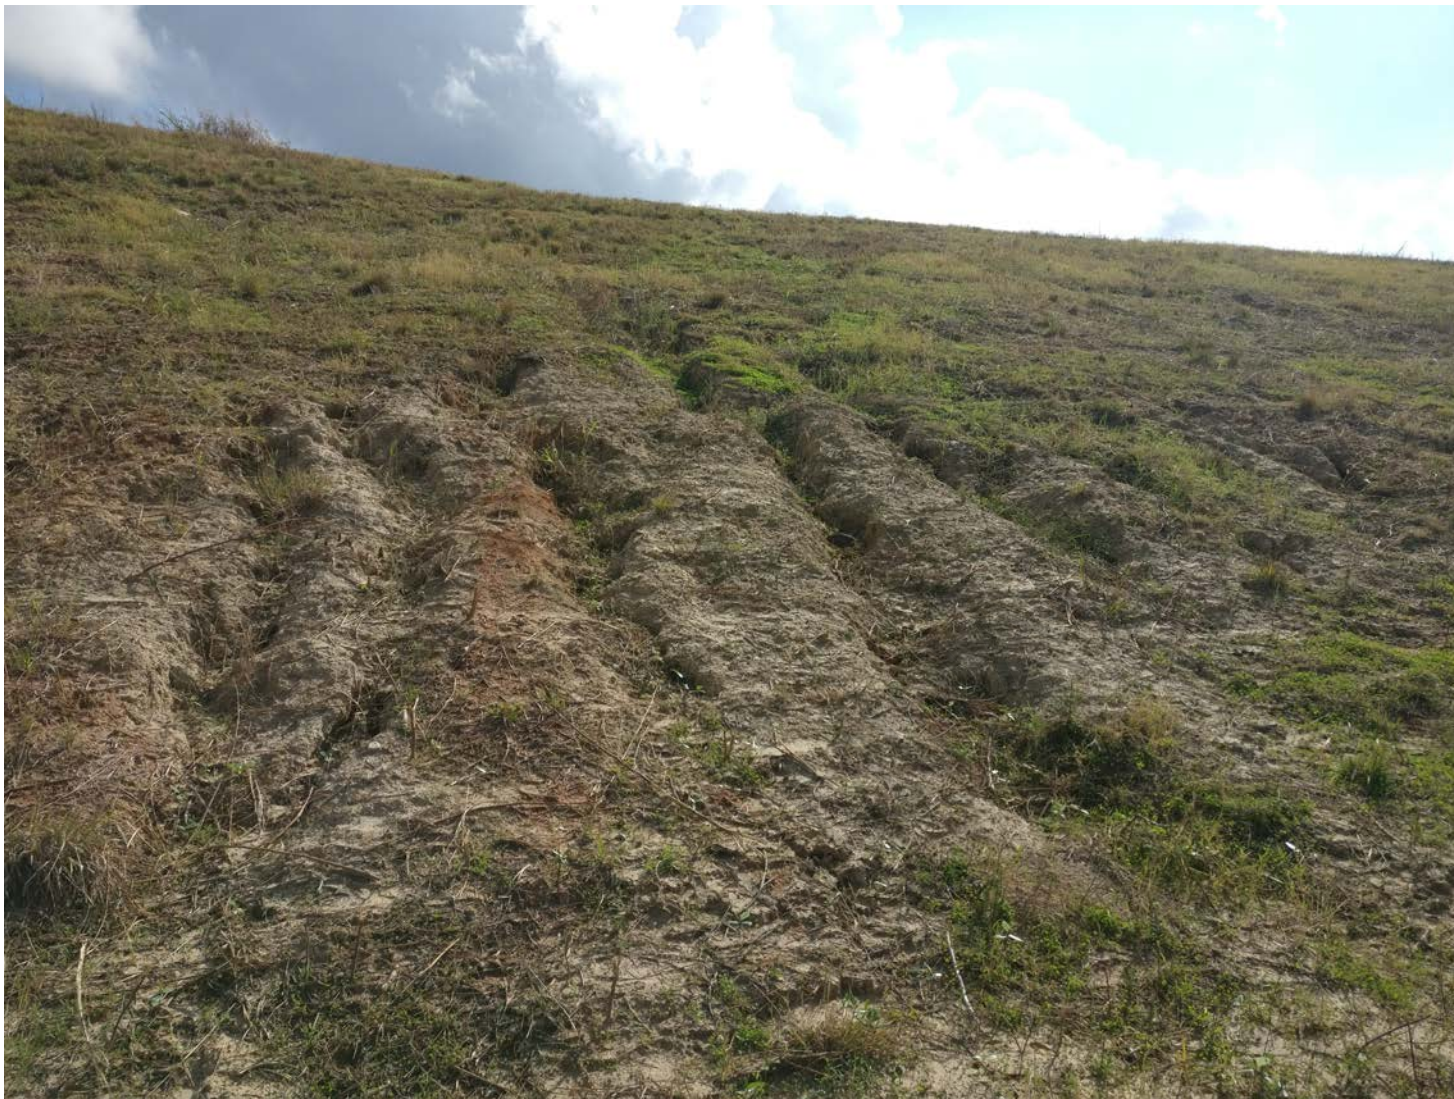
PROJECT NO. 1782004		FILE REF. IMG_20171116_125859.jpg	
	DESIGN	VK	11/09/2017	SCALE: NTS
	CHECK	VK	11/09/2017	REV: 0
	REVIEW	JBF	11/09/2017	PHOTO 12

PHOTO DESCRIPTION:
 Erosion rills on north slope
 of Cell 1 (central)

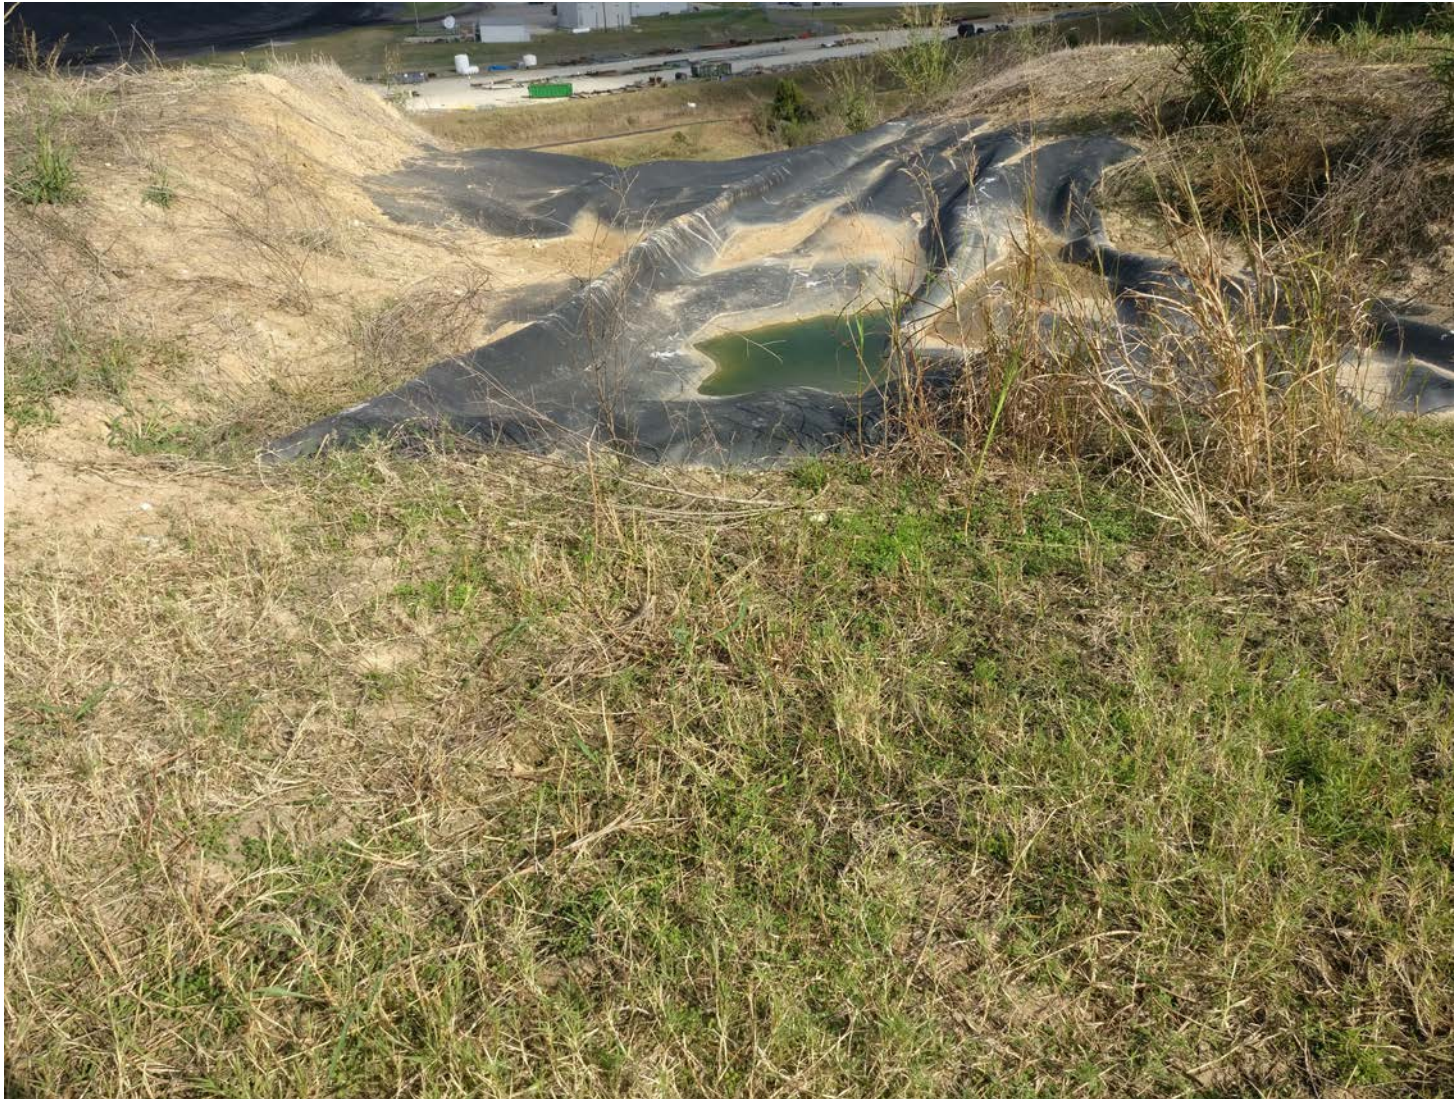
PROJECT NO. 1782004		FILE REF. IMG_20171116_131428.jpg	
	DESIGN	VK	11/09/2017	SCALE: NTS
	CHECK	VK	11/09/2017	REV: 0
	REVIEW	JBF	11/09/2017	PHOTO 14

PHOTO DESCRIPTION:
 Minor ponding and vegetation
 at the top of geomembrane
 downchute on Cell 1 eastern
 slope.

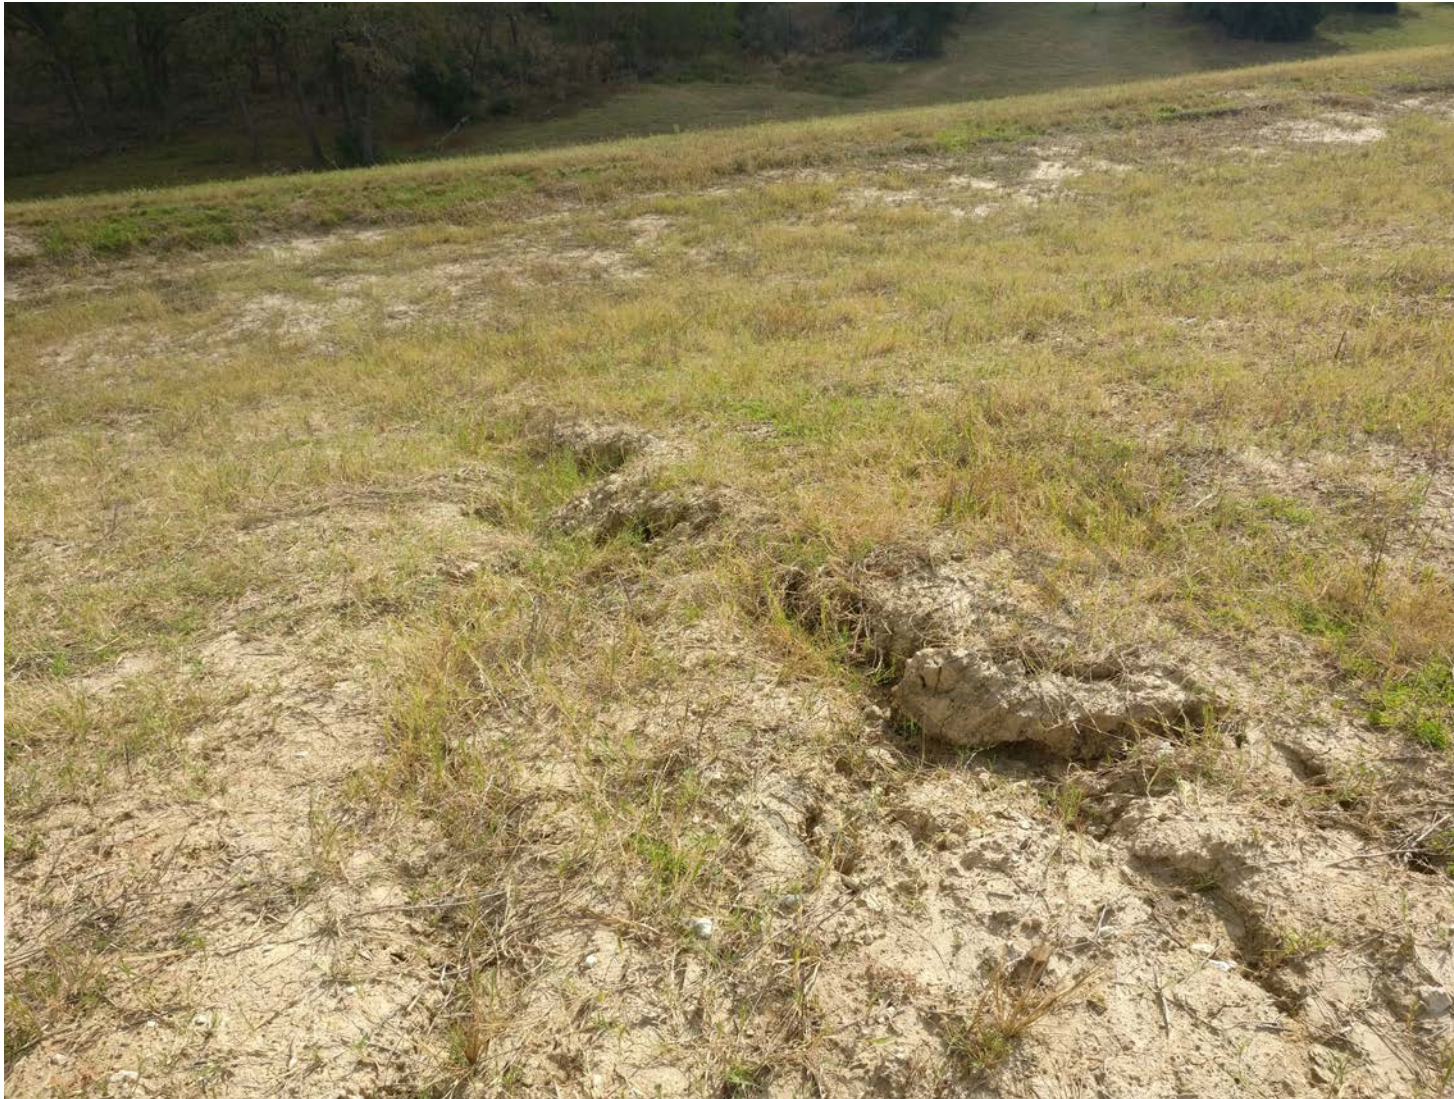
PROJECT NO. 1782004		FILE REF. IMG_20171116_131652.jpg	
	DESIGN	VK	11/09/2017	SCALE: NTS
	CHECK	VK	11/09/2017	REV: 0
	REVIEW	JBF	11/09/2017	PHOTO 15

PHOTO DESCRIPTION:
 Erosion rills on upper bench
 of southern slope of Cell 1.

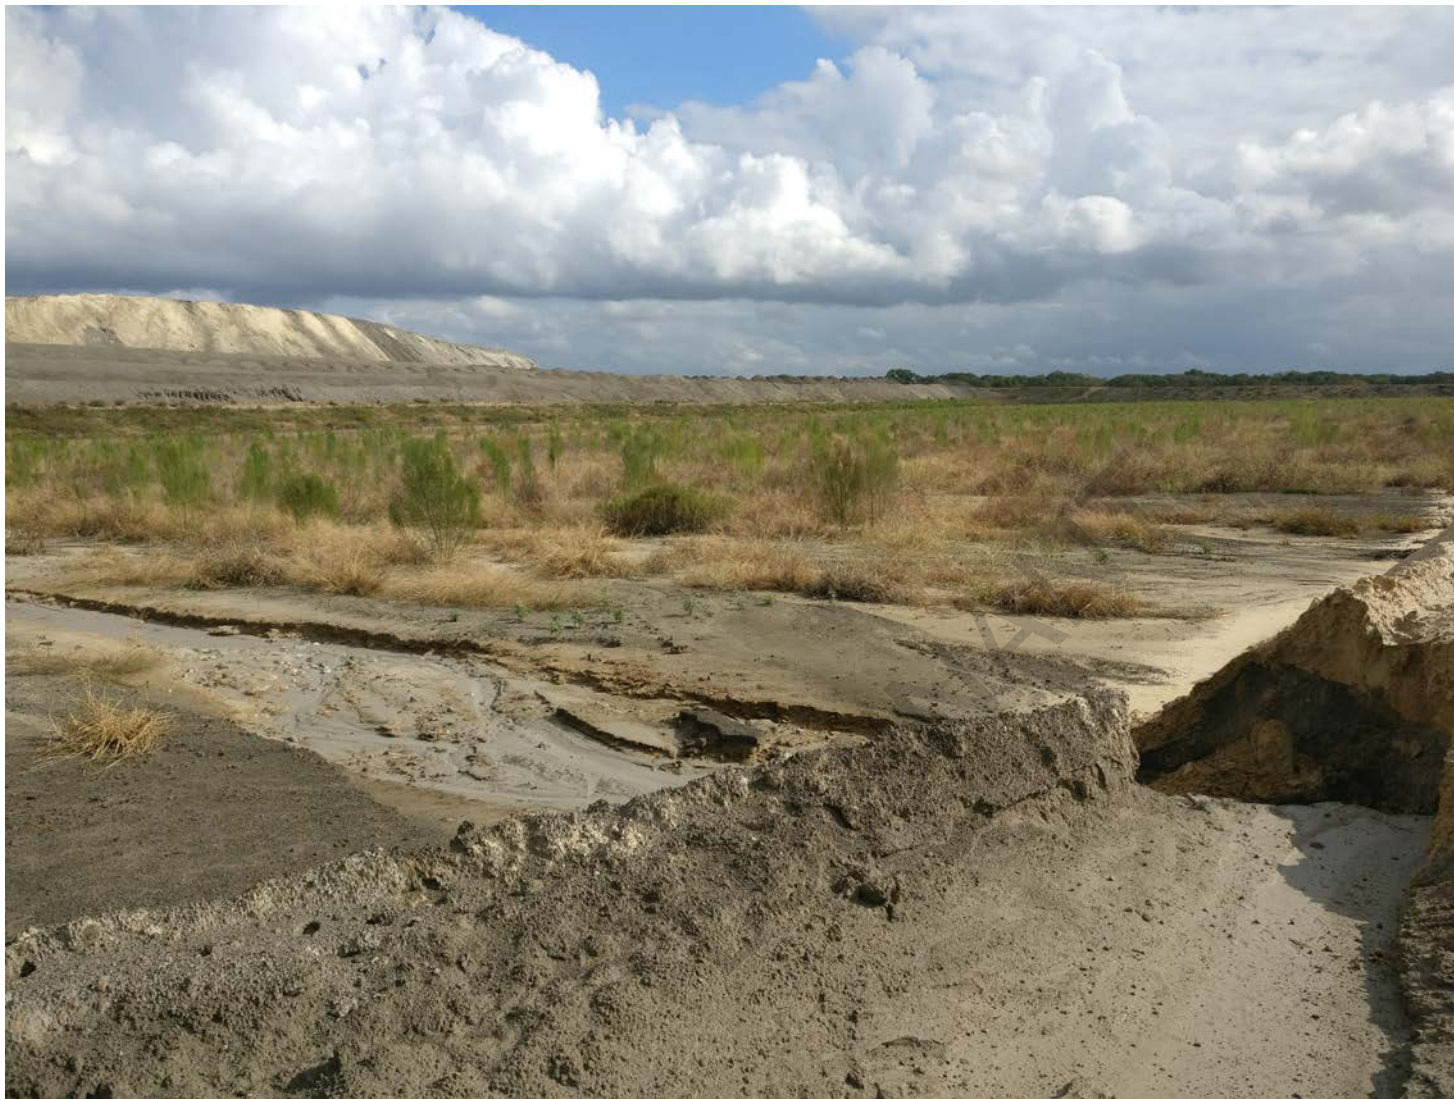
PROJECT NO. 1782004		FILE REF. IMG_20171116_132512.jpg	
	DESIGN	VK	11/09/2017	SCALE: NTS
	CHECK	VK	11/09/2017	REV: 0
	REVIEW	JBF	11/09/2017	PHOTO 16

PHOTO DESCRIPTION:
 Vegetation on the floor of
 Cell 4.

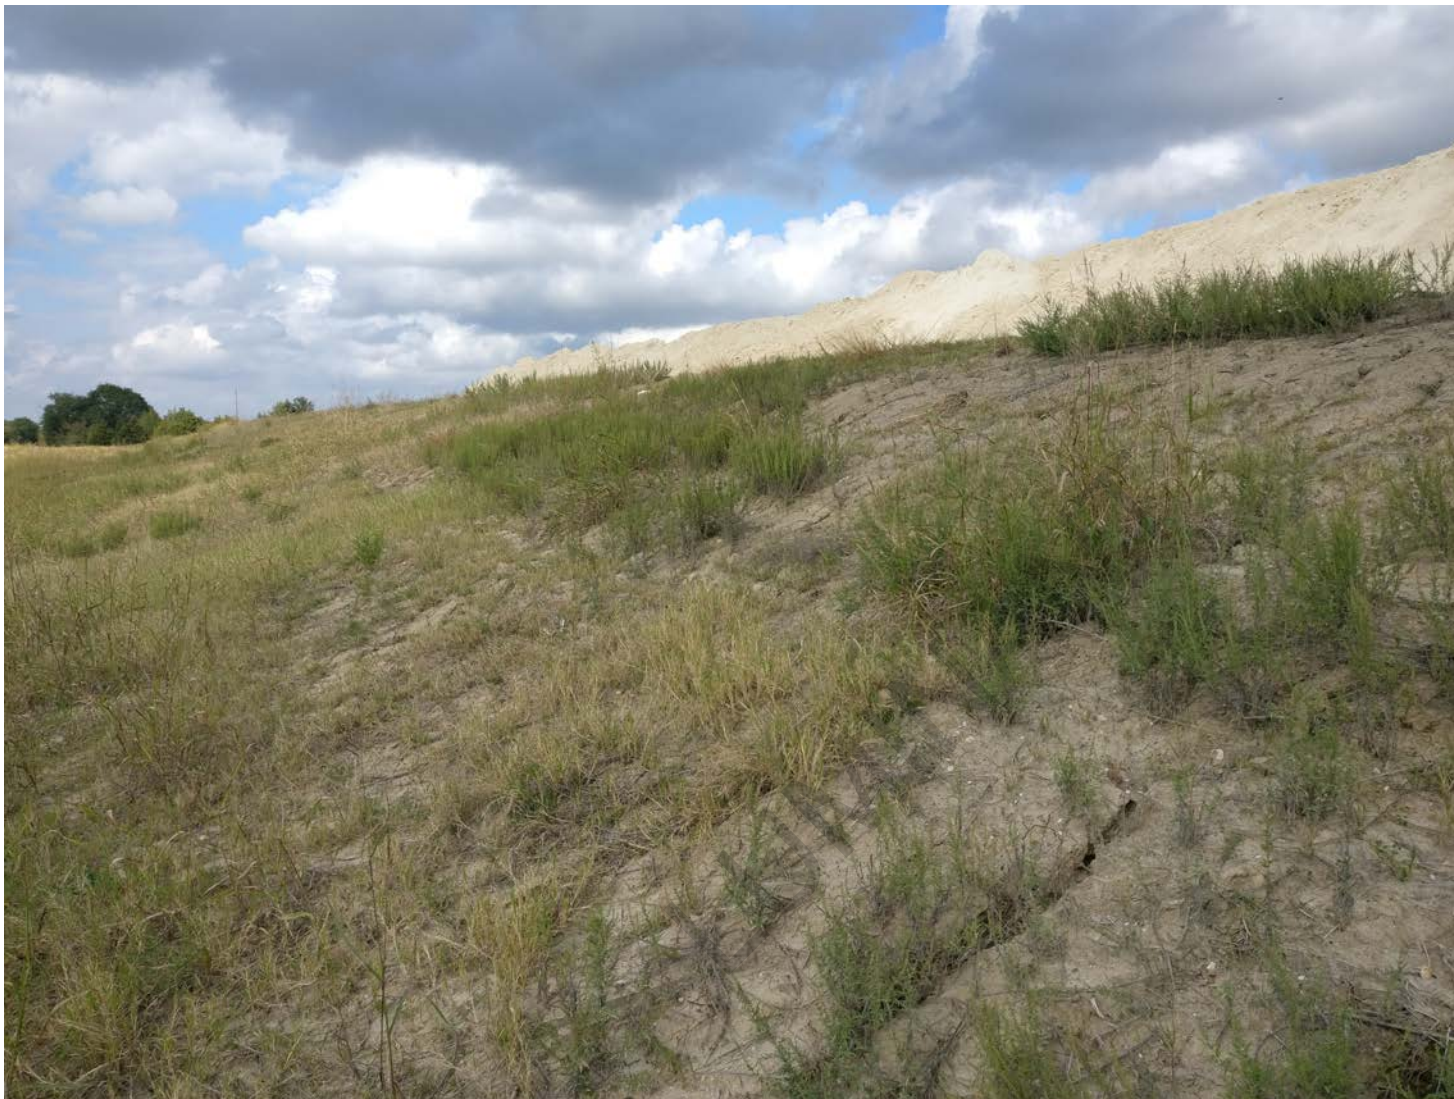
ANNUAL INSPECTION – OAK GROVE SES			
	LUMINANT ENERGY			
	OAK GROVE, TEXAS			
ASH LANDFILL 1				
 	PROJECT NO. 1782004		FILE REF. IMG_20171116_134136.jpg	
	DESIGN	VK	11/09/2017	SCALE: NTS
	CHECK	VK	11/09/2017	REV: 0
	REVIEW	JBF	11/09/2017	PHOTO 17

PHOTO DESCRIPTION:
 Erosion and sparse vegetation
 on western slope of Cell 4.

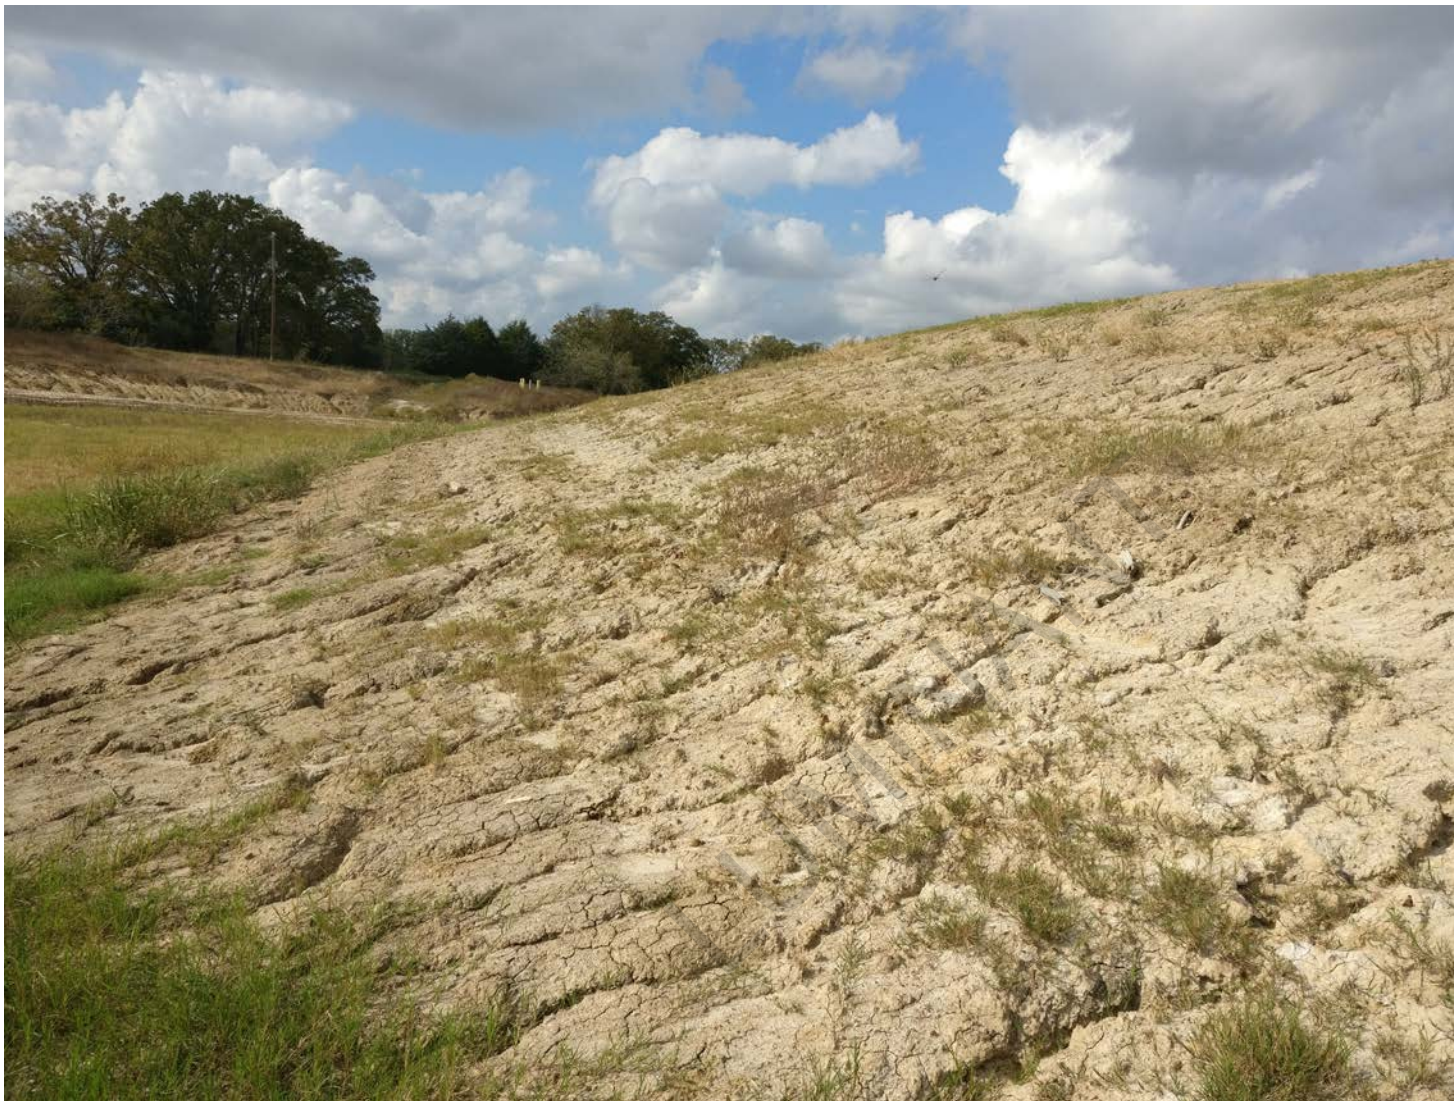
PROJECT NO. 1782004		FILE REF. IMG_20171116_134537.jpg	
	DESIGN	VK	11/09/2017	SCALE: NTS
	CHECK	VK	11/09/2017	REV: 0
	REVIEW	JBF	11/09/2017	PHOTO 18

PHOTO DESCRIPTION:
 Erosion on Cell 4 – SW corner
 of embankment.

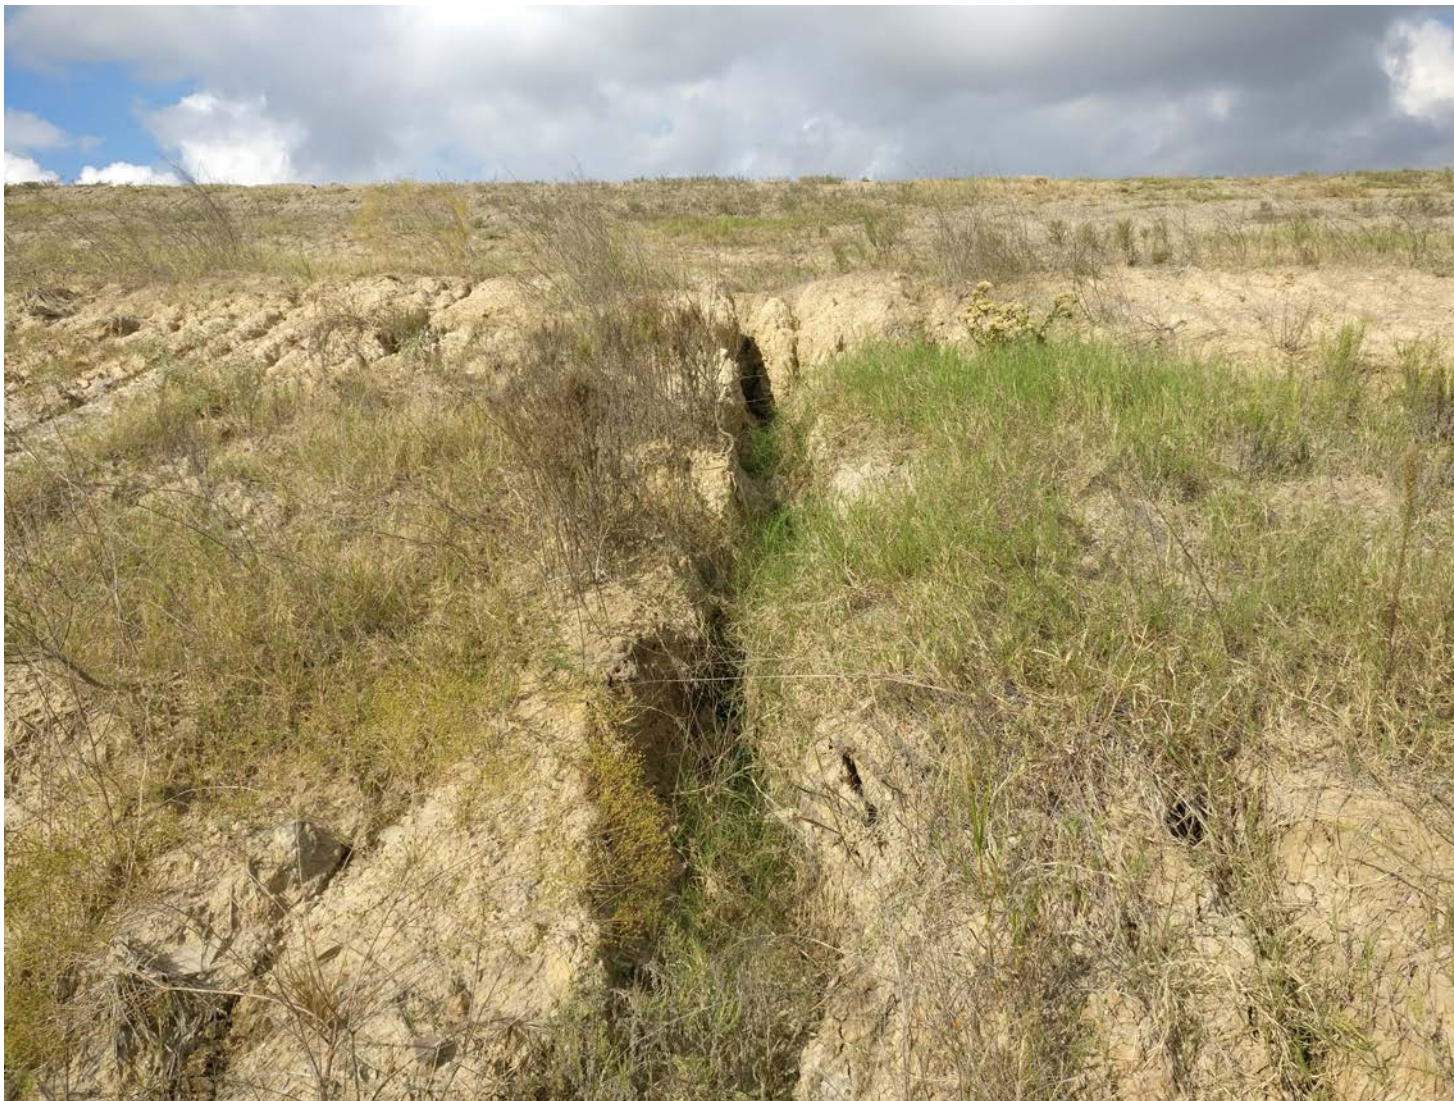
PROJECT NO. 1782004		FILE REF. IMG_20171116_134900.jpg	
	DESIGN	VK	11/09/2017	SCALE: NTS
	CHECK	VK	11/09/2017	REV: 0
	REVIEW	JBF	11/09/2017	PHOTO 19

PHOTO DESCRIPTION:
 Large erosion rills on Cell 4
 – southern embankment.

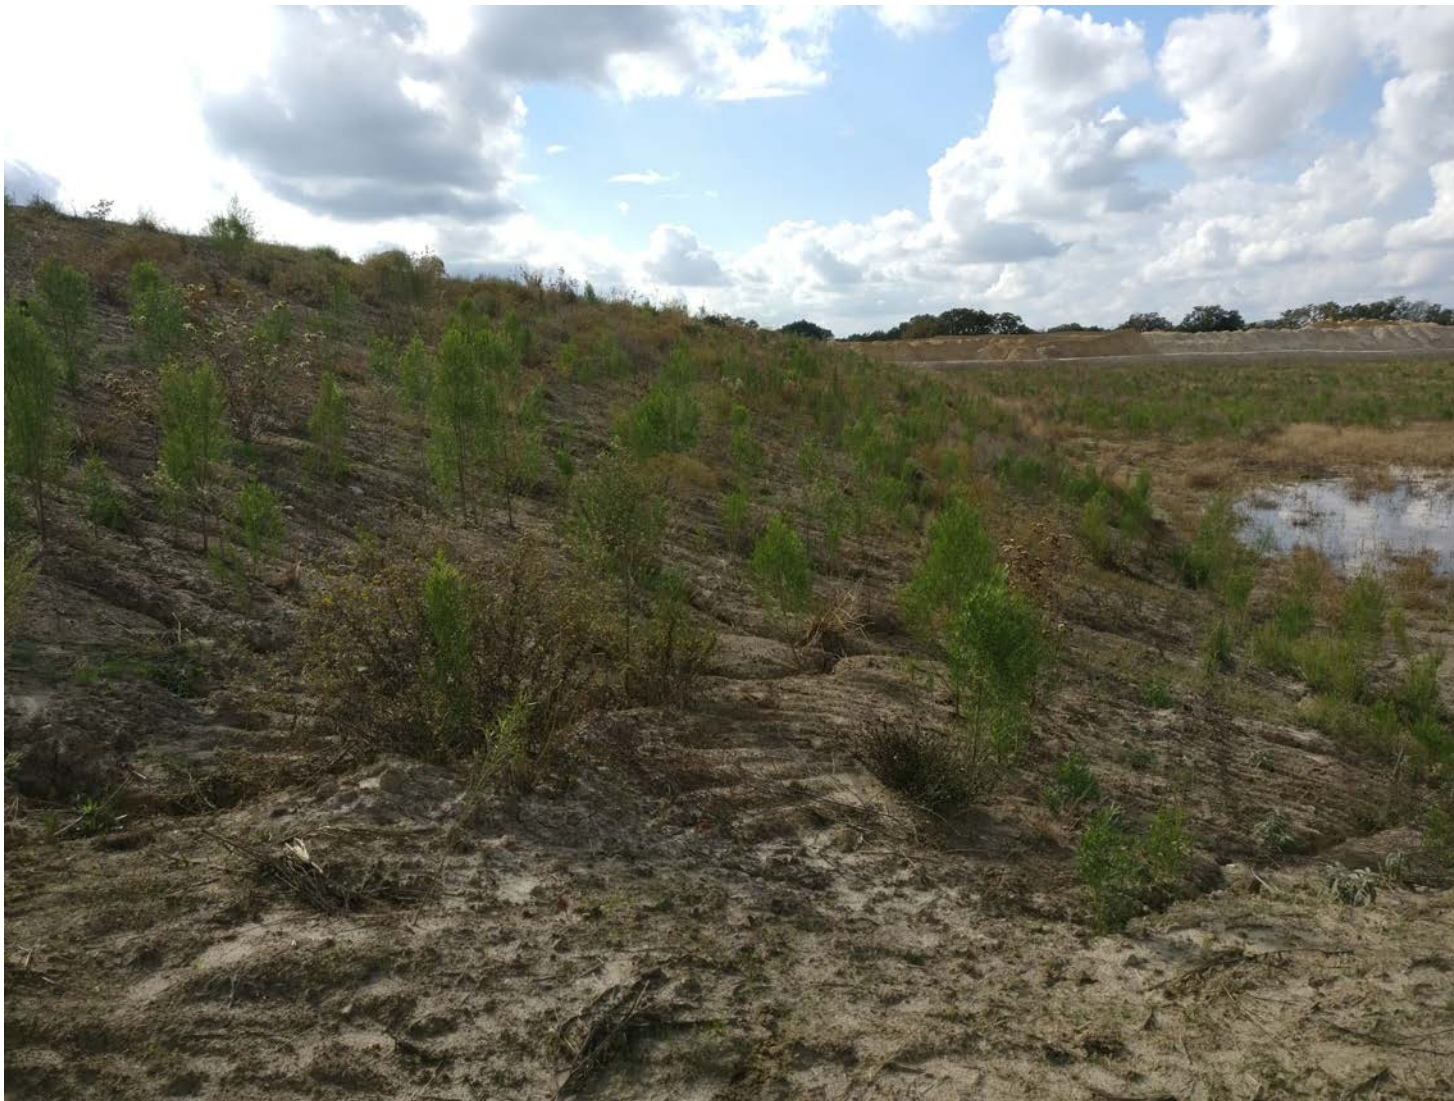
PROJECT NO. 1782004		FILE REF. IMG_20171116_135113.jpg	
	DESIGN	VK	11/09/2017	SCALE: NTS
	CHECK	VK	11/09/2017	REV: 0
	REVIEW	JBF	11/09/2017	PHOTO 20

PHOTO DESCRIPTION:
 Vegetation on internal slopes
 of Cell 4 – SW corner.
