Dynegy Midwest Generation, LLC

BALDWIN POWER PLANT
CITY OF BALDWIN, RANDOLPH COUNTY, ILLINOIS

Emergency Action Plan (EAP)

40 C.F.R. § 257.73(a)(3); 35 Ill. Adm. Code 845.520
Coal Combustion Residual (CCR) Impoundments
& Related Facilities

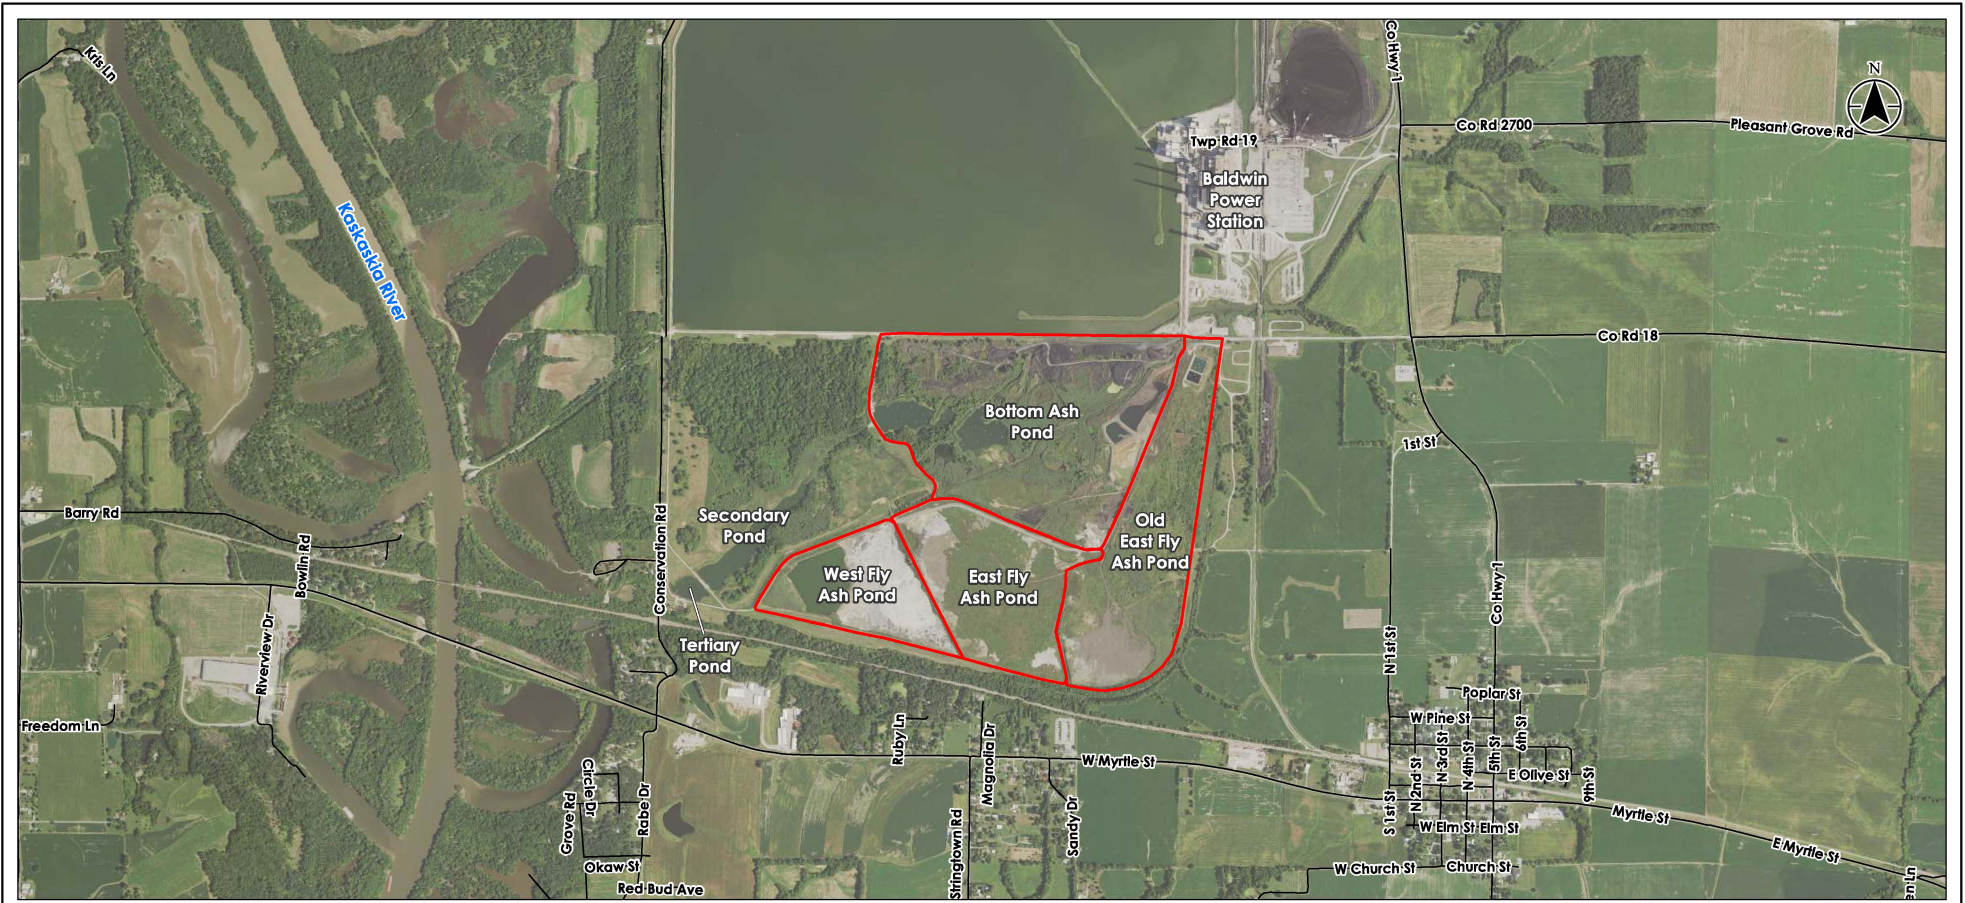
Legend
 CCR Surface Impoundment Boundary
