JOPPA POWER PLANT *JOPPA, MASSAC COUNTY, ILLINOIS*

Emergency Action Plan (EAP)

40 C.F.R. § 257.73(a)(3), Ill. Adm. Code 845.520 Coal Combustion Residual (CCR) Impoundment & Related Facilities

- East Ash Pond (NID # IL50714) (IEPA # W1270100004-02)

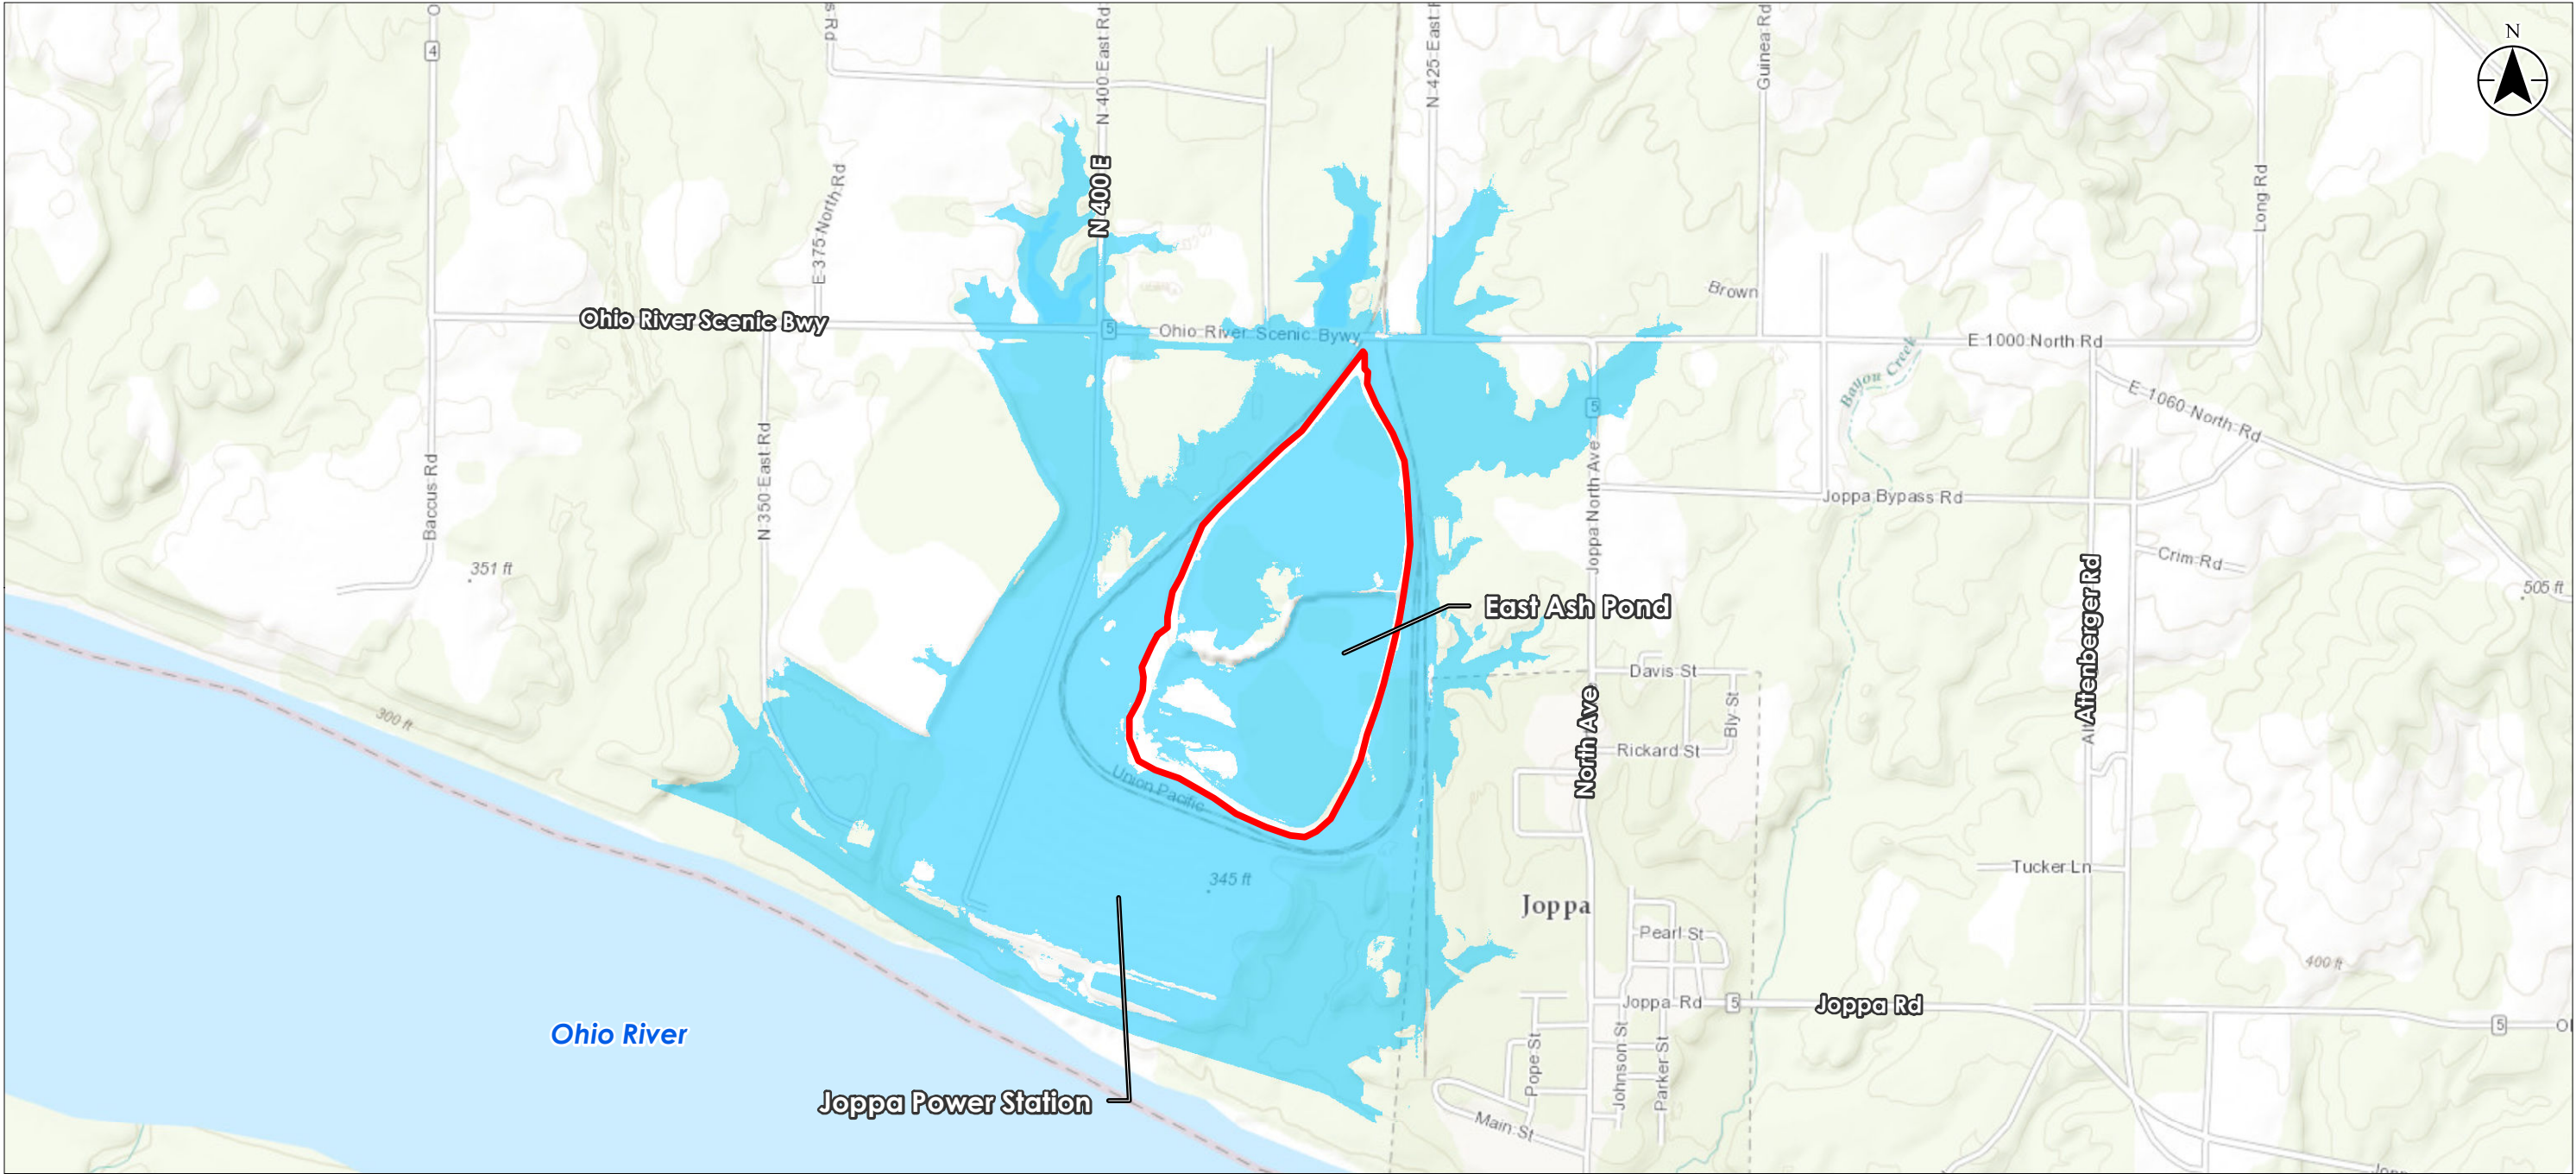
The breach scenario evaluated for the East Ash Pond was a piping breach during the Probable Maximum Precipitation (PMP) event. The East Ash Pond is perched and inflow from the storm events would consist of rainfall falling directly on the Pond. The freeboard for the Pond is greater than the PMP volume, therefore the pool elevation for the breach scenario was the normal pool plus the volume of the PMP event (38-inch depth across 103 AC footprint). Since the PMP event does not overtop the crest of the East Ash Pond, a piping breach was evaluated instead of an overtopping breach. Six breach locations were selected around the East Ash Pond. These locations include: one to the north, two breaches to the west, one breach to the south, and two breaches to the east. The total inundation extents were a combination of the six breach scenarios.

Approximate inundation area is illustrated in Figure 7-1.

- CCR Surface Impoundment Boundary
- Expected Breach Inundation Area
